Pima Environmental Services, LLC
1601 N. Turner Ste 500
Hobbs, NM 88240
575-964-7740

November 1st, 2021

Re: Site Assessment, Remediation, and Closure Report
Forty Niner Ridge Unit #14
API No. 30-015-38563
GPS: Latitude 32.31320 Longitude -103.86963
Unit Letter "I", Sec. 10, T23S, R30E
Eddy County, NM
NMOCD Ref. No. NAPP2116666757

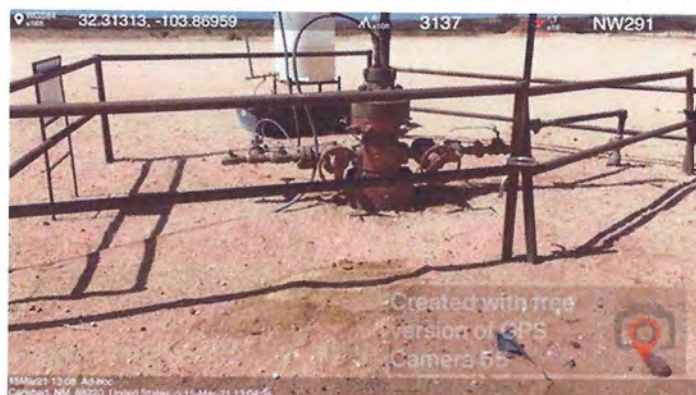
Staining around wellhead on unit #14.

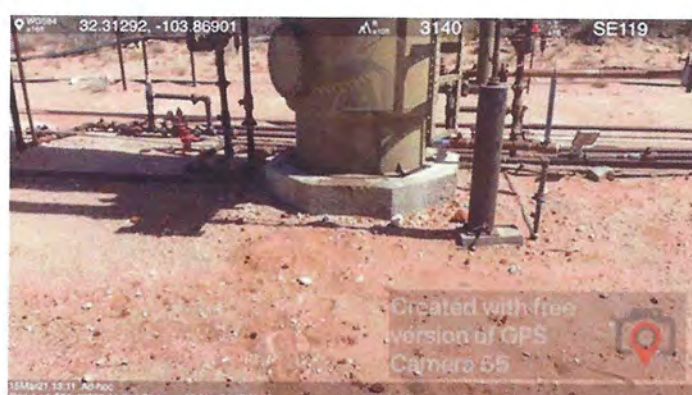
Staining from heater treater.

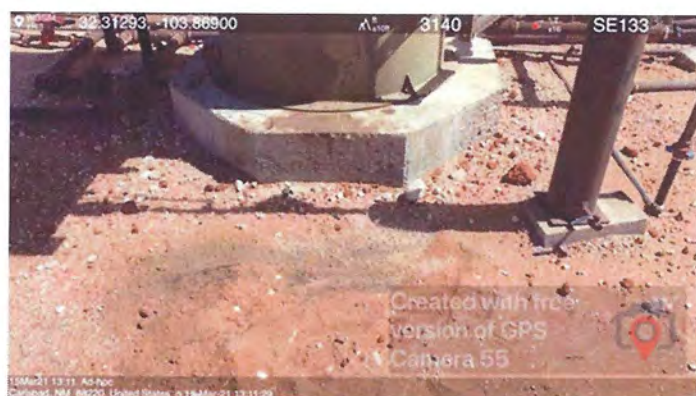
Staining from heater treater visible with minor scrapings.

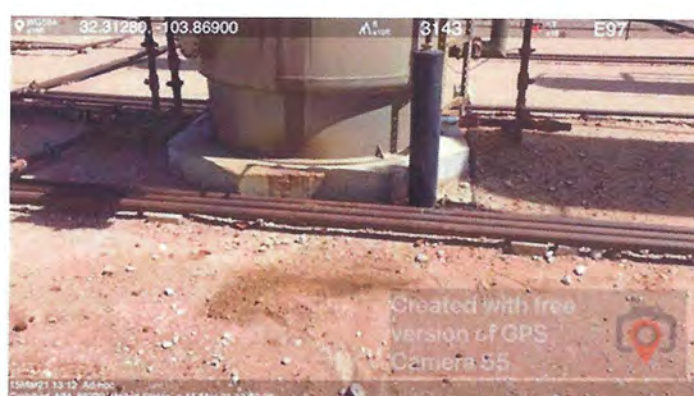
Staining around heater treater.

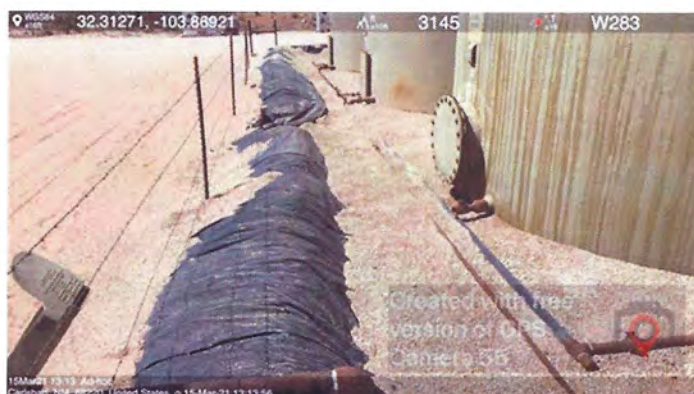
Gravel around tank battery.

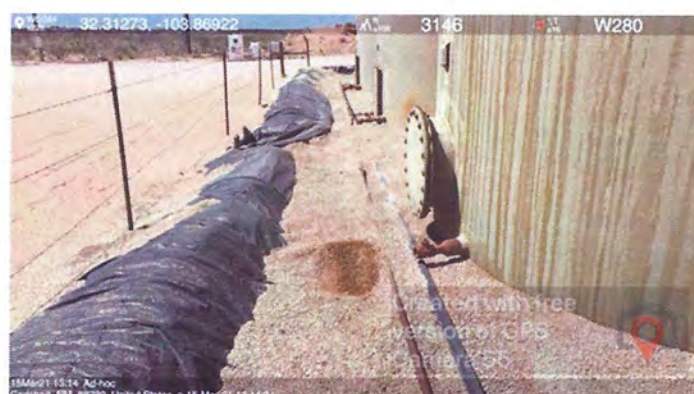
Gravel around tank battery, top layer of gravel scraped away.

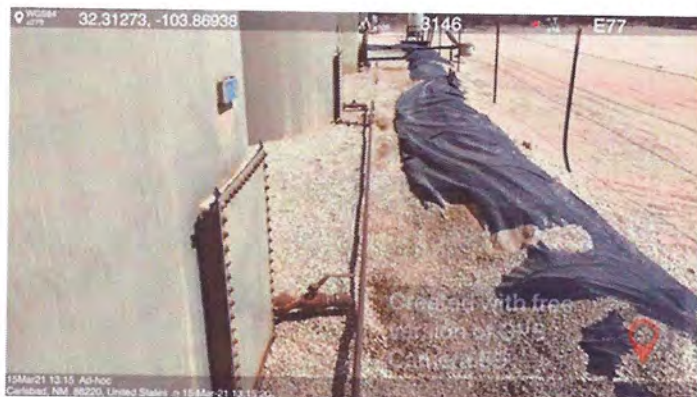
Gravel around tank battery, second location of top layer of gravel moved as noted from previous slide.

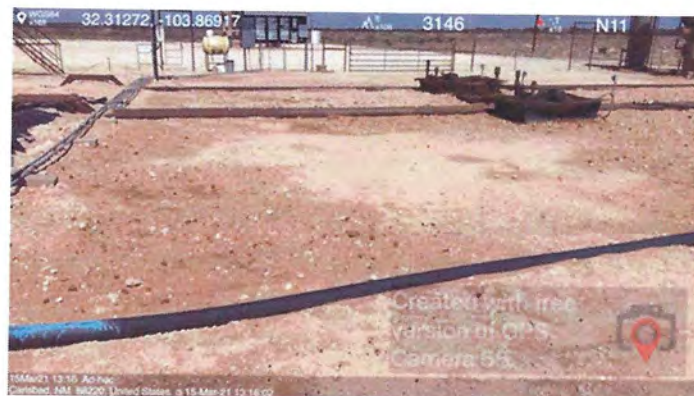
Staining around pump containments and general area.

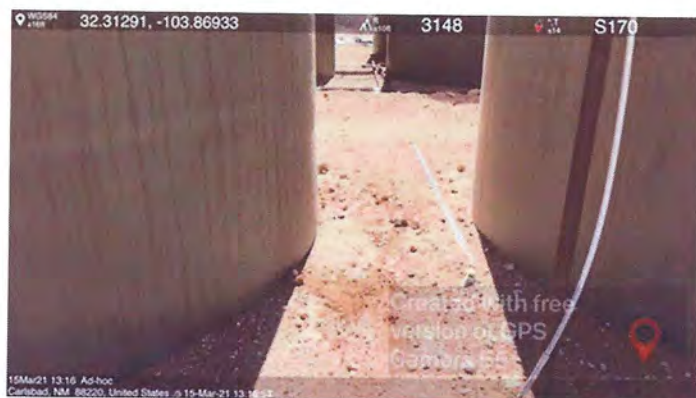
Staining between tanks.

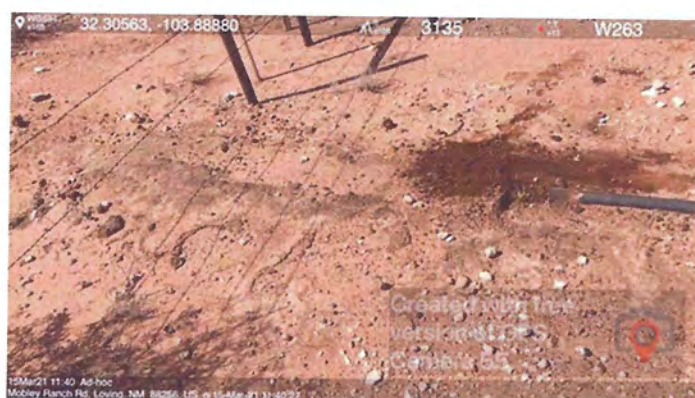
Staining from heater treater visible with minor scrapings.
