Re: Mark Battery #1 & #2: UL G, Sec 3, Ts22S, R37E

Work Plan Mark Battery #1 & #2 Site Chevron USA

**Mark #1 & #2
Tank Battery Closure Report
Lea County, New Mexico**

July 19, 1999

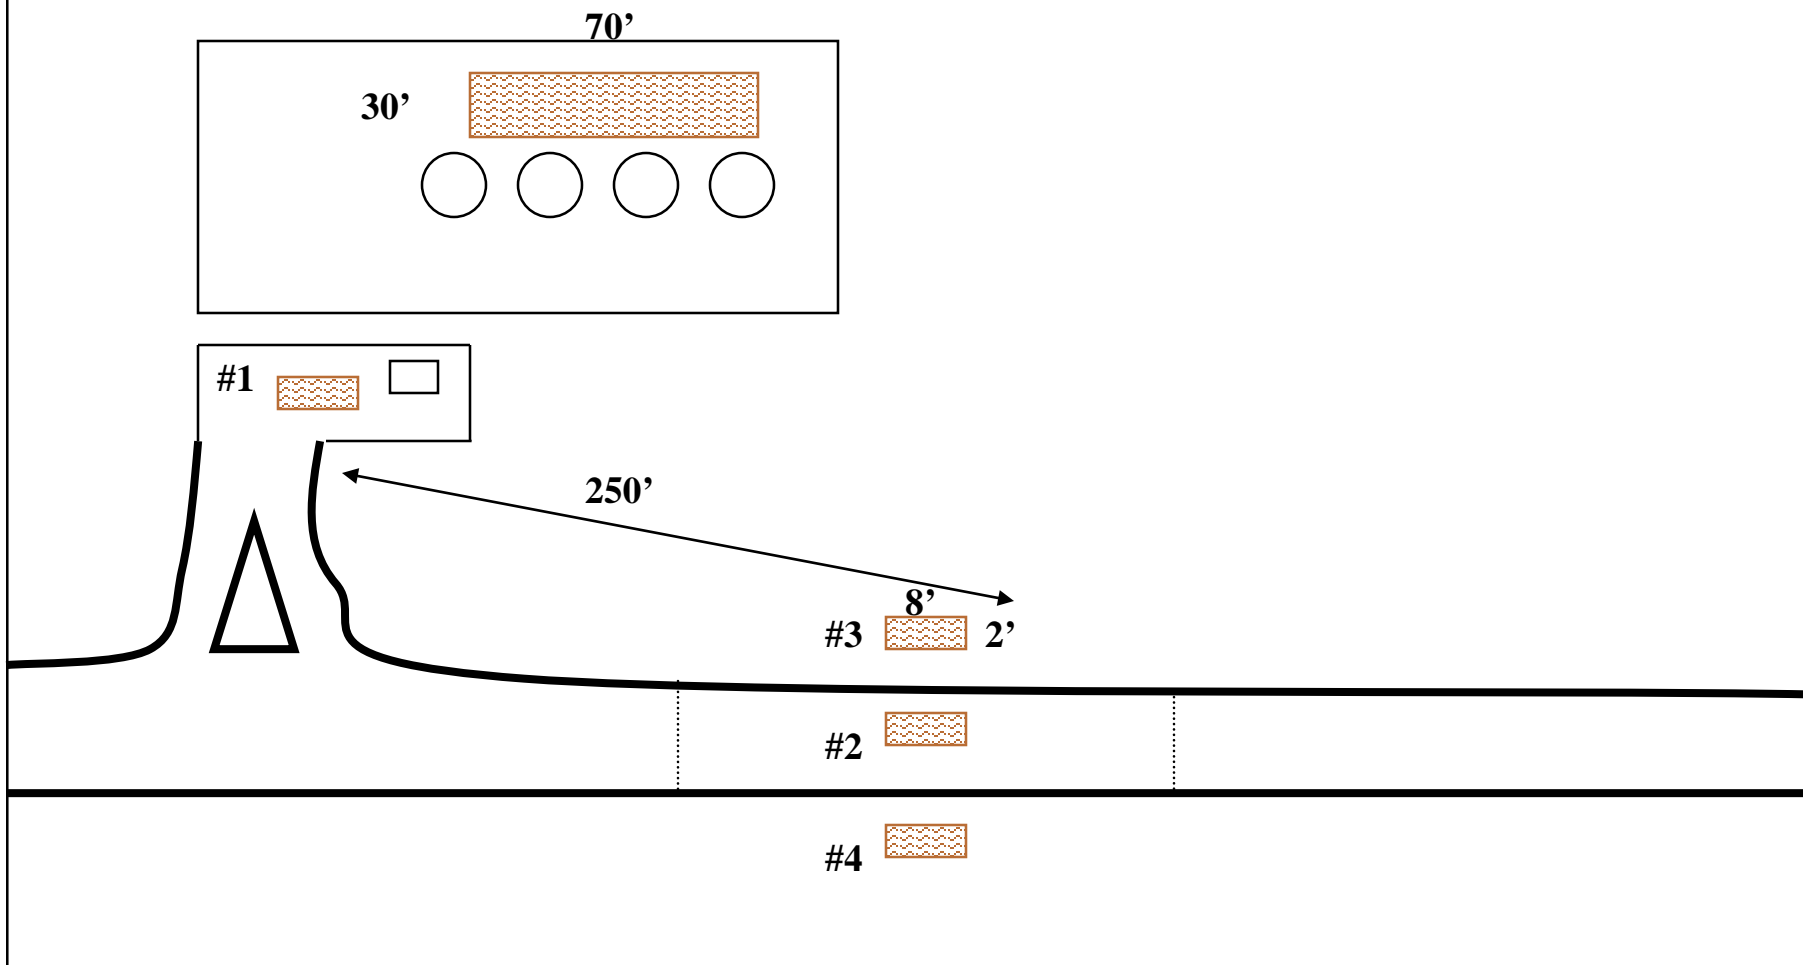
Figure 2 Site Plan

The leak at the tank battery resulted in crude oil being discharged approximately 12" to 18" underground, pooling to the north of the tank battery and then streaming to the west along the load line a pipeline right of way for approximately 400' with widths varying from 1' to 2'. (Site Plan)

Mark Battery #1 & #2 Leak Site Plan

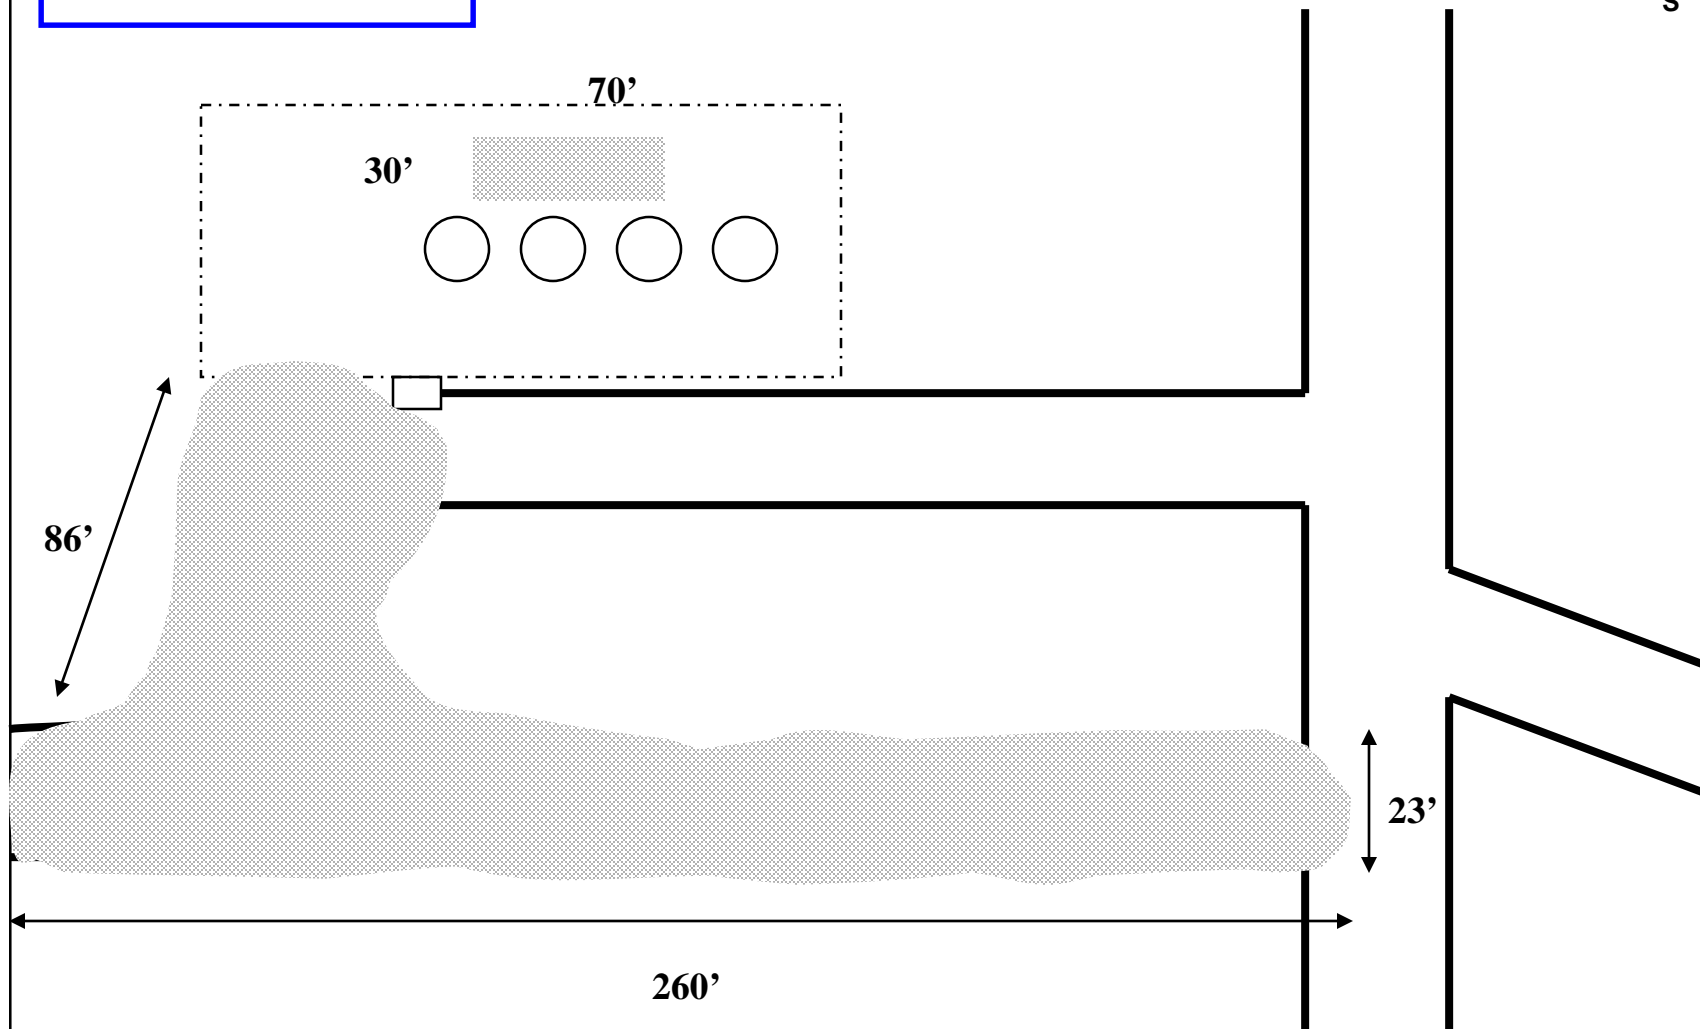
Mark Battery #1 & #2 Final Site Plan

Upon the confirmation of the TPH level of the blended material, the soils were returned to the Mark Battery where they were further blended into the excavated areas onsite. Composite samples were taken of the bottom area in the roadway and the load line area of the Mark battery site. The results from Cardinal laboratories are as follows:
