Release Notification

Closure

Cypress B Tank Spill in containment

Date of incident: 12/18/2020 Location: 32°15′55.65″ N, 103°58′18.23″ W Site Type: Central Tank Battery Incident ID: nAPP2035756355

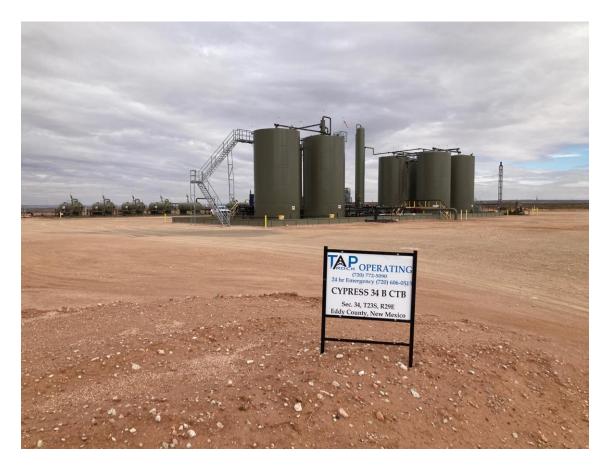
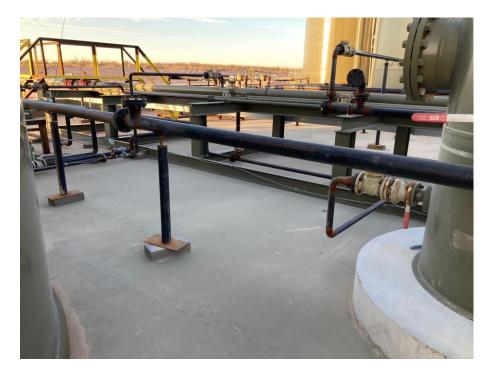
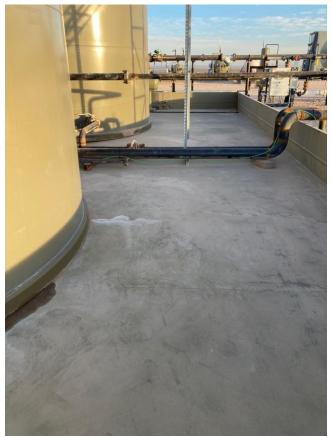
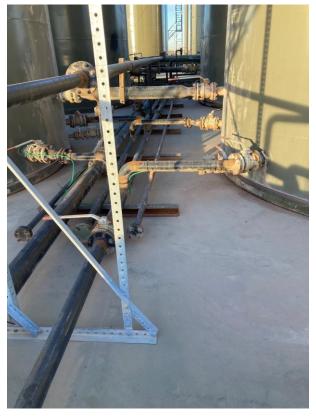
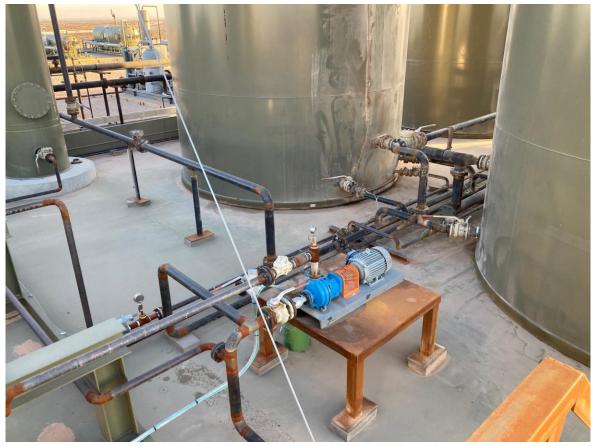
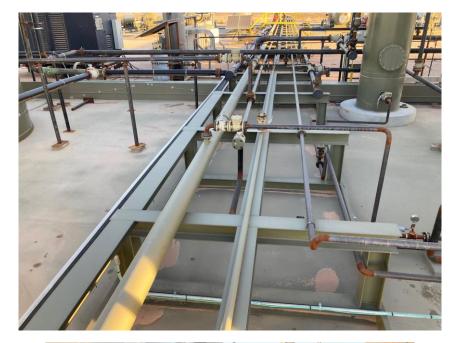
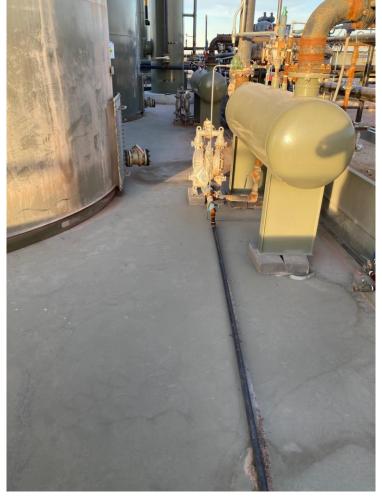
As there was no fluid that left containment a site map, nor a sampling was never done for this release. No lab release was necessary, and a notice was sent to NMOCD on 11/23/2021 to Mike Bratcher for an inspection of the liner. Pictures of liner integrity were taken and are attached below:
