**RE: Liner Inspection and Closure Report
Rattlesnake 16 SWD #001
API No. 30-025-42335
GPS: Latitude 32.043804 Longitude -103.48184
UL "E ", Section 16, Township 26S, Range 34E
NMOCD Reference No. NAPP2114632553**

Liner Inspection FormCompany Name: Devon EnergySite: Rattlesnake 16 SWD #1Lat/Long: 32.043804, -103.481814NMOCD Incident ID
& Incident Date: NAPP2114632553 // 5-25-20212-Day Notification
Sent: via Email from Tom Bynum on 6/1/2021Inspection Date: 6/3/2021

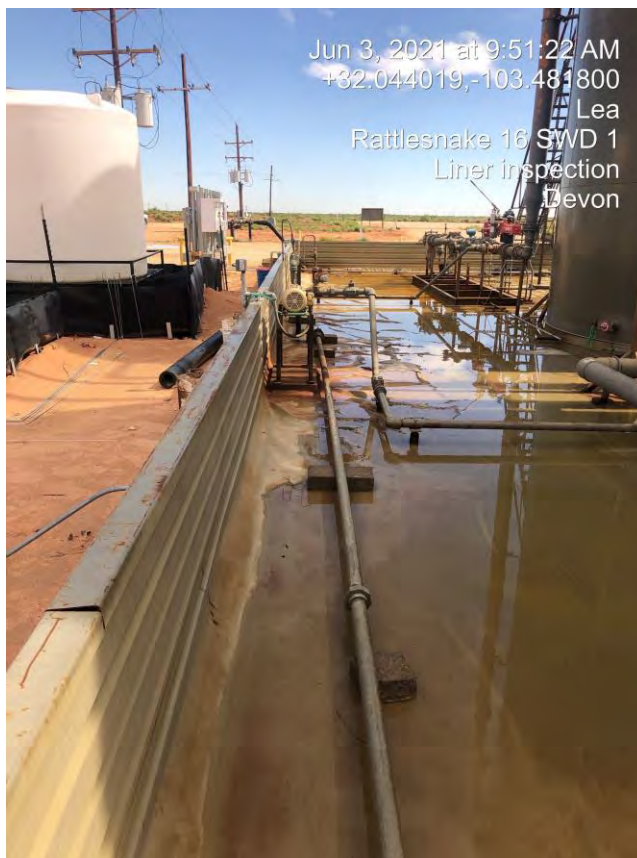
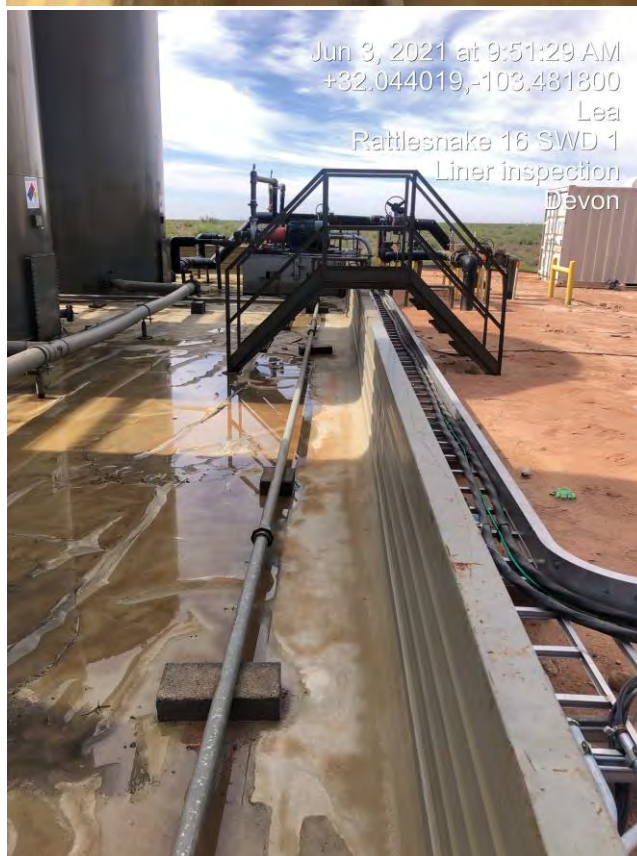
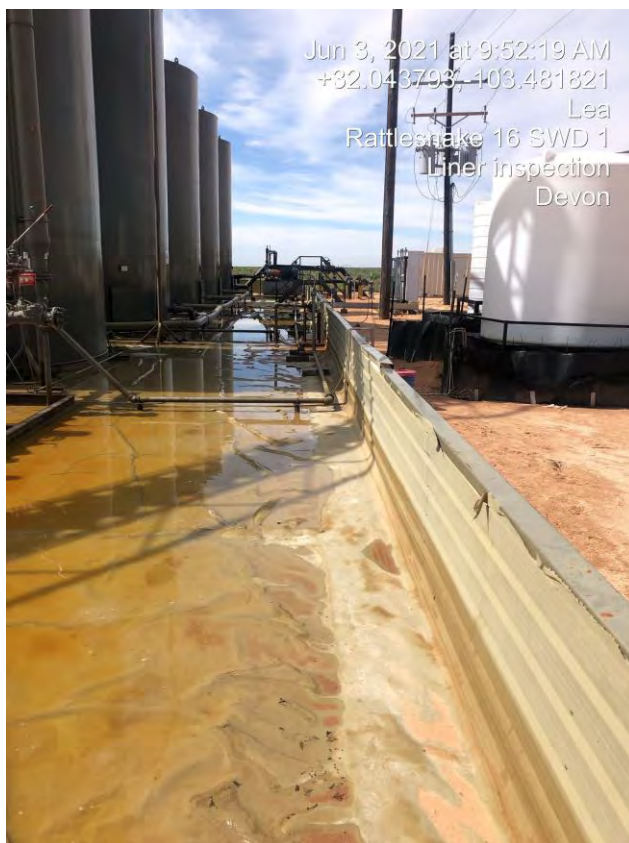
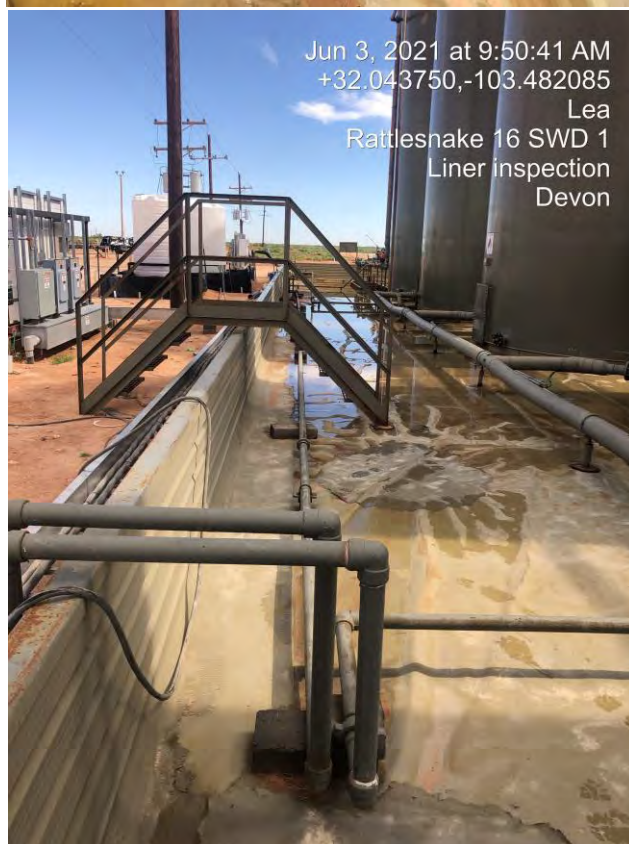
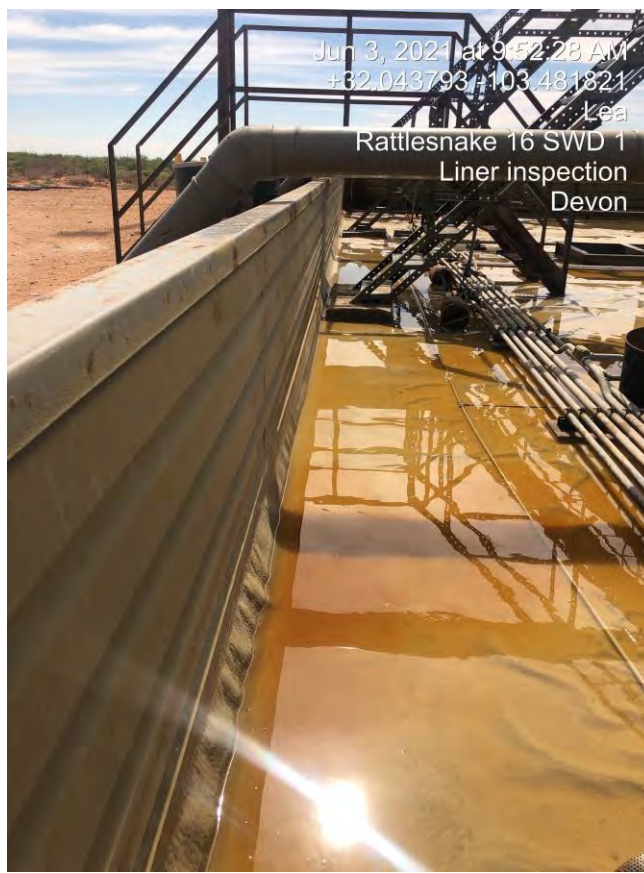
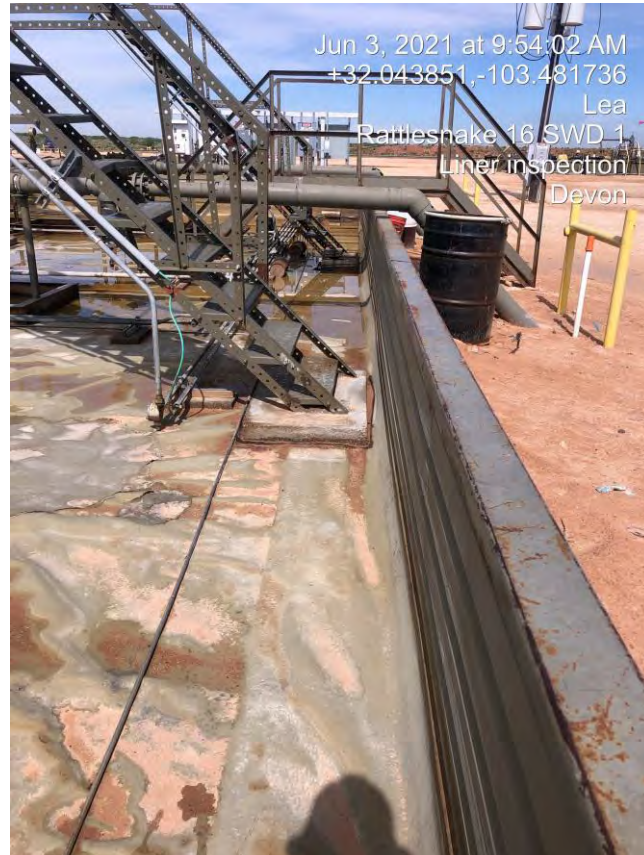
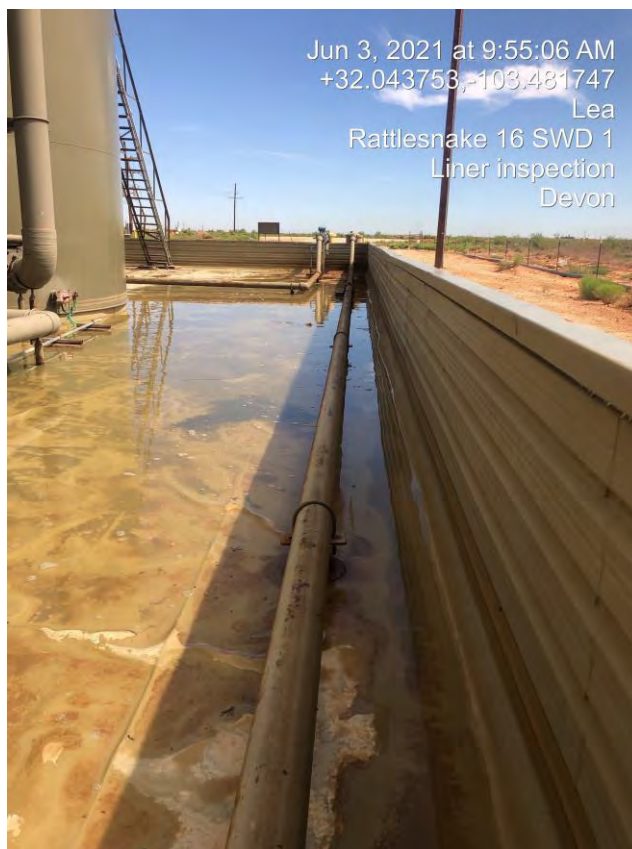
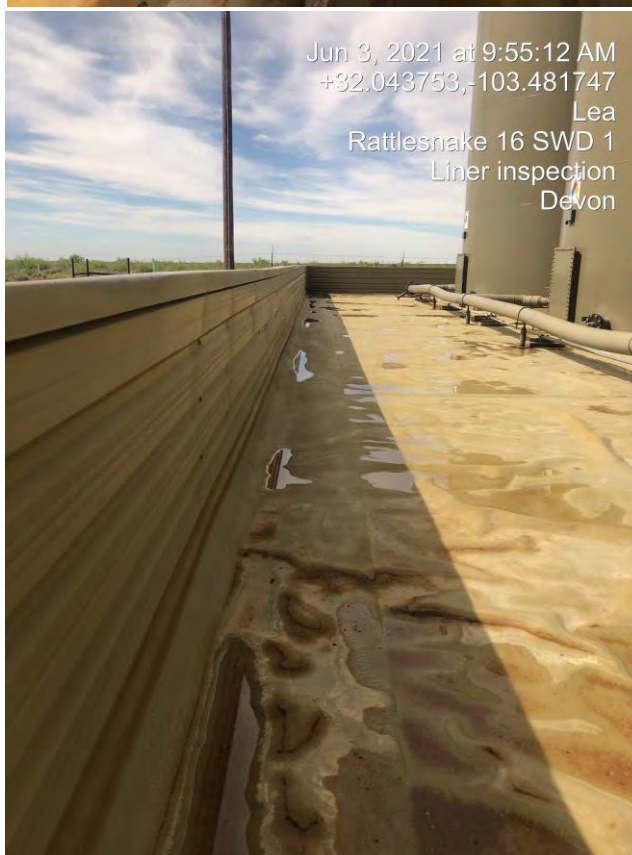
Photographic Documentation

Visualization	Yes	No	Comments
Is there a tear in the liner?		×	
Are there holes in the liner?		×	
Is the liner retaining any fluids?	×		Rainwater
Does the liner have integrity to contain a leak?	×
