Re: Status Report – 2nd Quarter 2021
San Juan 28-7 Unit 183M
Rio Arriba County, New Mexico
OCD Incident No. NCS1901627746

On behalf of Hilcorp Energy Company (Hilcorp), Timberwolf Environmental, LLC (Timberwolf) presents this report to document remedial activities conducted during the second quarter of 2021 (2Q21) at the San Juan 28-7 Unit 183M (Site).

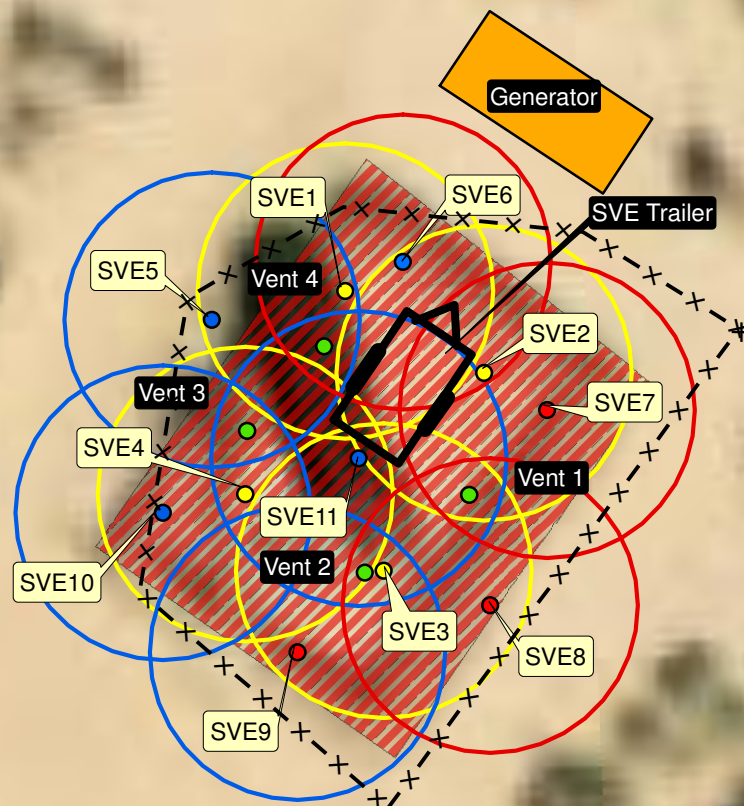
Figure 4
SVE System Overview

The SVE system creates a treatment field of approximately 0.15 acres and treats soil to a depth of approximately 30 ft bgs for a total volume of approximately 7,021 cubic yards of soil. The SVE wells, measured radius of influence of 25 ft, and leg configurations are shown in Figure 4.

Treatment Area= 6,320 ft²
Assuming a 25 ft radius of influence
