Vertex Project #: 22E-01896

Spill Closure Report: Ross Draw Unit #047H
Section 22, Township 26 South, Range 30 East
API: 30-015-41581
County: Eddy
Incident Report: nAPP2213830227

2022 Spill Assessment and Closure
July 2022

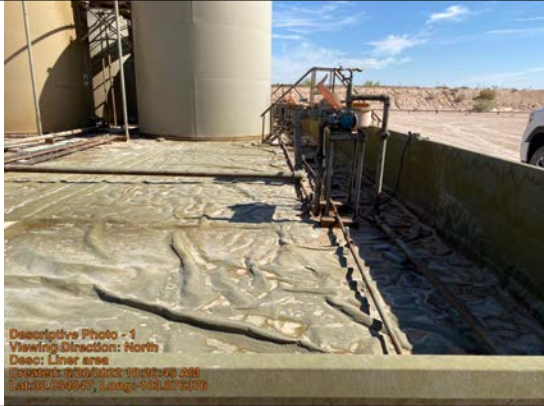
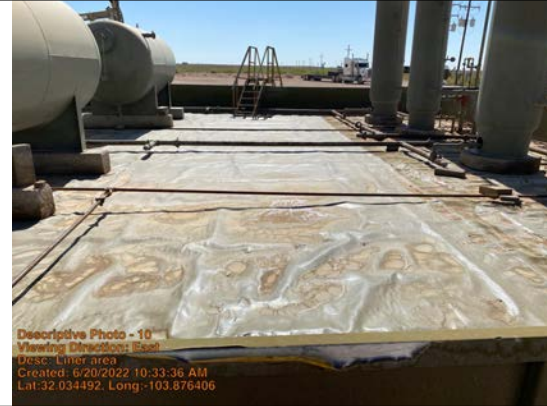
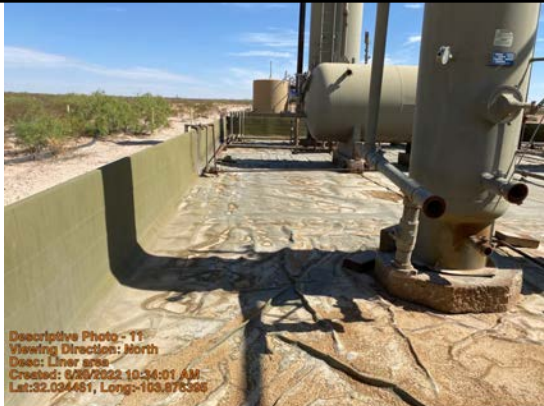
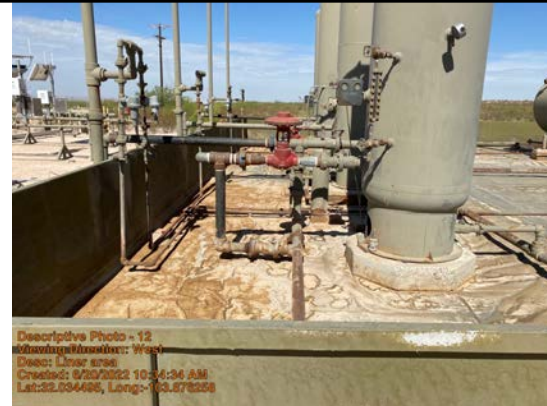
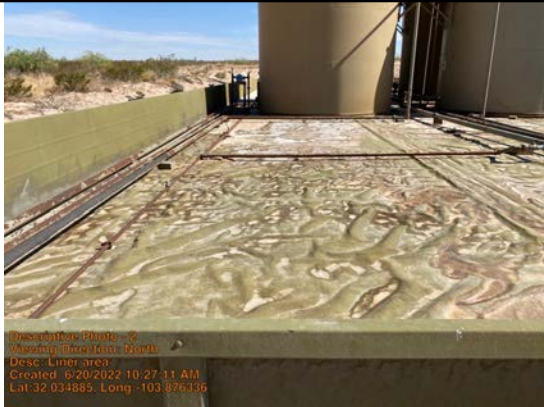
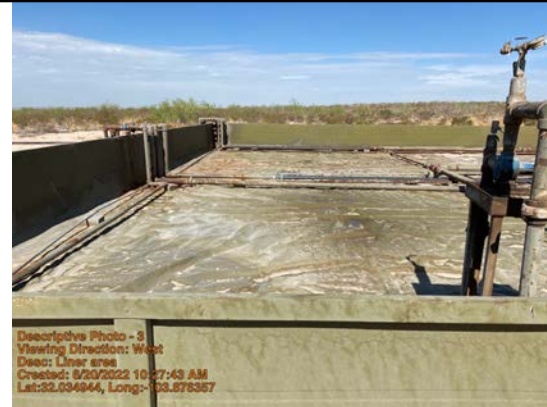
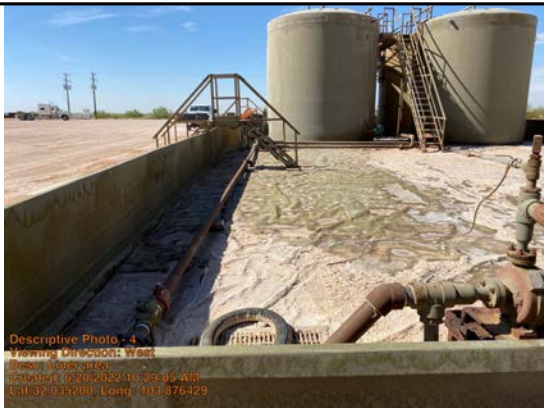
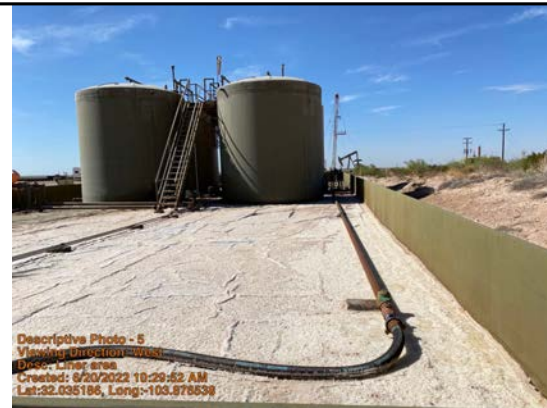
Vertex recommends no remediation action to address the release at RDU 47. The secondary containment liner appeared to be intact and had the ability to contain the release, as shown in the inspection photographs included with the DFR (Attachment 2). There are no anticipated risks to human, ecological or hydrological receptors associated with the release site.

Liner area
