LINER INSPECTION AND CLOSURE REPORT REPORTABLE RELEASE

Spur Energy Partners

Bradley 8 Fee #2H Incident ID: nAPP2207368796 API #30-015-39811 Eddy County, NM

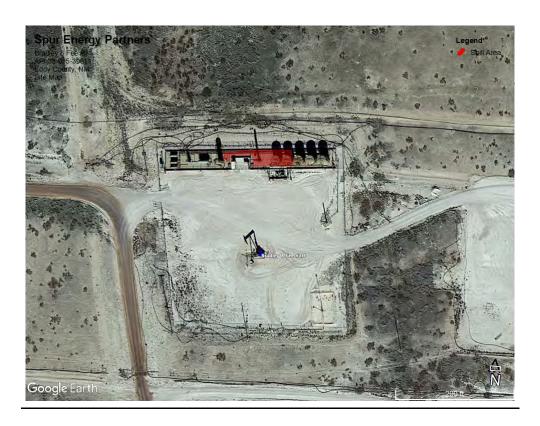
On May 23, 2022, Paragon went to the Bradley and conducted an initial assessment. There were noticeable oil stains on the liner from the spill. There were no signs outside the containment that the liner had been breached. Therefore, no samples were taken. See the site map below showing the affected area.

On June 9, 2022, Paragon returned to the site with equipment and personnel to conduct cleanup activities. We initially sprayed the affected area with surface cleaner. We then power washed and squeegeed the runoff to where the vacuum truck could capture the fluids.
