LINER INSPECTION AND CLOSURE REPORT

Spur Energy Partners
Romo SWD #1
Incident ID: NAPP2212226375
Eddy County, NM

Paragon Environmental LLC
1601 N. TURNER ST. STE.500
Hobbs, NM 88240
575-964-7814

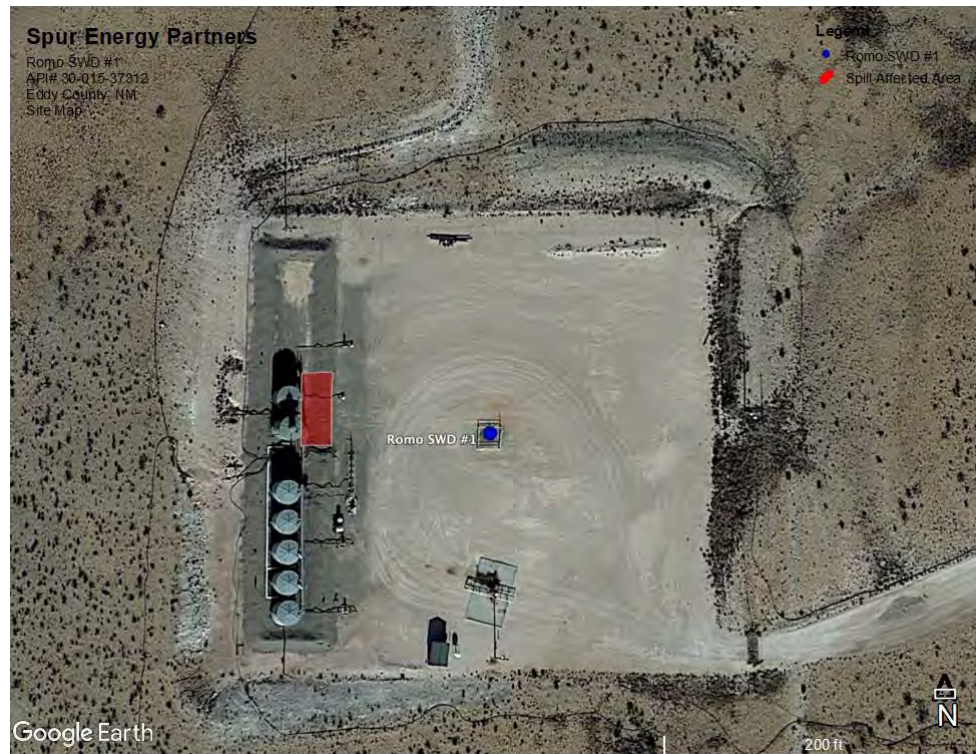
On April 28, 2022, Paragon went to the Romo and conducted an initial assessment. There was obvious staining on the pea-gravel from the spill. There was nothing outside the containment that showed any signs that the spill had breached the containment. Therefore, no samples were taken. See the site map below showing the affected area.

On May 3, 2022, Paragon returned to the site with equipment and personnel to conduct cleanup activities. Utilizing hand tools, we removed the stained and contaminated soils and pea-gravel. We then power washed and squeegeed the runoff to where the vacuum truck could capture the fluids. New pea-gravel was obtained and placed back in the area that was soiled.

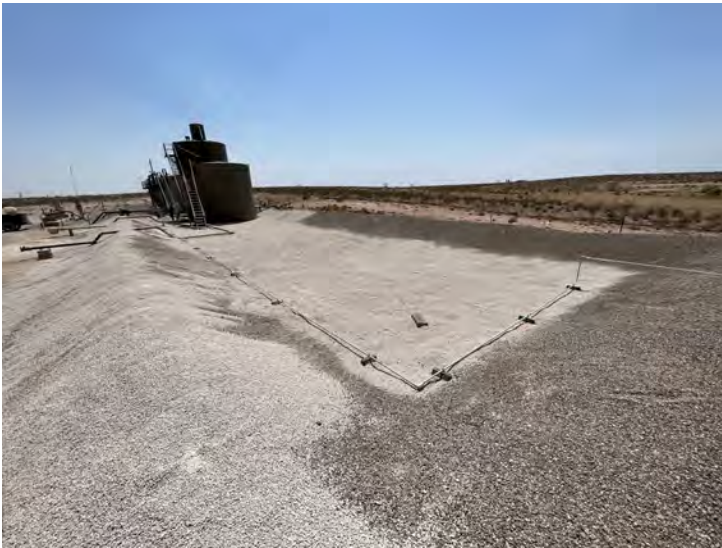
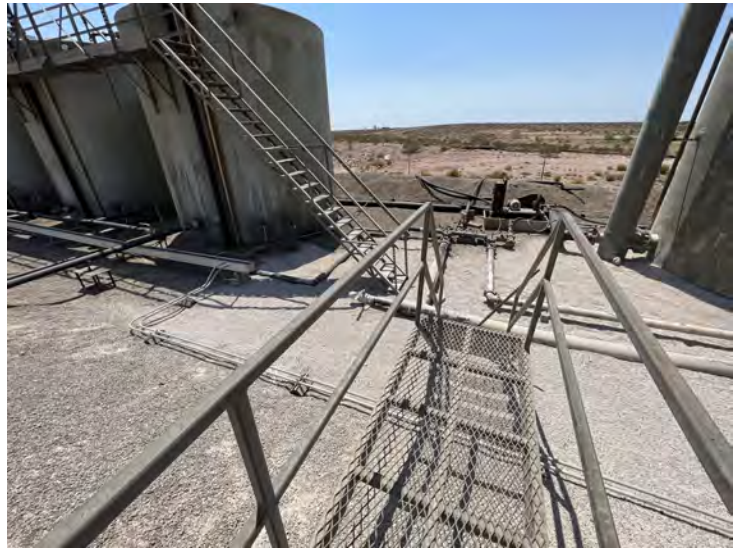
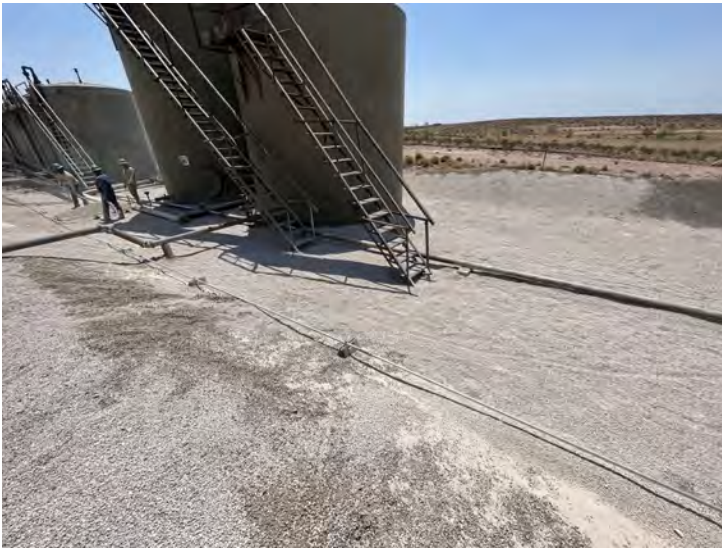
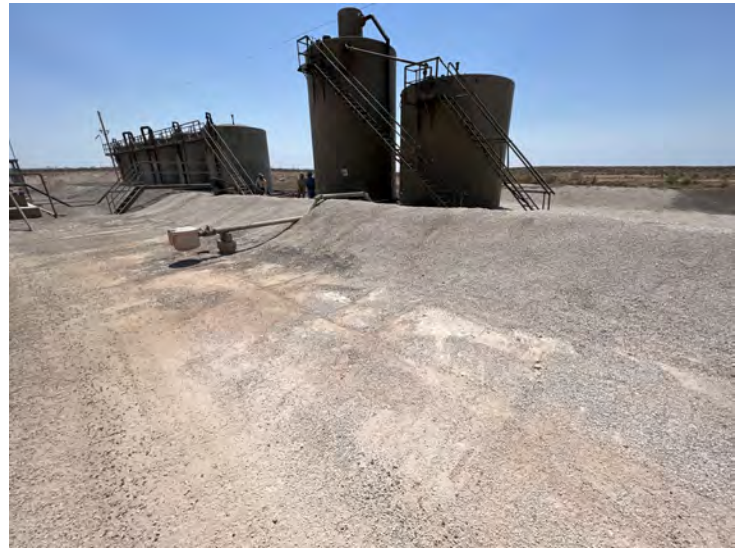
Completed

On August 12, 2022, Paragon returned to the site to conduct a liner inspection. A 48-hour notification was sent out to the NMOCD on August 10, 2022. The liner inspection concluded that the liner was all intact and in good condition. The integrity of the liner appears to have the ability to contain spills. See Appendix D for the email notification and liner report.
