Re: Status Report – 3rd Quarter 2021
Kaufman No. 1
San Juan County, New Mexico
OCD No.: AP-0138

On behalf of Hilcorp Energy Company (Hilcorp), Timberwolf Environmental, LLC (Timberwolf) prepared this letter to document the 3rd Quarter 2021 (3Q21) groundwater monitoring activities at the Kaufman No. 1 (Site). The Site is located approximately 9.1 miles north of Farmington in San Juan County, New Mexico (Figure 1).

Status Report - 3rd Quarter 2021 (AP-0138)

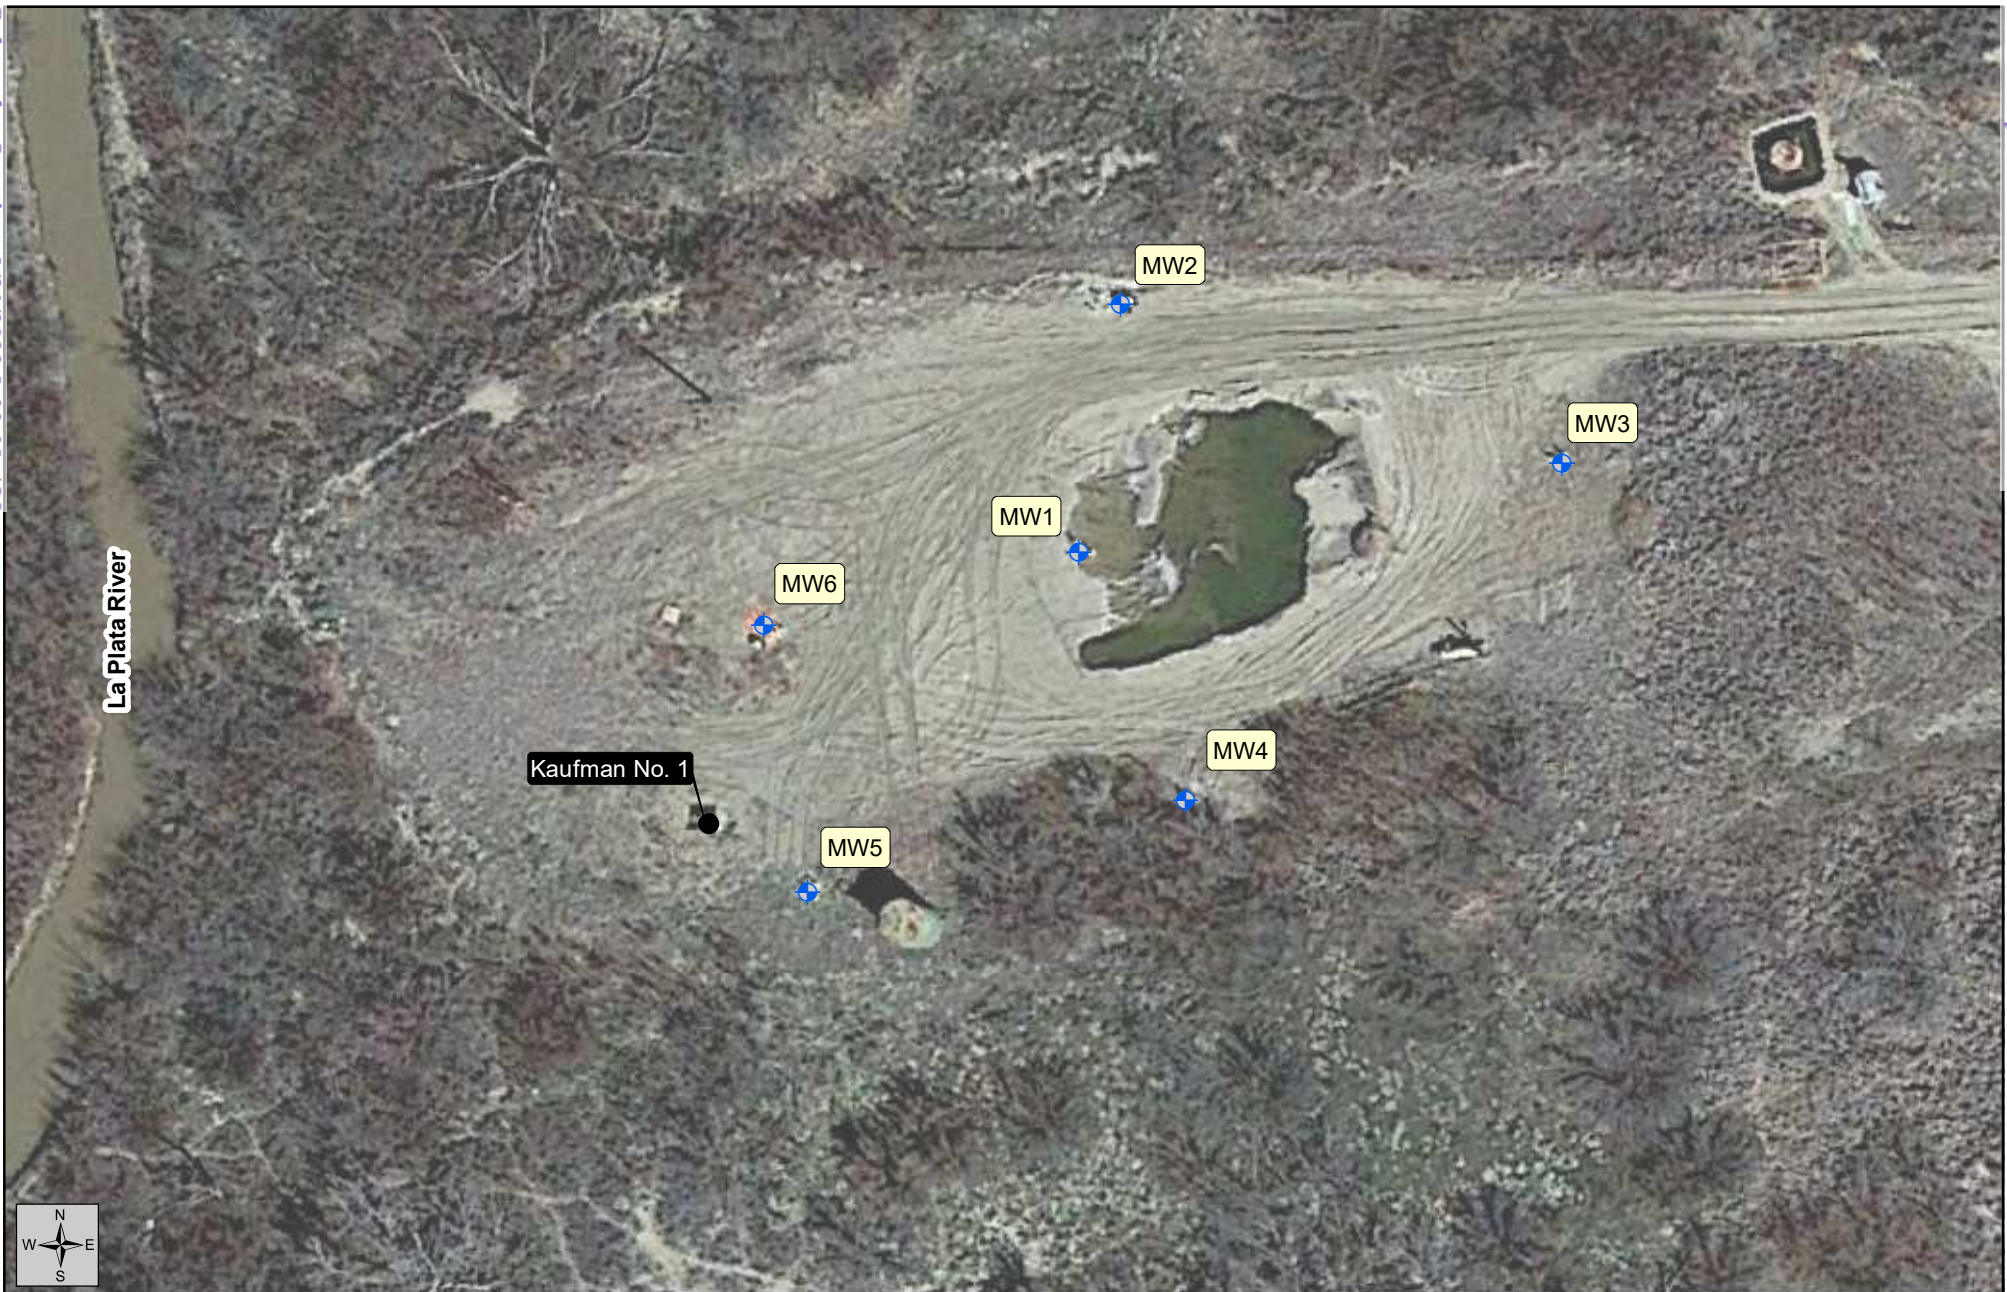
Figure 4
Monitor Well Location Map

On 09/09/21, Timberwolf conducted the 3Q21 groundwater monitoring event at the Site. Groundwater and surface water gauging, groundwater sample collection, and analytical results are documented below. Monitor well locations are shown in the attached Figure 4.

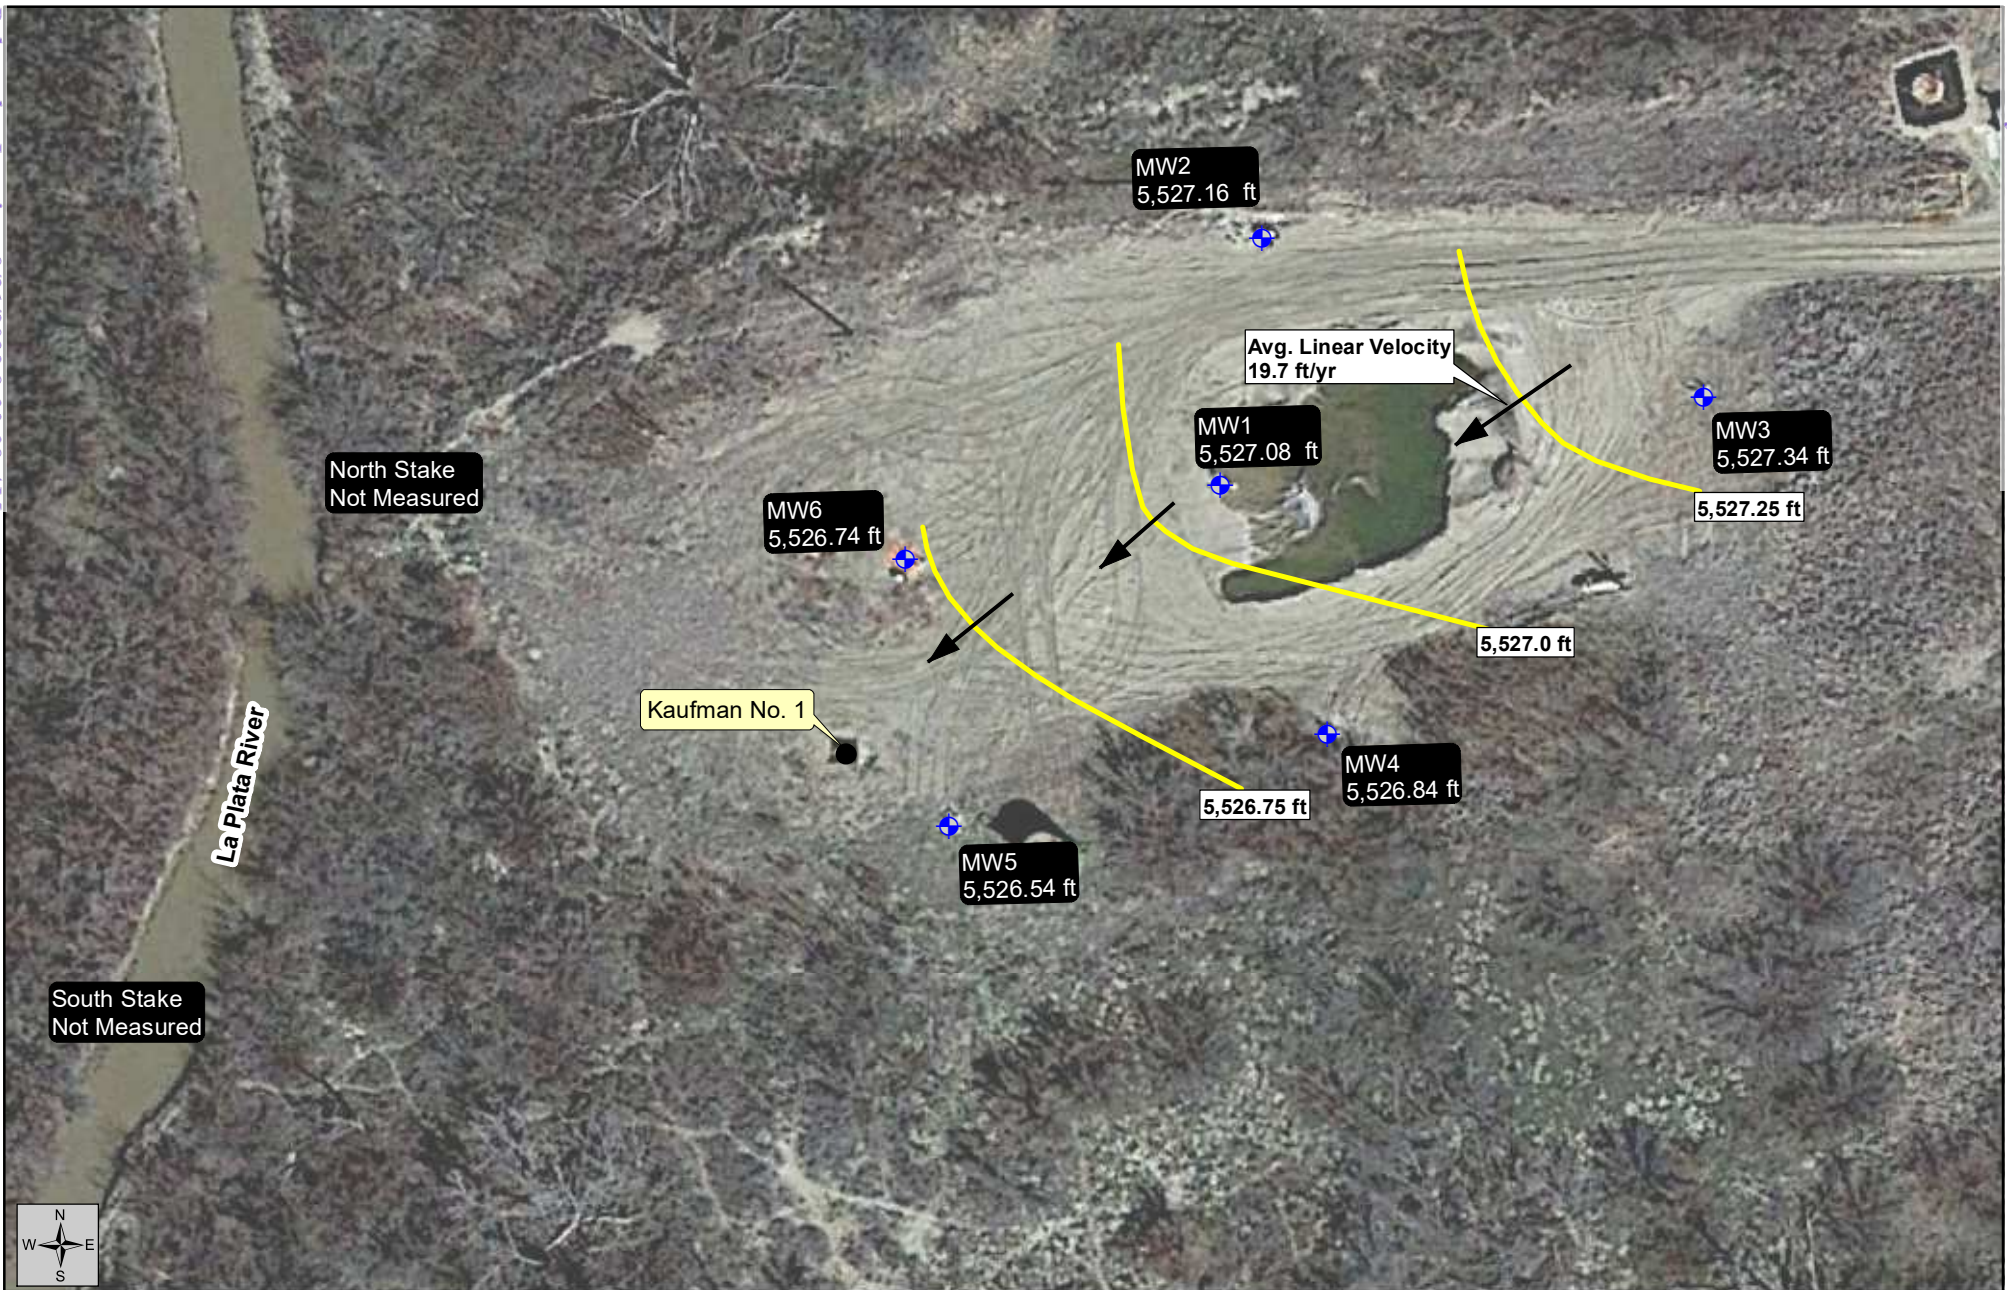
Figure 5
Potentiometric Surface
Elevation Map

Timberwolf prepared a potentiometric surface elevation (PSE) map as shown in Figure 5. The 3Q21 PSE map revealed that groundwater flow across the Site was west-southwest towards the La Plata River with an average linear velocity of 19.7 feet per year (ft/yr).

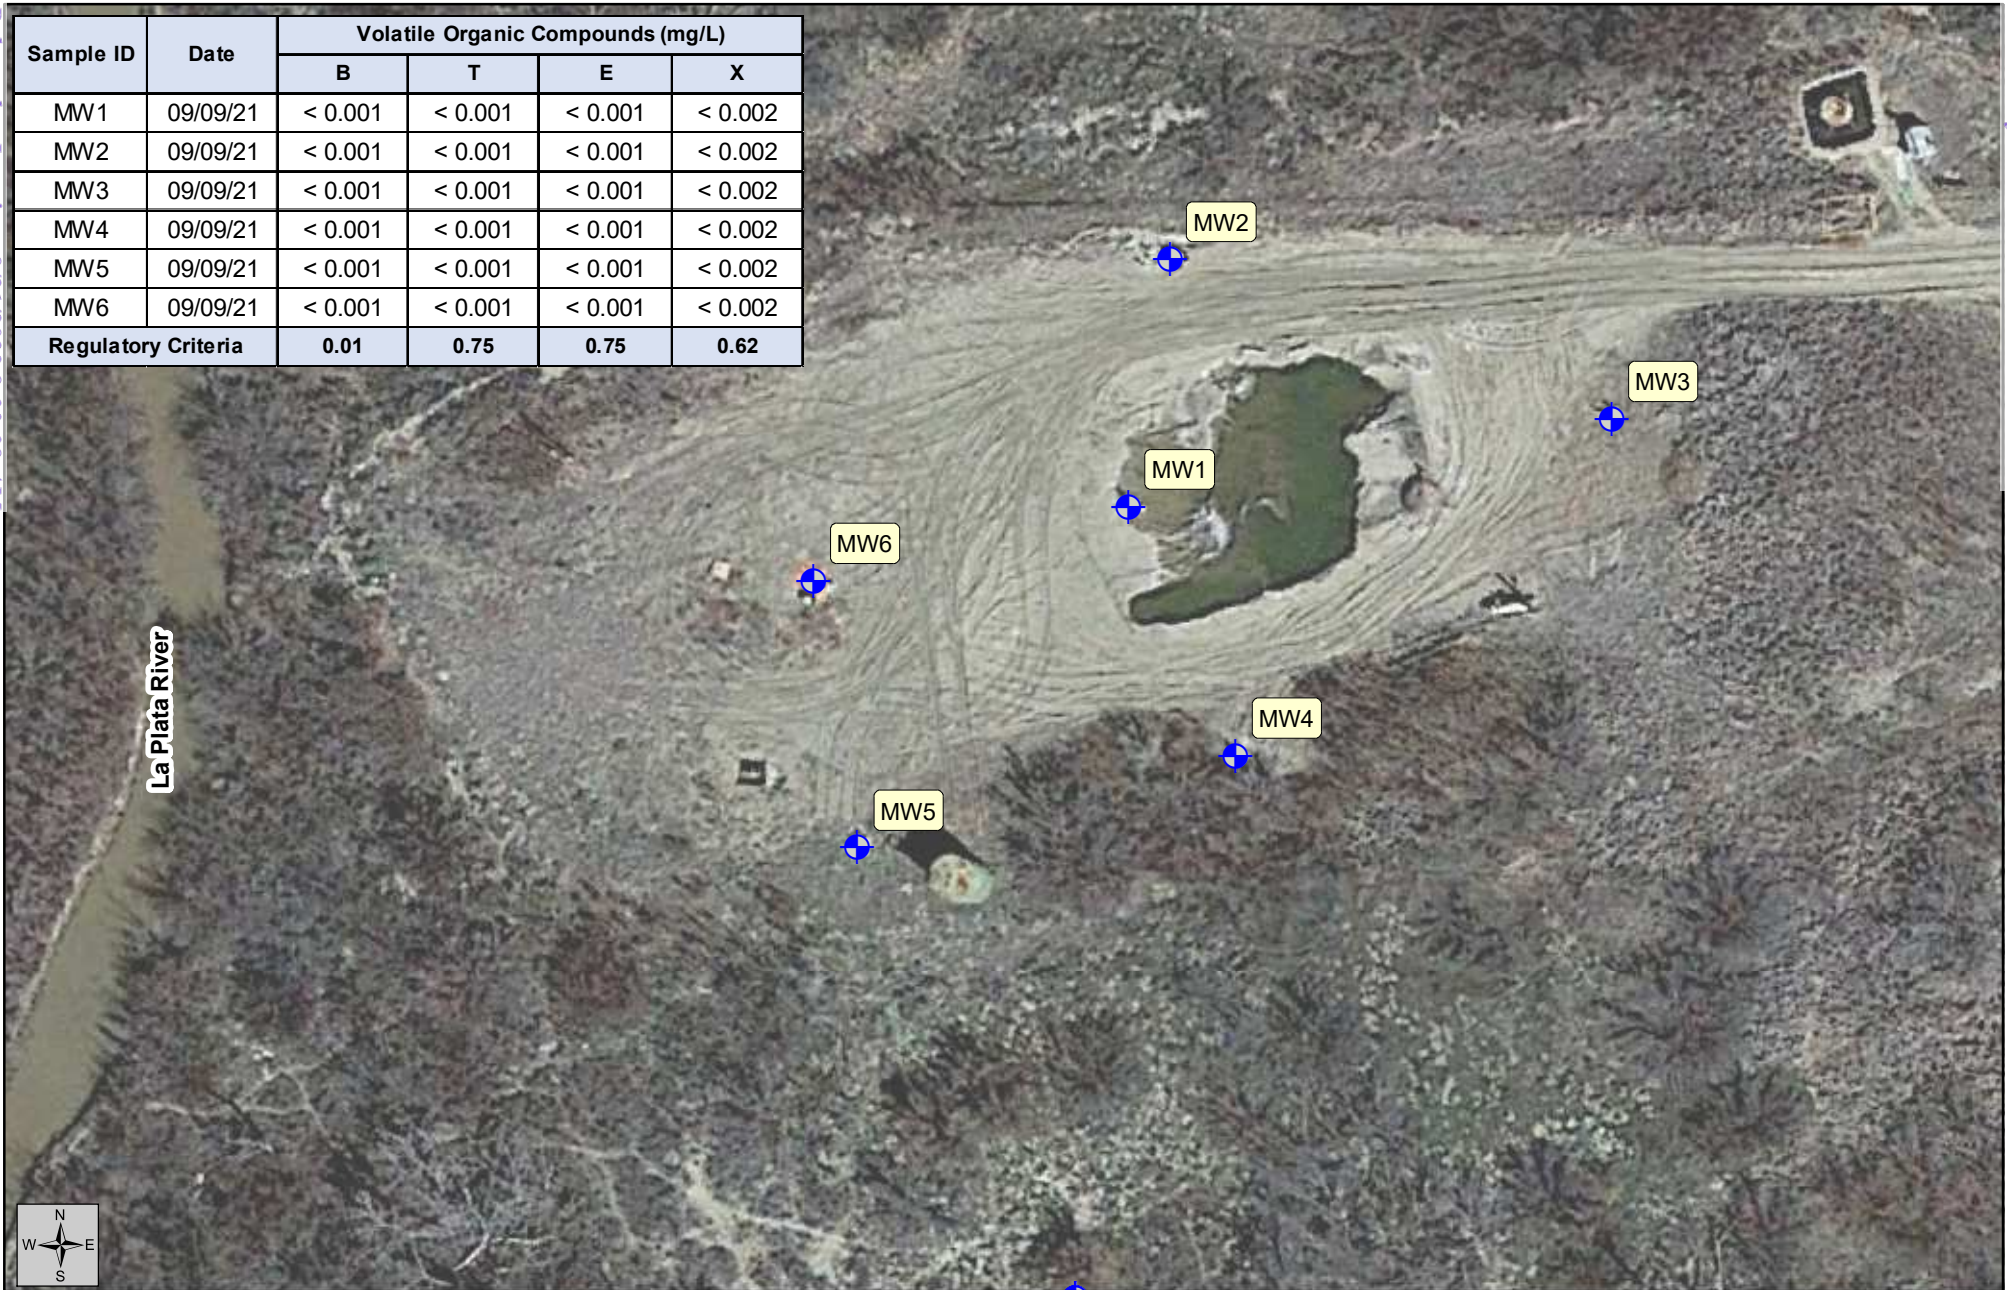
Figure 6
BTEX Results - 3Q21

Groundwater samples were analyzed for BTEX by EPA Method 8260. Analytical results for the 3Q21 groundwater monitoring event are summarized in Table 2 below and shown in Figure 6. Cumulative analytical results from each groundwater sampling station are documented in Table A-3 (attached).

- BTEX concentrations were below regulatory human health criteria and laboratory detection limits at all sampling stations (i.e., MW1 – MW6)
- Groundwater flow across the Site is west-southwest towards the La Plata River
