Re: Status Report – 4th Quarter 2021
San Juan 28-7 Unit 183M
Rio Arriba County, New Mexico
OCD Incident No. NCS1901627746

On behalf of Hilcorp Energy Company (Hilcorp), Timberwolf Environmental, LLC (Timberwolf) presents this report to document remedial activities conducted during the fourth quarter of 2021 (4Q21) at the San Juan 28-7 Unit 183M (Site).

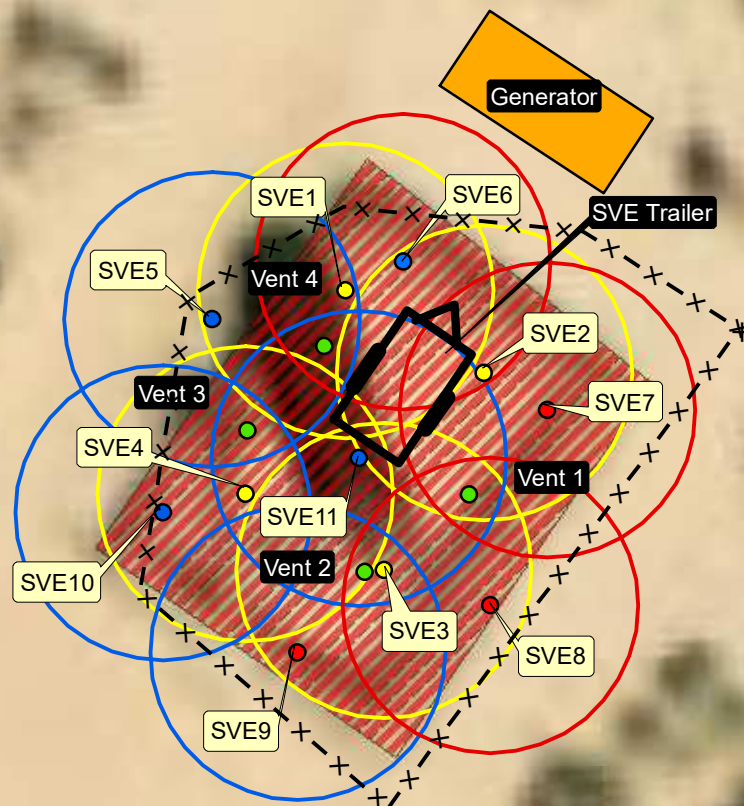
Figure 4
SVE System Overview

The SVE system creates a treatment field of approximately 0.15 acres and treats soil to a depth of approximately 30 ft bgs for a total volume of approximately 7,021 cubic yards of soil. The SVE wells, measured radius of influence of 25 ft, and leg configurations are shown in Figure 4.

Treatment Area= 6,320 ft²
Assuming a 25 ft radius of influence
