LINER INSPECTION AND CLOSURE REPORT REPORTABLE RELEASE

Spur Energy Partners

California 29 Fee #1 Battery Incident ID: NRM2024759404 Eddy County, NM

Incident ID: NRM2024759404

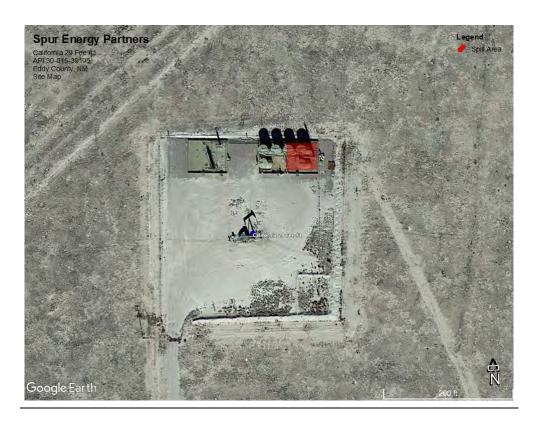
On July 12, 2022, Paragon went to the California and conducted an initial assessment. There was obvious staining on the liner from the spill. There was nothing outside the containment that showed any signs that the liner had been breached. Therefore, no samples were taken. See the site map below showing the affected area.

On July 18, 2022, Paragon returned to the site with equipment and personnel to conduct cleanup activities. We initially sprayed the affected area with surface cleaner. We then power washed and squeegeed the runoff to where the vacuum truck could capture the fluids.

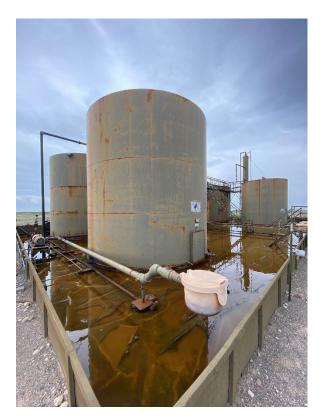
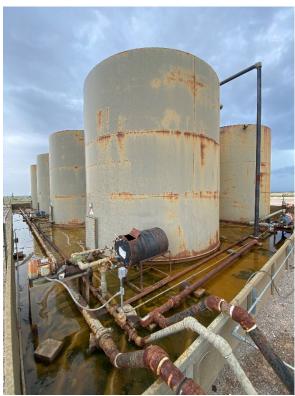
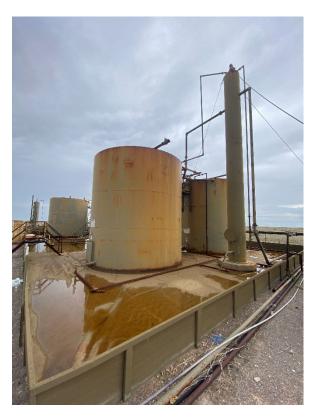
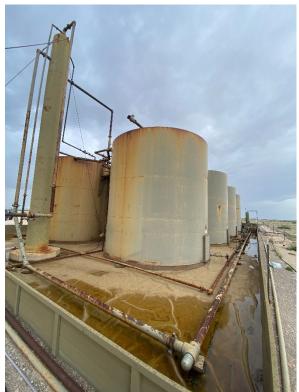
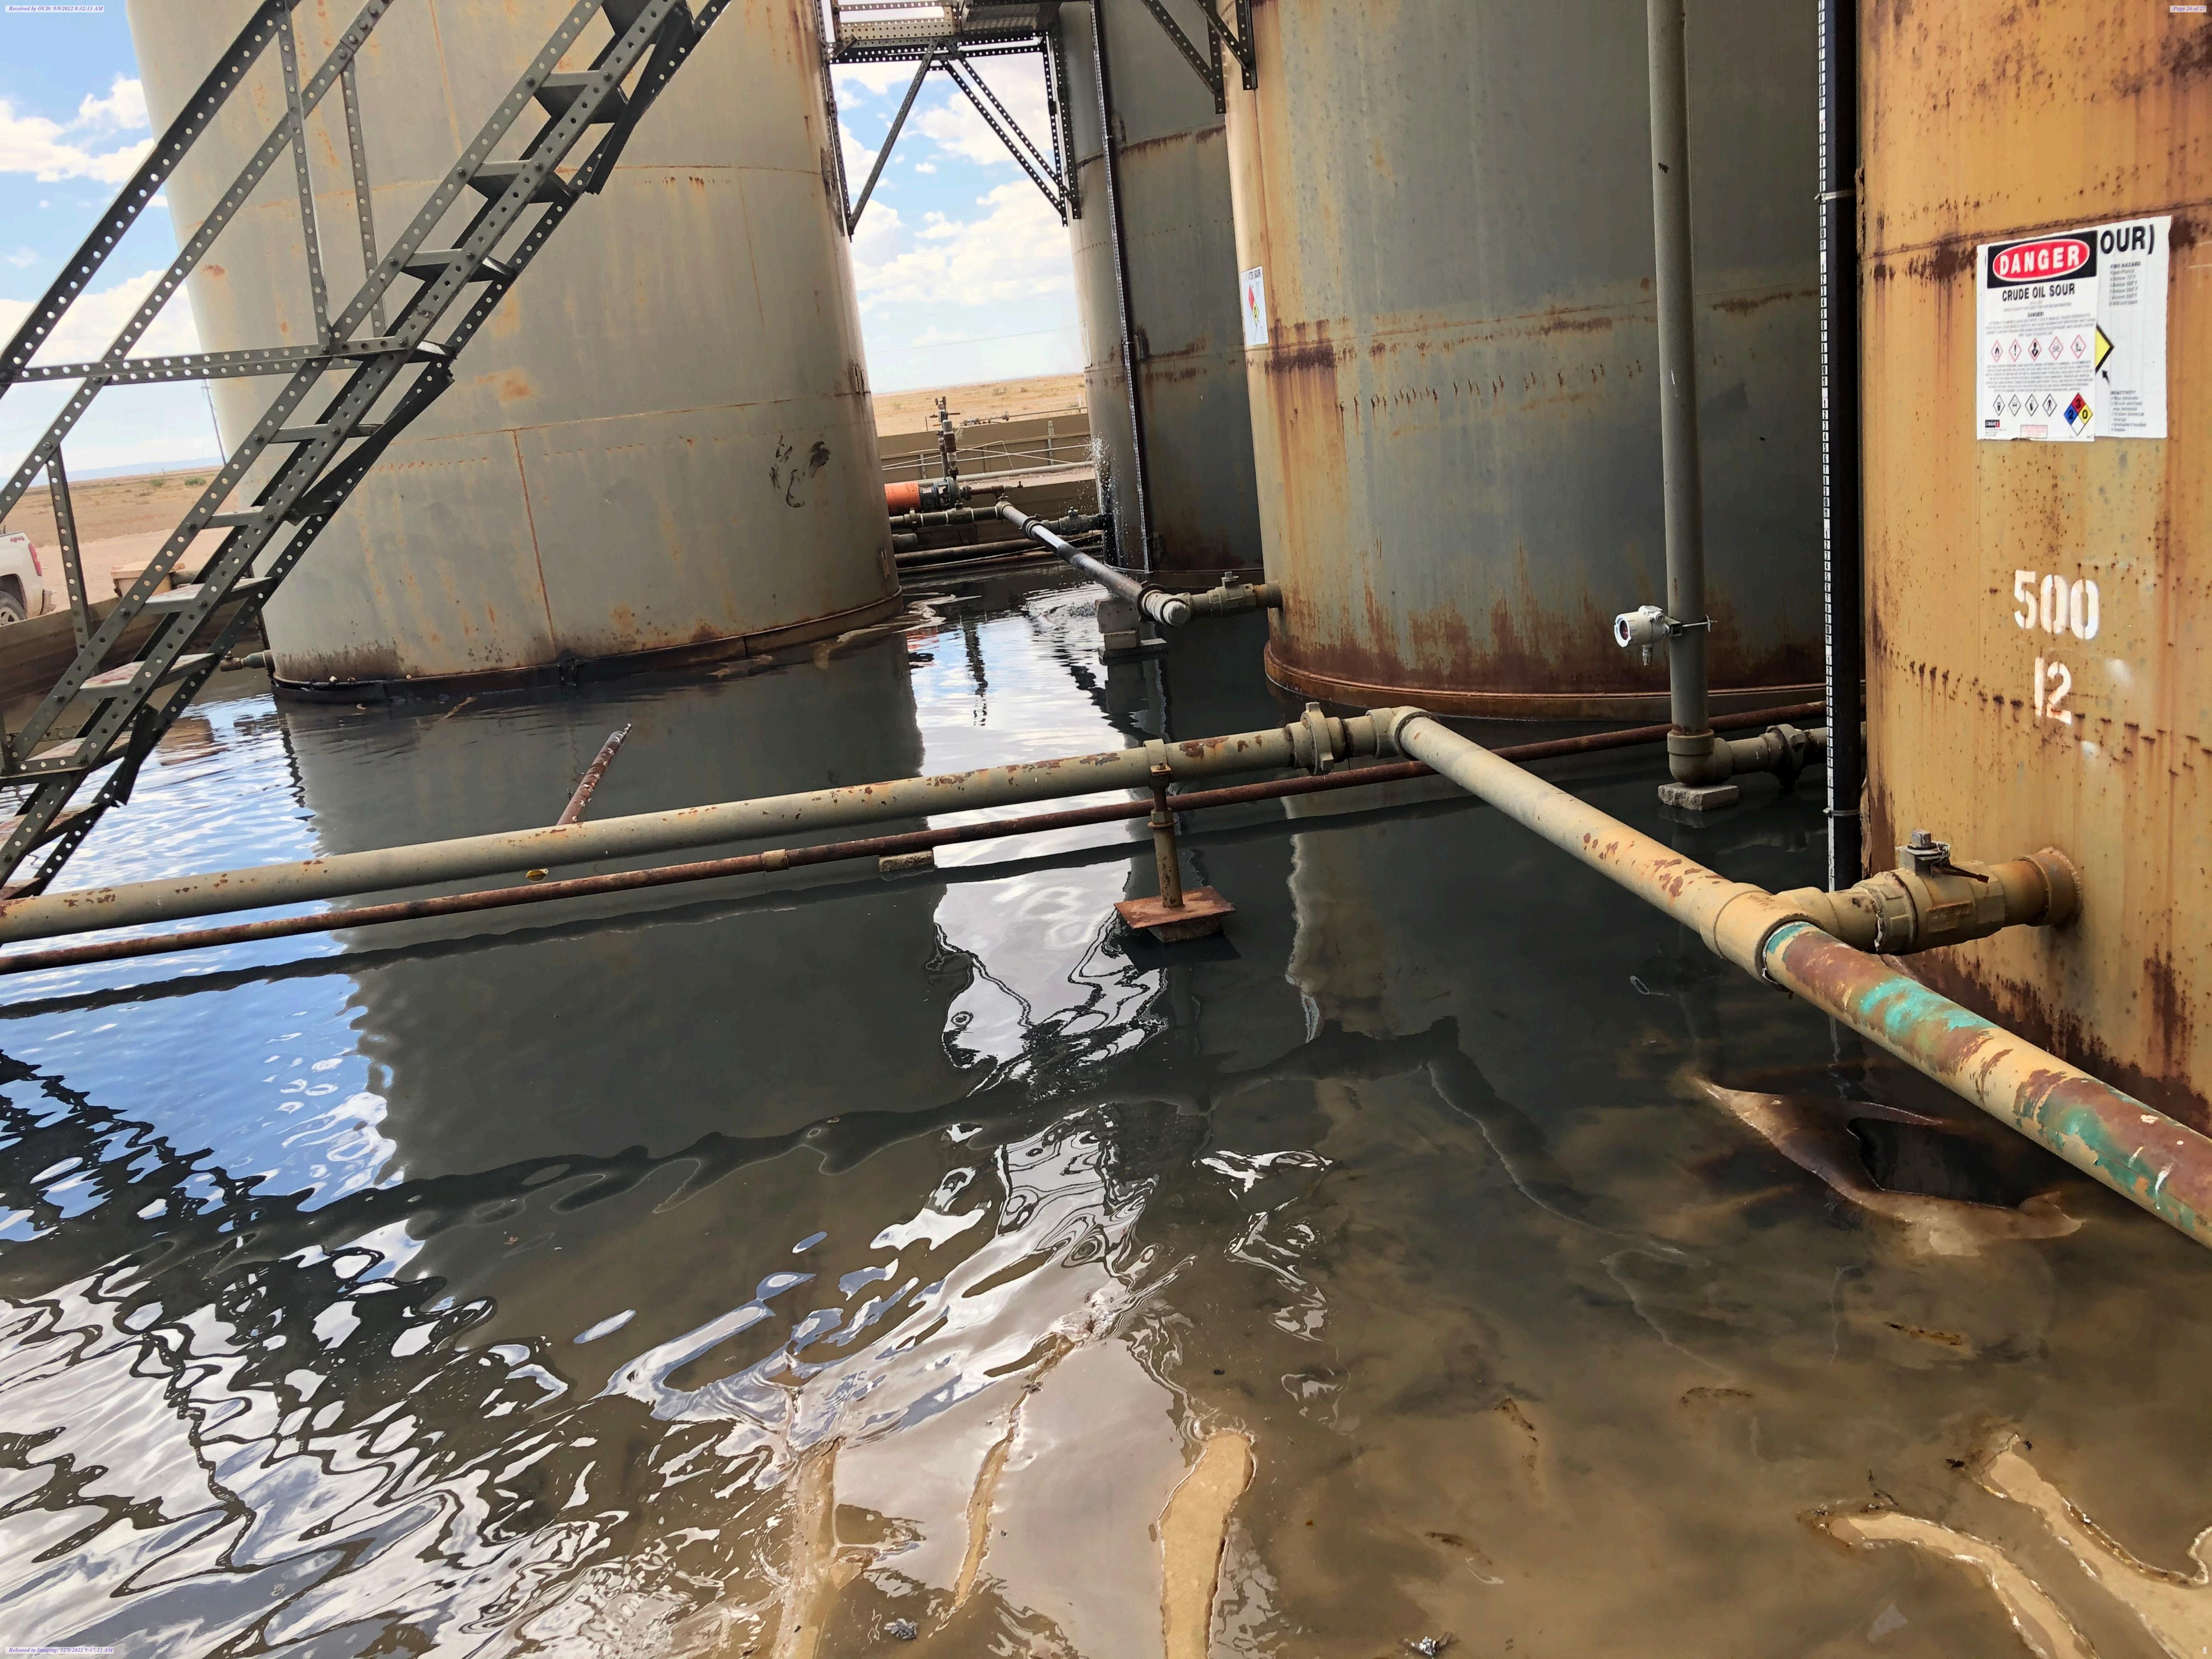
Liner Inspection

On August 6, 2022, Paragon returned to the site to conduct a liner inspection. A 48-hour notification was sent out to the NMOCD on August 3, 2022. The liner inspection concluded that the liner was all intact and in good condition. The integrity of the liner appears to have the ability to contain spills. See Appendix D for the email notification and liner report.

Visualization	Yes	No	Comments
Is there a tear in the liner?		X	
Are there holes in the liner?		X	
Is the liner retaining any fluids?		X	
Does the liner have integrity to contain a leak?	X
