LINER INSPECTION AND CLOSURE REPORT

Spur Energy Partners
Clydesdale 1 Fee #6H Battery
Incident ID: NAPP2119559000
Eddy County, NM

Paragon Environmental LLC
1601 N. TURNER ST. STE.500
Hobbs, NM 88240
575-964-7814

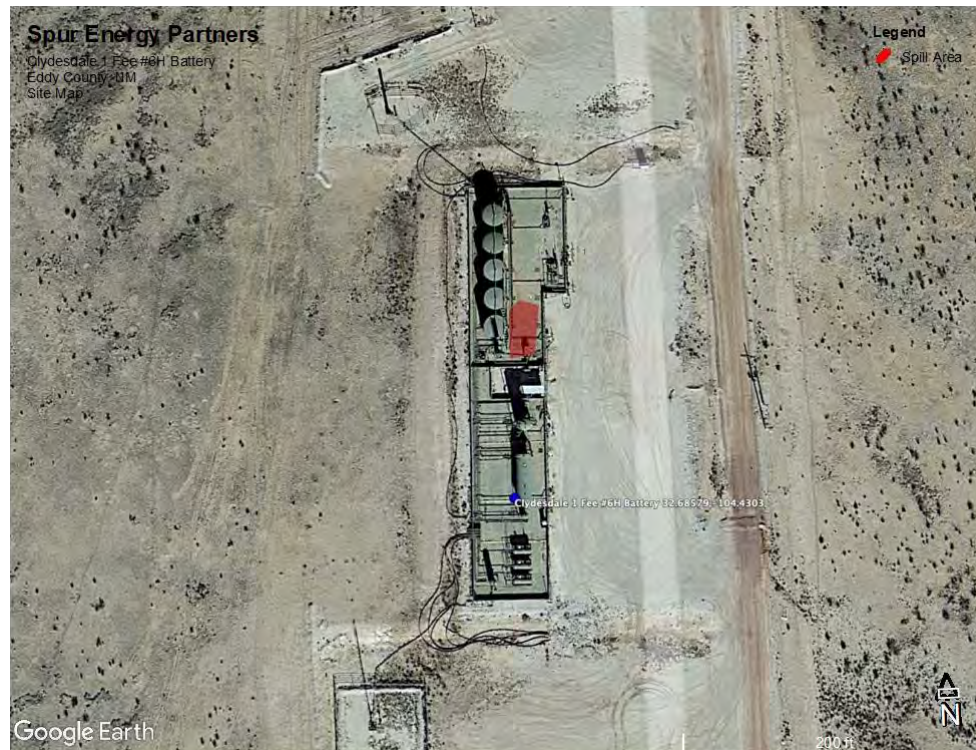
On July 12, 2022, Paragon went to the Clydesdale and conducted an initial assessment. There was obvious staining on the liner from the spill. There was nothing outside the containment that showed any signs that the liner had been breached. Therefore, no samples were taken. See the site map below showing the affected area.

On July 18, 2022, Paragon returned to the site with equipment and personnel to conduct cleanup activities. We initially sprayed the affected area with surface cleaner. We then power washed and squeegeed the runoff to where the vacuum truck could capture the fluids.

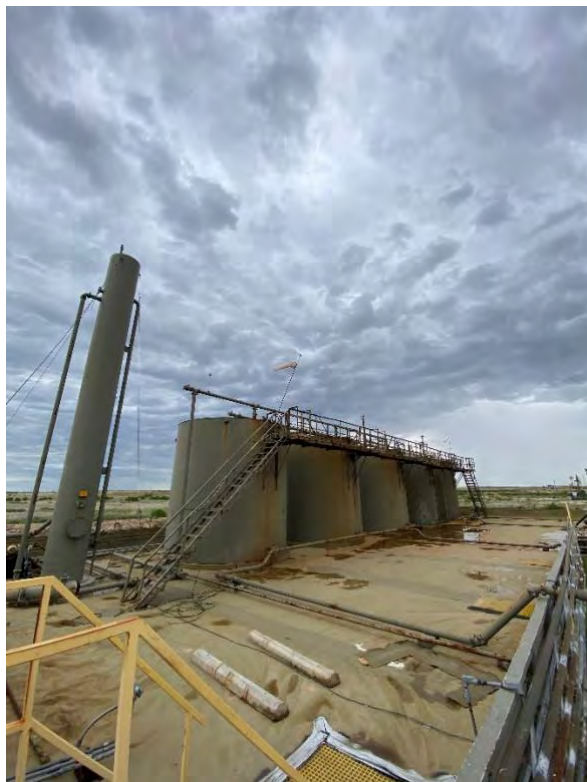
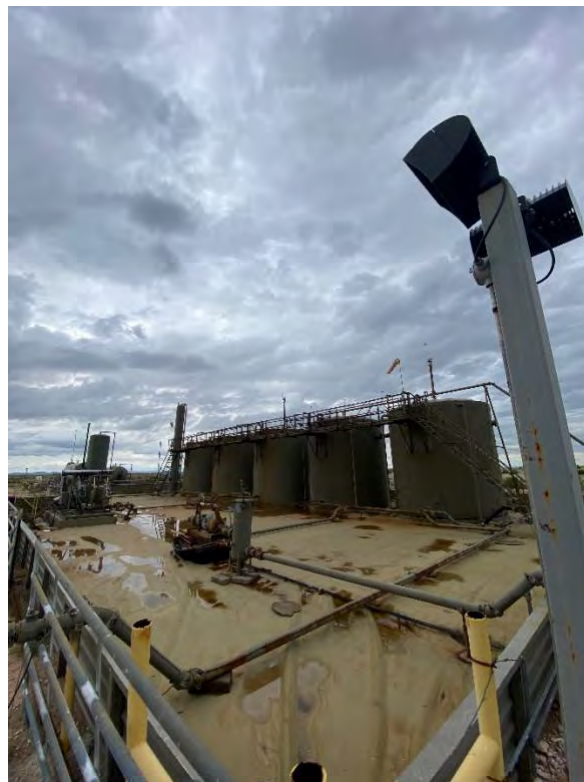
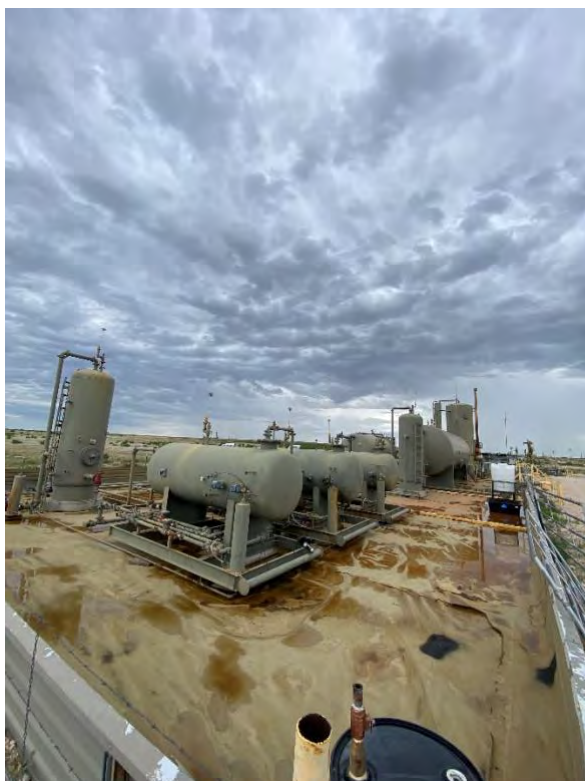
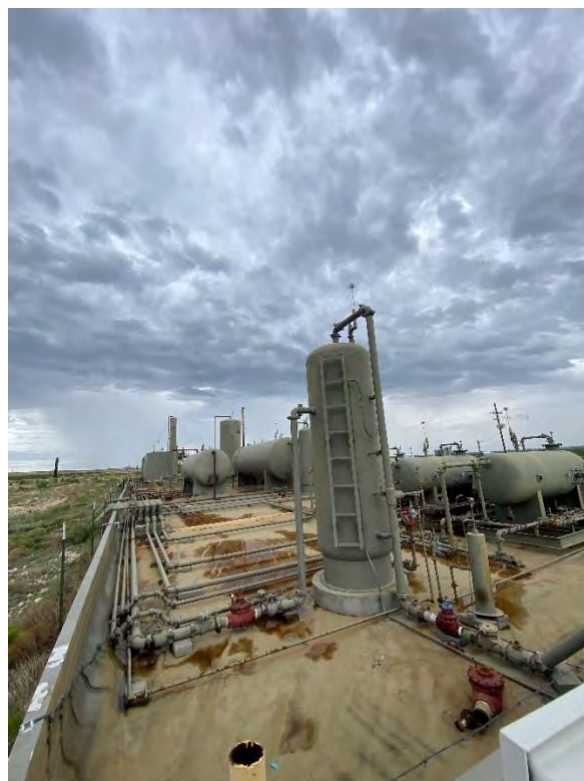
Liner Inspection

On July 20, 2022, Paragon returned to the site to conduct a liner inspection. A 48-hour notification was sent out to the NMOCD on July 18, 2022. The liner inspection concluded that the liner was all intact and in good condition. The integrity of the liner appears to have the ability to contain spills. See Appendix D for the email notification, liner inspection and photos.
