Closure Report
Boo Radley 21 CTB (08.05.22)
Incident #: NAPP2223044639
Eddy County, New Mexico
Unit C Sec 21 T26S R28E
32.033700°, -104.092900°

Produced Water Release
Point of Release: Hole in Transfer Pump

Re: Closure Report

Boo Radley 21 CTB (08.05.22) Concho Operating, LLC Incident ID NAPP2223044639 Site Location: Unit C, S21, T26S, R28E

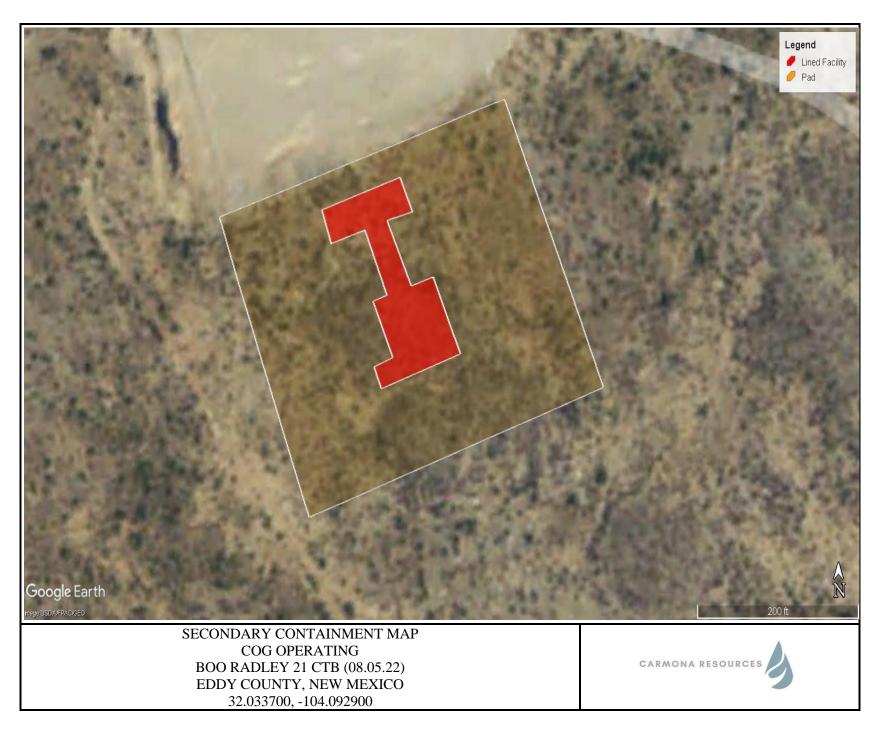
FIGURE 3 SECONDARY CONTAINMENT MAP

Based on the initial C-141 obtained from the New Mexico Oil Conservation Division (NMOCD), the release was discovered on August 5, 2022, due to a development in the transfer pump. It resulted in approximately fourteen (14) barrels of produced water and thirteen (13) barrels of produced water recovered. See figure 3. The initial C-141 form is attached in Appendix B.

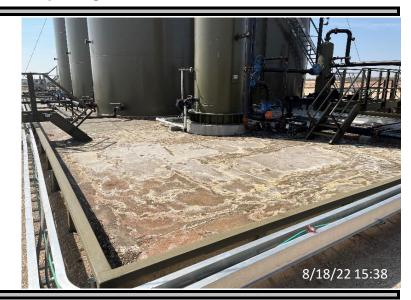
Photograph No. 1

View of the secondary containment.

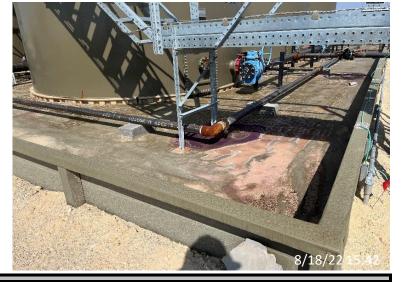
Photograph No. 2

View of the secondary containment.

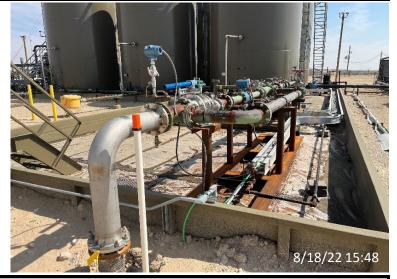
Photograph No. 3

View of the secondary containment.

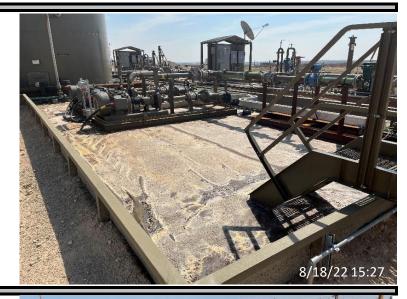
Photograph No. 4

View of the secondary containment.

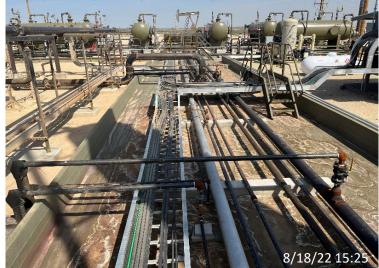
Photograph No. 5

View of the secondary containment.

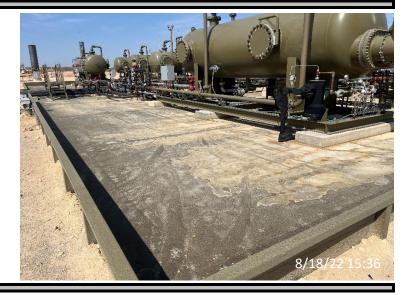
Photograph No. 6

View of the secondary containment.
