November 4, 2022

Vertex Project #: 22E-02178

Spill Closure Report: Collie Pad (Section 35, Township 22 South, Range 27 East)
County: Eddy
Incident ID: nAPP2216427127

Prepared For: **Devon Energy Production Company**
6488 Seven Rivers Highway
Artesia, New Mexico 88220

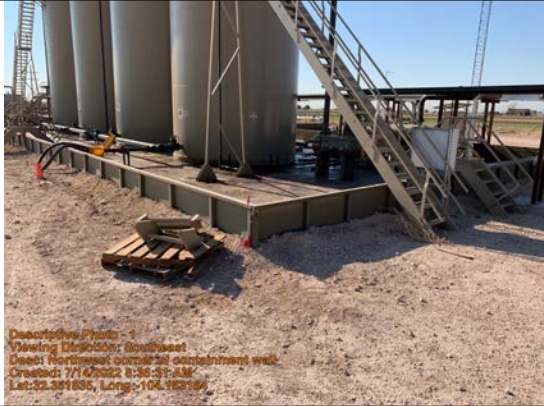
Northwest corner of containment wall

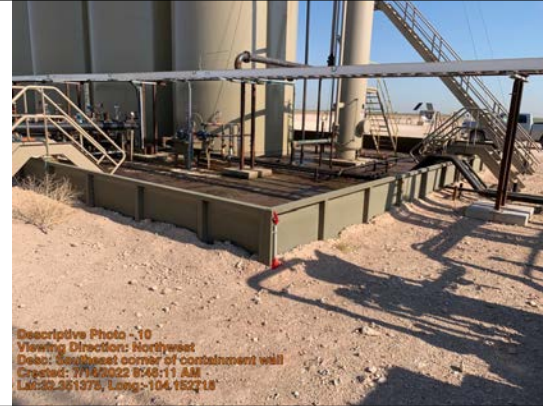
Southeast corner of containment wall

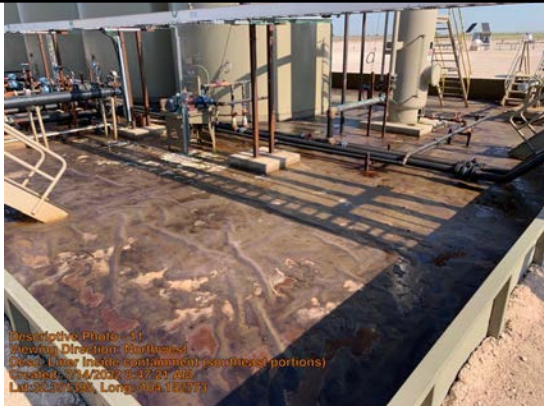
Liner inside containment (southeast portions)

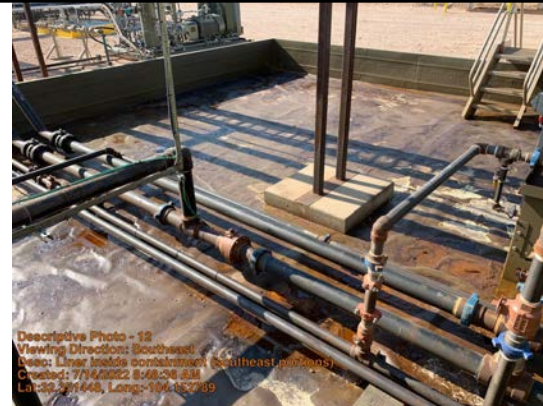
Liner inside containment (southeast portions)

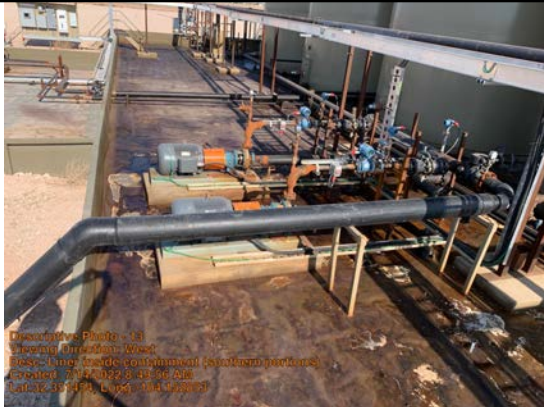
Liner inside containment (southern portions)

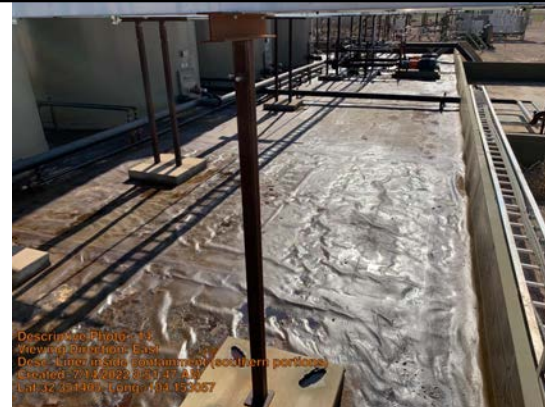
Liner inside containment (southern portions)

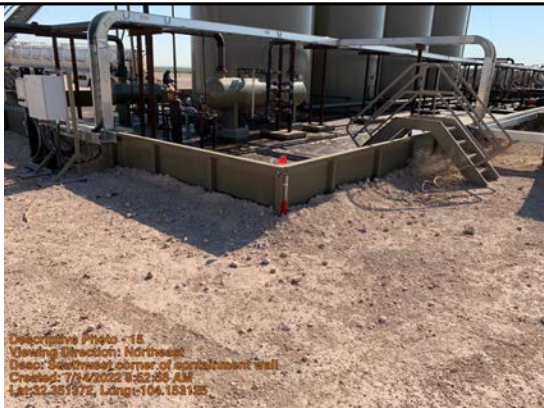
Southwest corner of containment wall

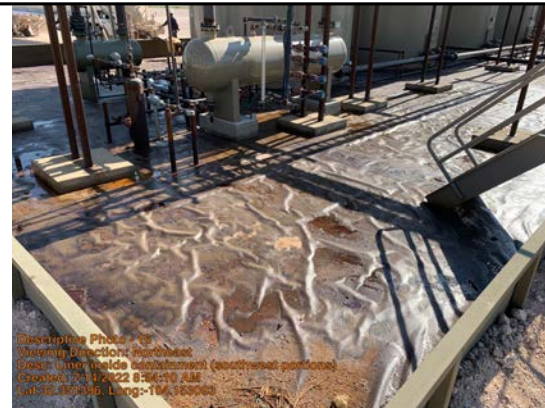
Liner inside containment (southwest portions)

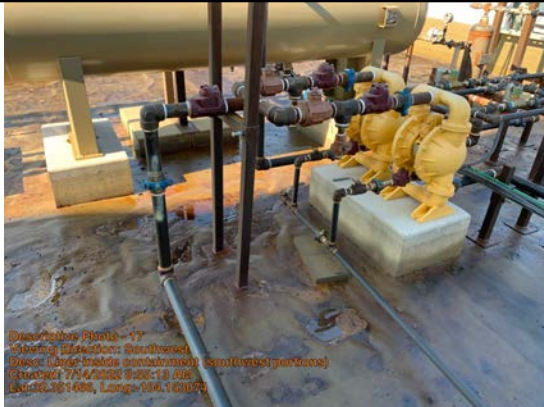
Liner inside containment (southwest portions)

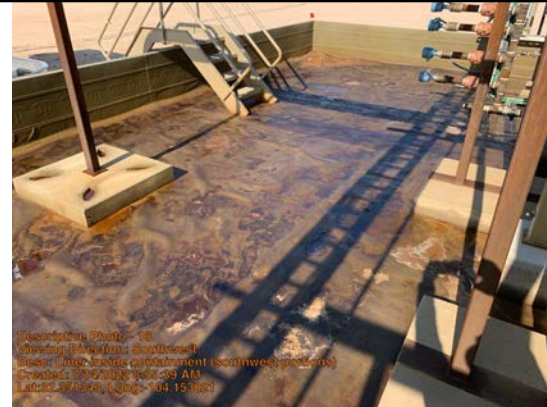
Liner inside containment (southwest portions)

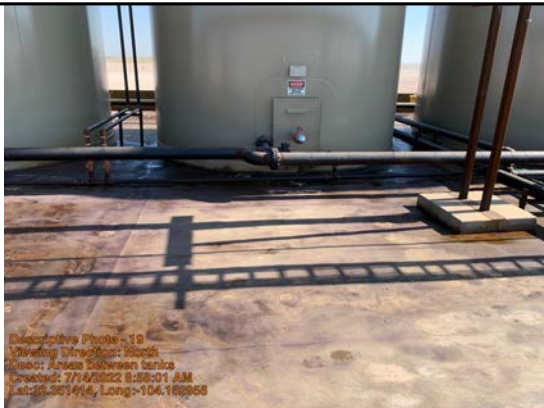
Areas between tanks

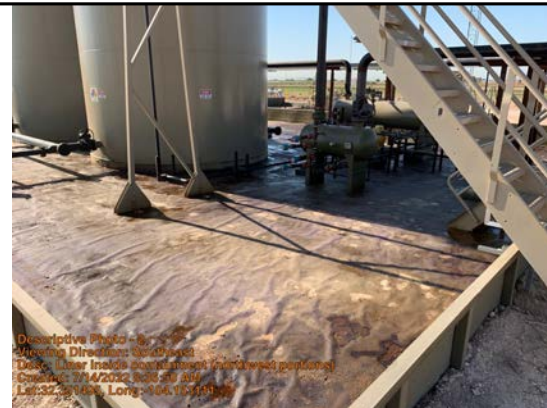
Liner inside containment (northwest portions)

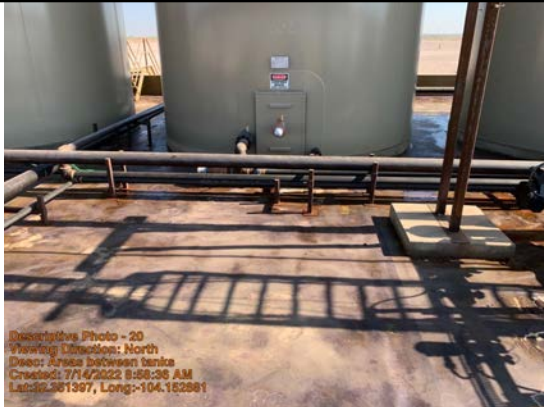
Areas between tanks

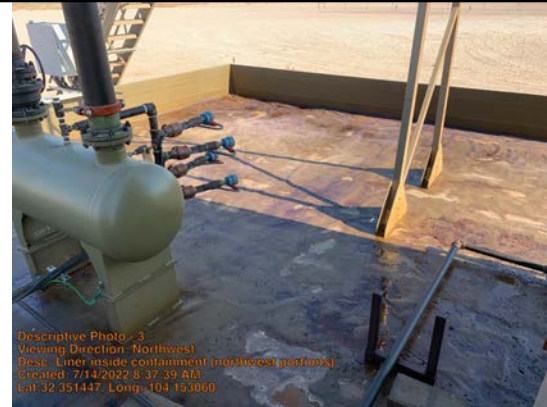
Liner inside containment (northwest portions)

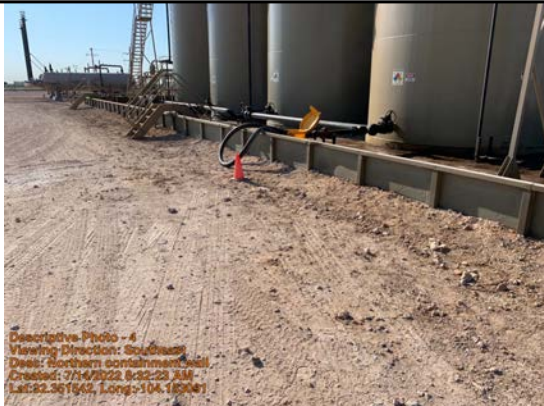
Northern containment wall

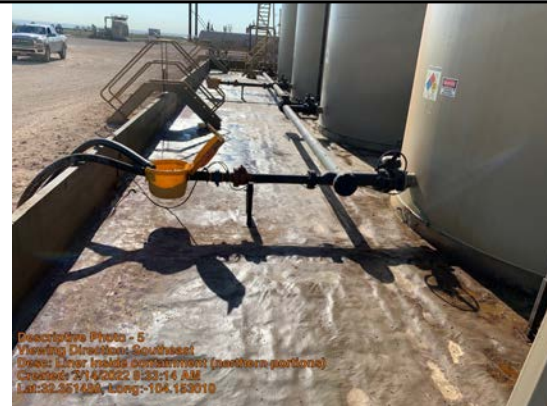
Liner inside containment (northern portions)

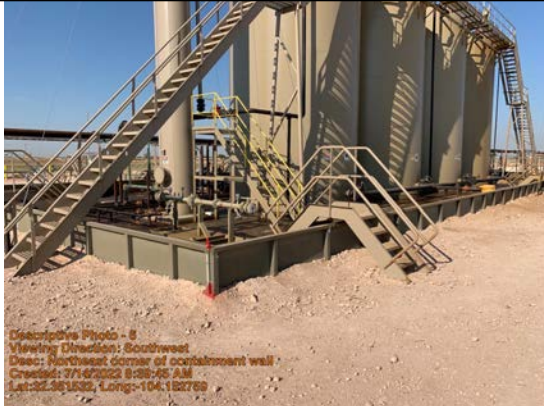
Northeast corner of containment wall

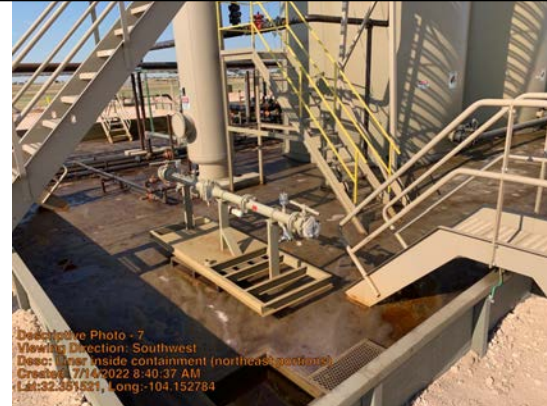
Liner inside containment (northeast portions)

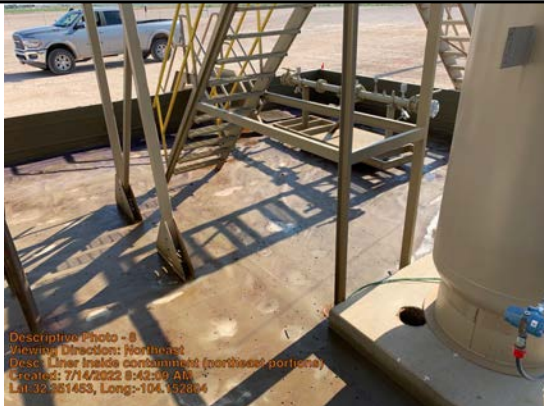
Liner inside containment (northeast portions)

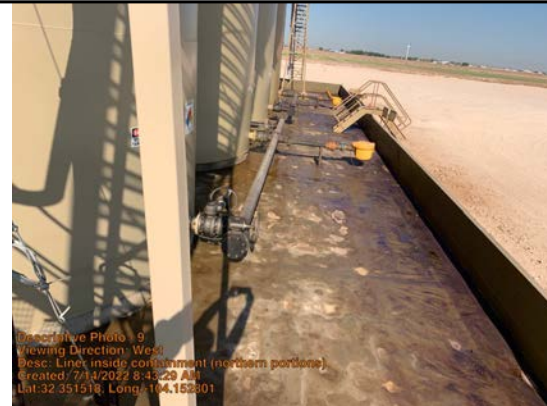
Liner inside containment (northern portions)
