December 8, 2022

Vertex Project #: 22E-04127

Spill Closure Report:	Pickard State #002H
	Section 20, Township 18 South, Range 34 East
	API: 30-025-41614
	County: Eddy
	Incident Report: nAPP2124457634

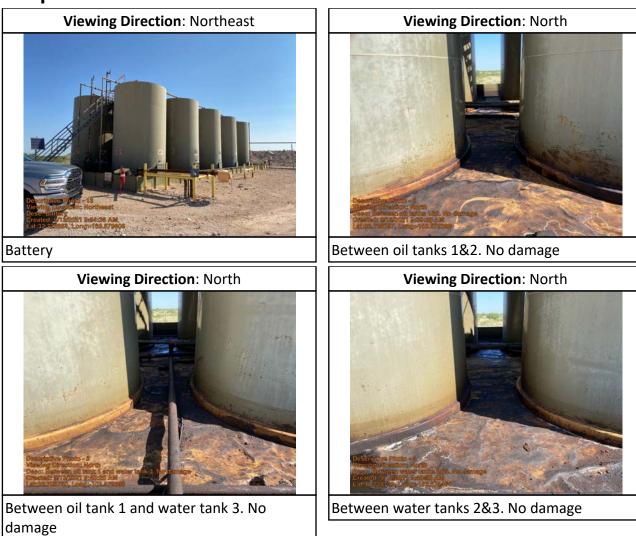
**9:37** The floor of the containment has heavy staining but does not appear to have any significant damage.

# **Site Photos** Viewing Direction: North Viewing Direction: North East side of containment with heavy staining East wall but no damage to the liner Viewing Direction: North Viewing Direction: West North wall West wall

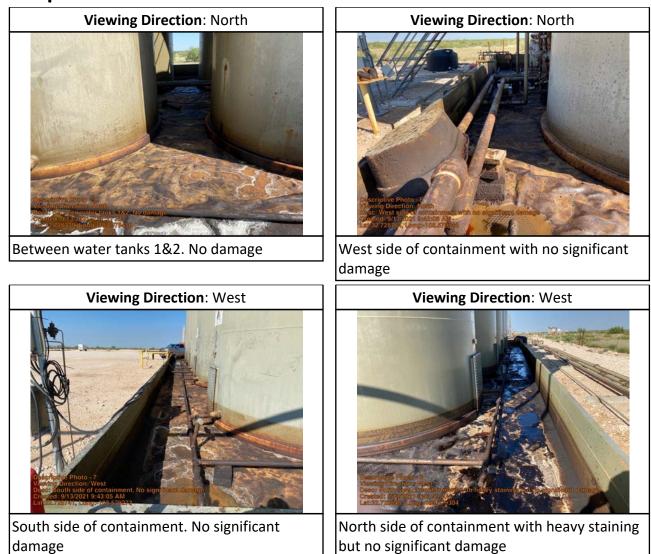
South wall. No significant damage
