Closure Report
Myox State 28B CTB (10.27.22)
Incident #: NAPP2231535960
Eddy County, New Mexico
Unit B Sec 28 T25S R28E
32.10562°, -104.0908°

Produced Water Release

Point of Release: Failed weld due to corrosion

Re: Closure Report

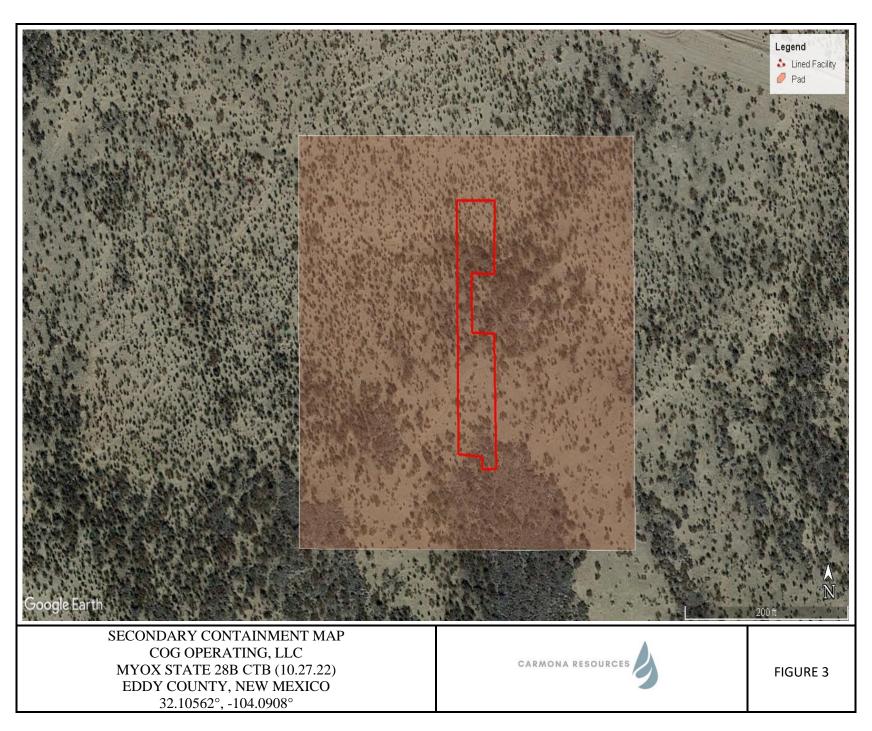
FIGURE 3 SECONDARY CONTAINMENT MAP

Based on the initial C-141 obtained from the New Mexico Oil Conservation Division (NMOCD), the release was discovered on October 27, 2022, due to corrosion. It resulted in approximately twenty-two point two hundred seventy-three (22.273) barrels of produced water and twenty-two (22) barrels of produced water recovered. See figure 3. The initial C-141 form is attached in Appendix B.

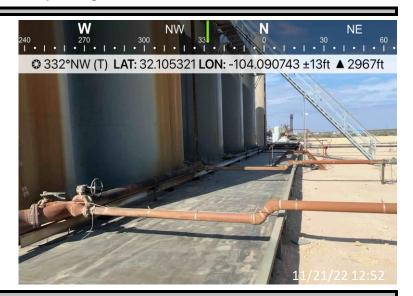
Photograph No. 1

View Northwest of the lined facility.

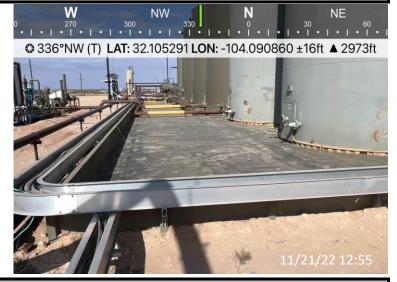
Photograph No. 2

View Northwest of the lined facility.

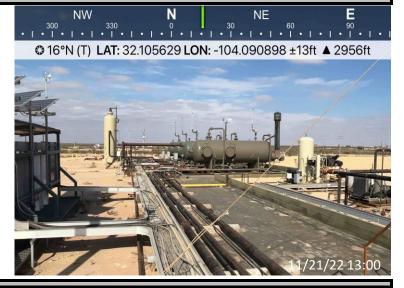
Photograph No. 3

View North of the lined facility.

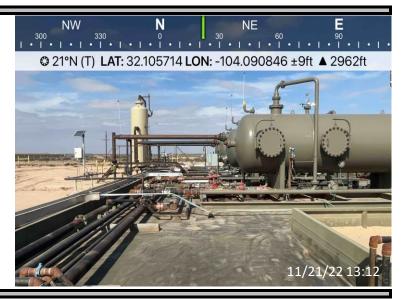
Photograph No. 4

View North of the lined facility.

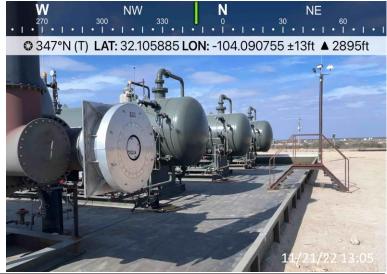
Photograph No. 5

View North of the lined facility.

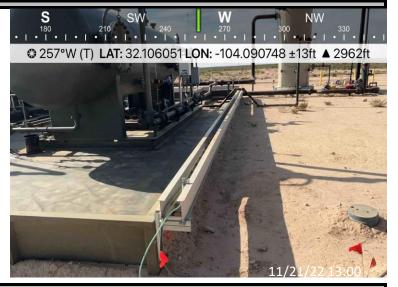
Photograph No. 6

View West of the lined facility.
