Vertex Project #: 22E-03902

Prepared For:	Black River Water Management Company, LLC		
	Incident Report: nAPP2231359751		
	County: Eddy		
	API: 30-015-44303		
	Section 24, Township 23 South, Range 27 East		
Spill Closure Report:	Rustler Breaks SWD #003

Black River Water Management Company, LLC Rustler Breaks SWD #003, nAPP2231359751 2022 Spill Assessment and Closure November 2022

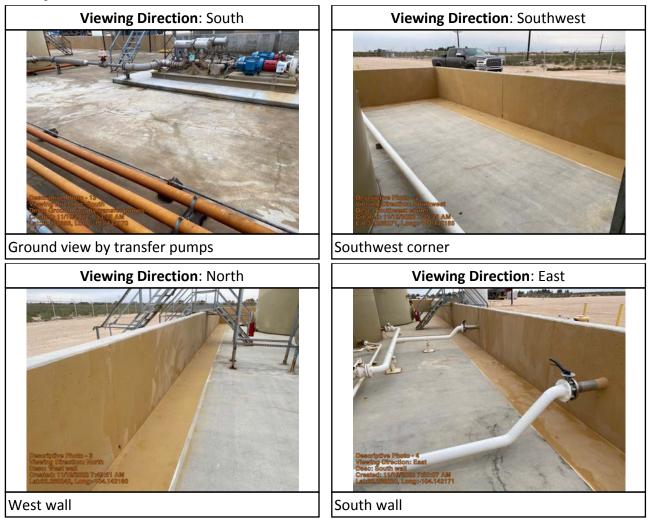
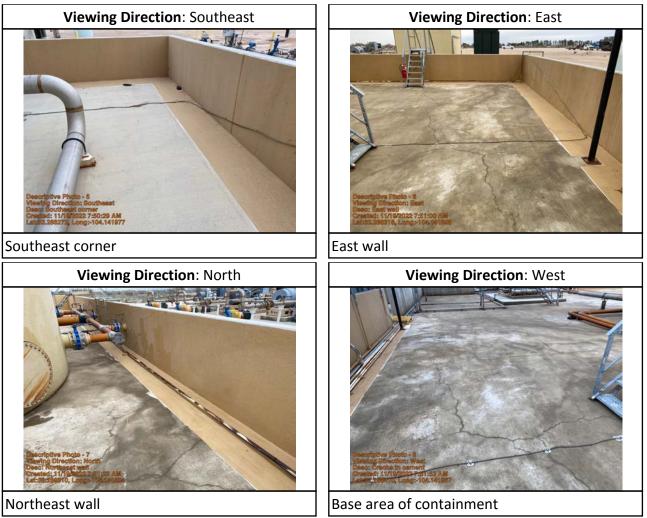
**7:55** No major holes / damage to cement containment

Vertex recommends no additional remediation action to address the release at Rustler Breaks. The secondary containment liner was intact and contained the release. There are no anticipated risks to human, ecological, or hydrological receptors associated with the release site.
