# LINER INSPECTION AND CLOSURE REPORT REPORTABLE RELEASE

# **Spur Energy Partners**

Clydesdale 1 Fee #6H Battery Incident ID: NAPP2119559000 Eddy County, NM

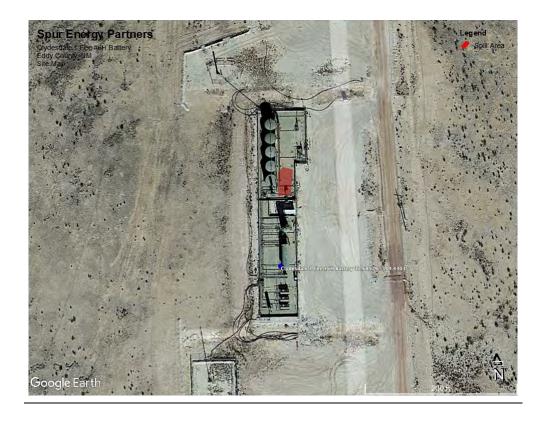
On July 12, 2022, Paragon went to the Clydesdale and conducted an initial assessment. There was obvious staining on the liner from the spill. There was nothing outside the containment that showed any signs that the liner had been breached. Therefore, no samples were taken. See the site map below showing the affected area.

On July 18, 2022, Paragon returned to the site with equipment and personnel to conduct cleanup activities. We initially sprayed the affected area with surface cleaner. We then power washed and squeegeed the runoff to where the vacuum truck could capture the fluids.

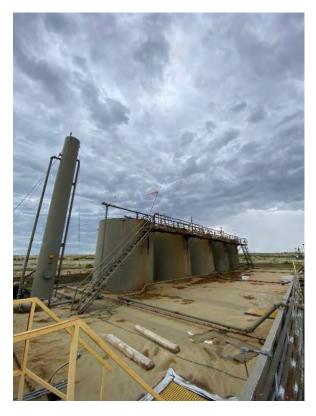
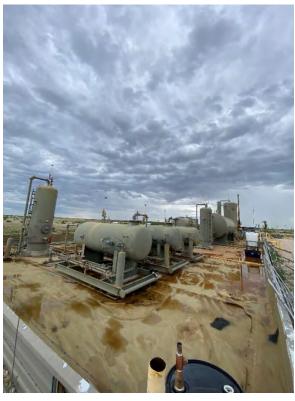
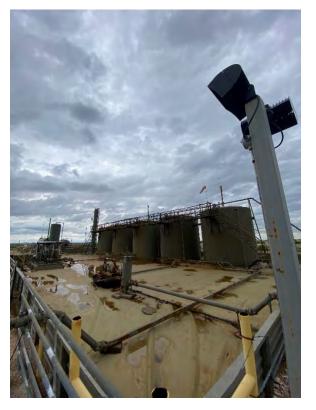
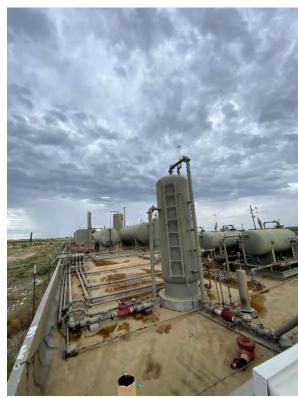
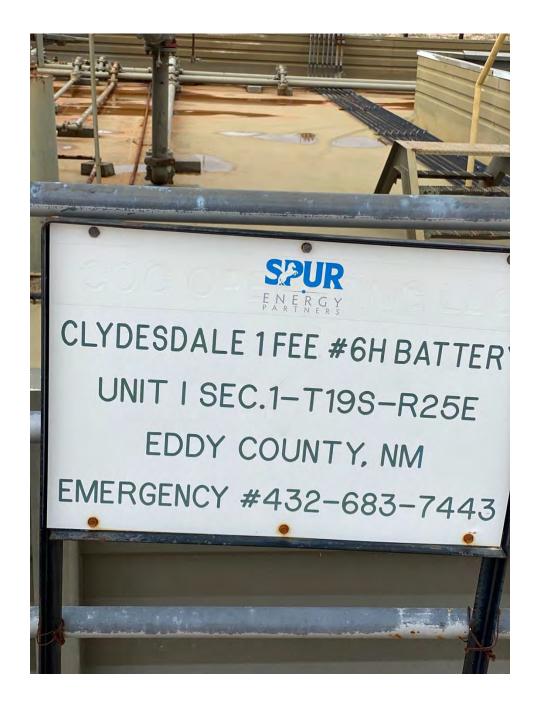
### **Liner Inspection**

On July 20, 2022, Paragon returned to the site to conduct a liner inspection. A 48-hour notification was sent out to the NMOCD on July 18, 2022. The liner inspection concluded that the liner was all intact and in good condition. The integrity of the liner appears to have the ability to contain spills. See Appendix D for the email notification, liner inspection and photos.

Visualization	Yes	No	Comments
Is there a tear in the liner?		X	
Are there holes in the liner?		X	
Is the liner retaining any fluids?		X	
Does the liner have integrity to contain a leak?	X
