March 13, 2023

RE: Liner Inspection and Closure Report
Cotton Draw 32 St Fed Com 1H
API No. 30-025-40583
GPS: Latitude 32.1730272 Longitude -103.6902696
UL- I, Section 32, Township 24S, Range 32E,
Lea County, NM
NMOCD Reference No. NTO1414739530

Liner Inspection FormCompany Name: Devon EnergySite: Cotton Draw 32 State Fed Com 1HLat/Long: 32.1730272, -103.6902696NMOCD Incident ID
& Incident Date: NT01414739530 5/22/20142-Day Notification
Sent: via Email by Gio Gomez 2/15/2023Inspection Date: 2/18/2023

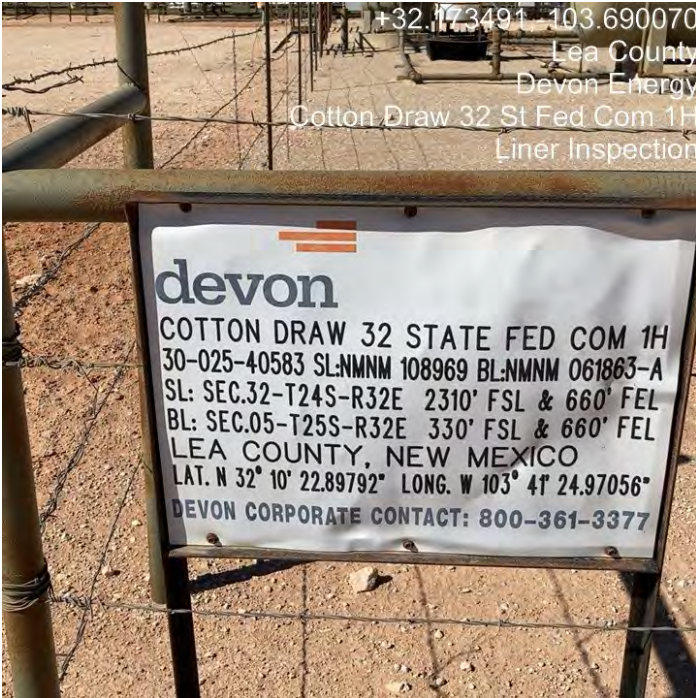
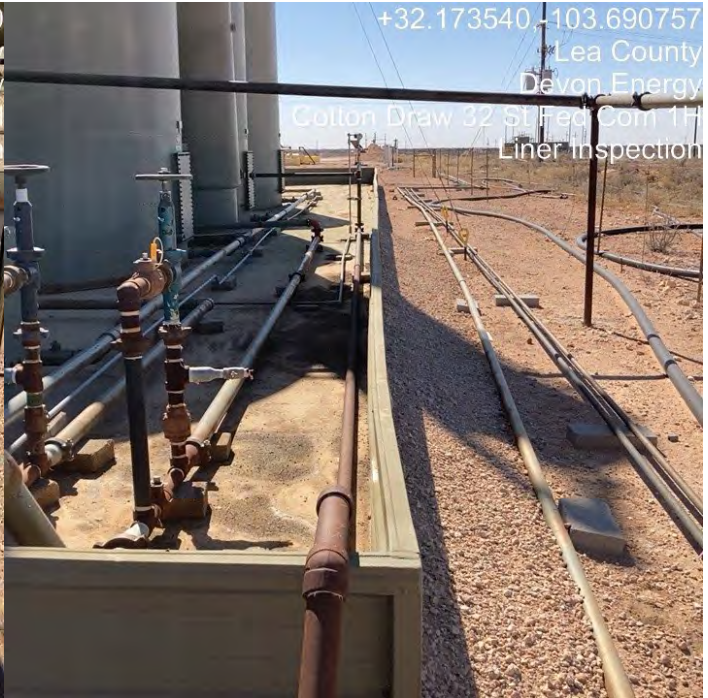
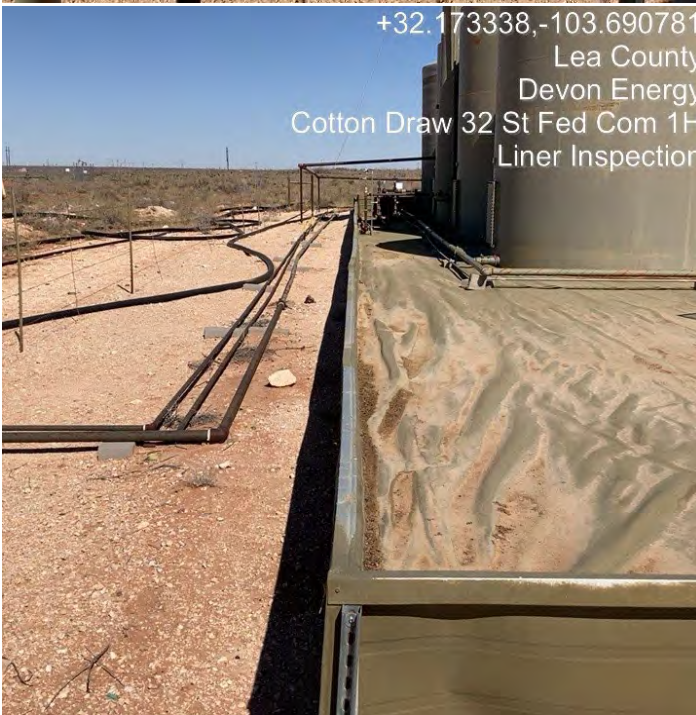
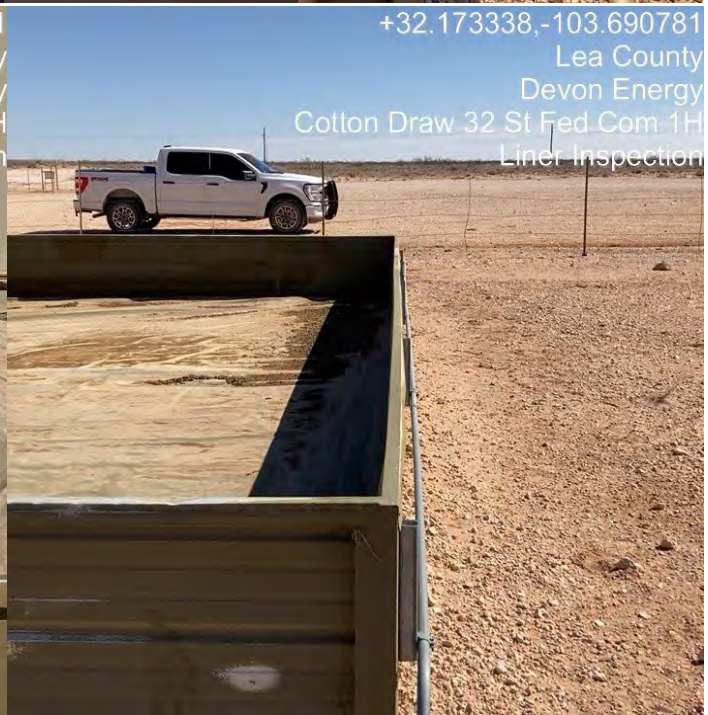
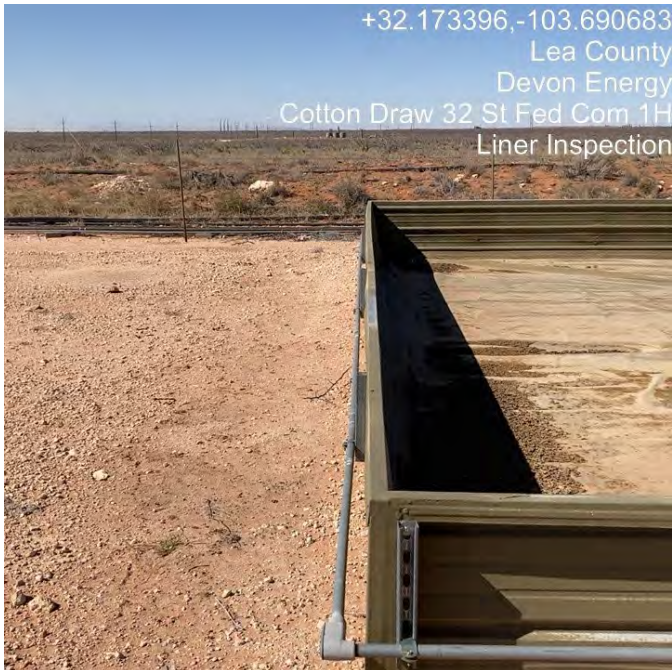
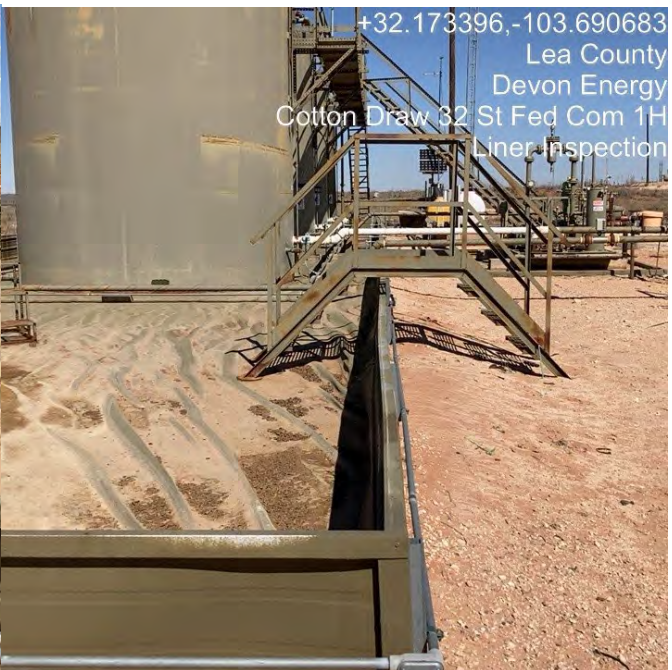
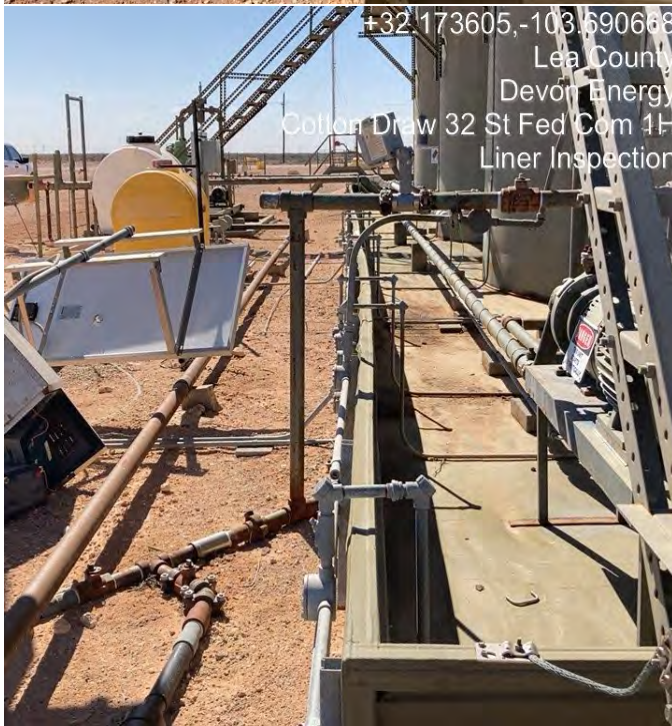
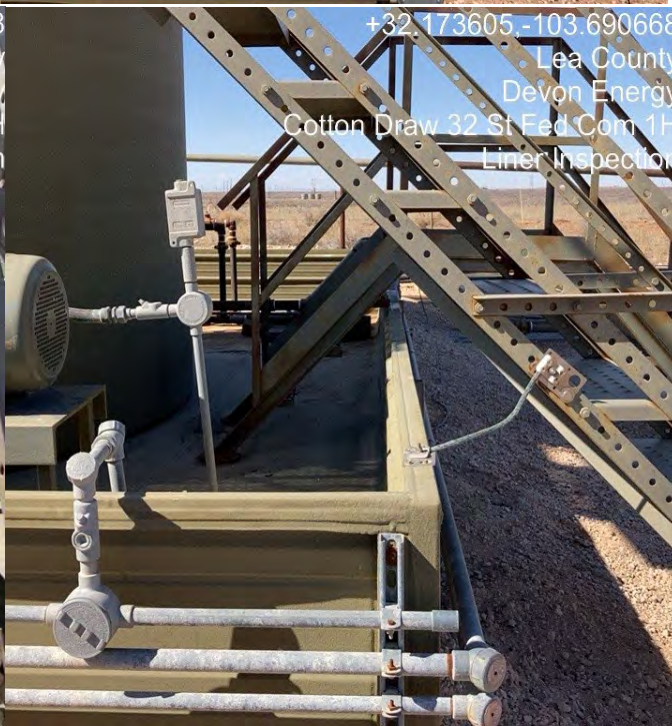
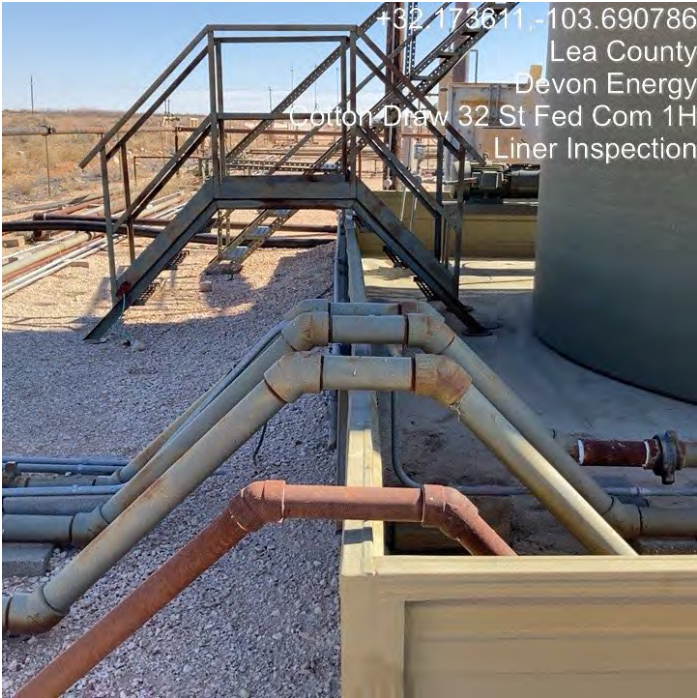
SITE PHOTOGRAPHS
DEVON ENERGY – LINER INSPECTION
COTTON DRAW 32 ST FED COM #001H

On February 18, 2023, after sending the 48-hour notification via email, Pima Environmental conducted a liner inspection at this location. We concluded that this liner and containment maintained its integrity and was able to retain the fluids. The liner inspection form and photographic documentation can be found in Appendix C.

Visualization	Yes	No	Comments
Is there a tear in the liner?		X	
Are there holes in the liner?		X	
Is the liner retaining any fluids?		X	
Does the liner have integrity to contain a leak?	X

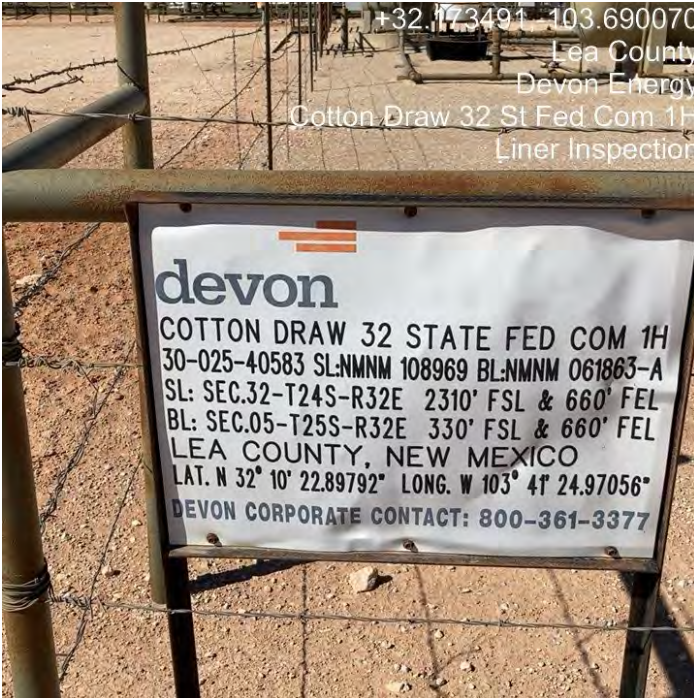
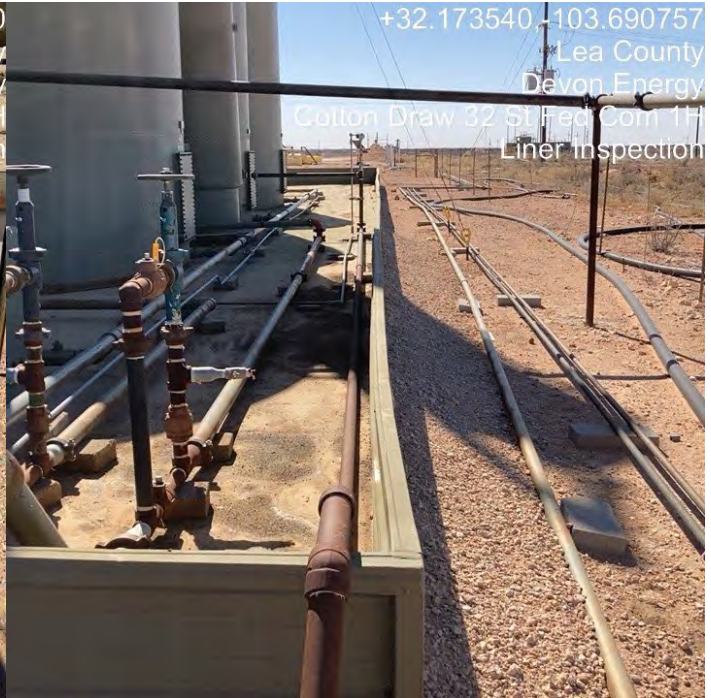
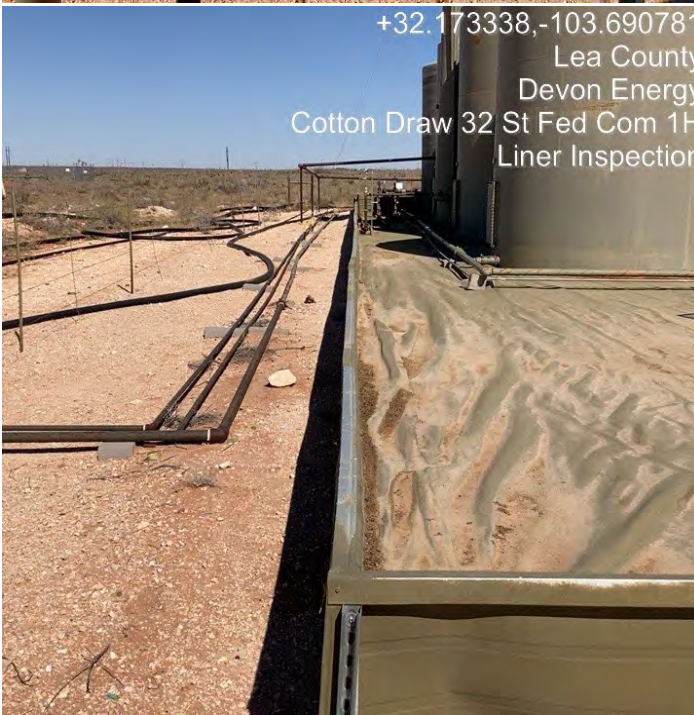
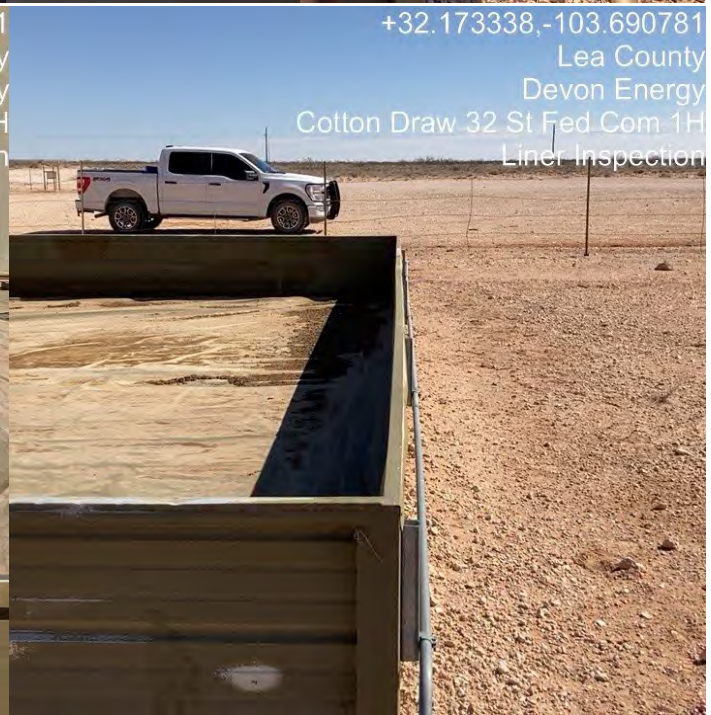
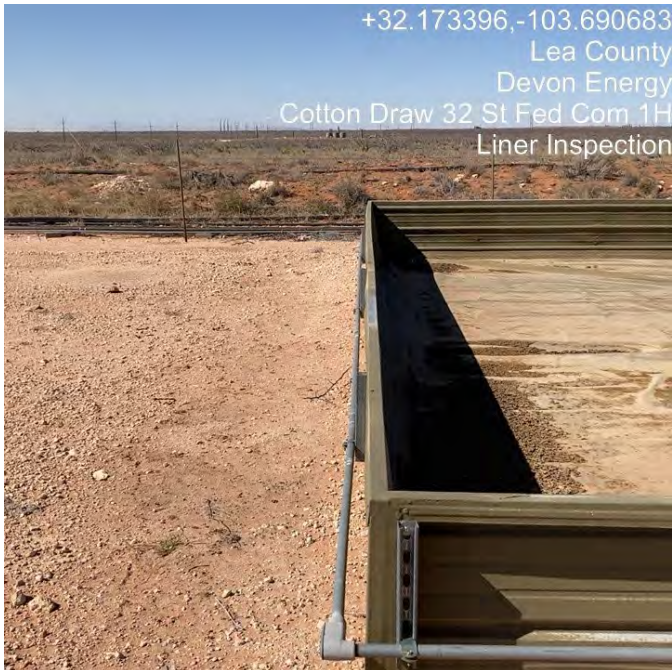
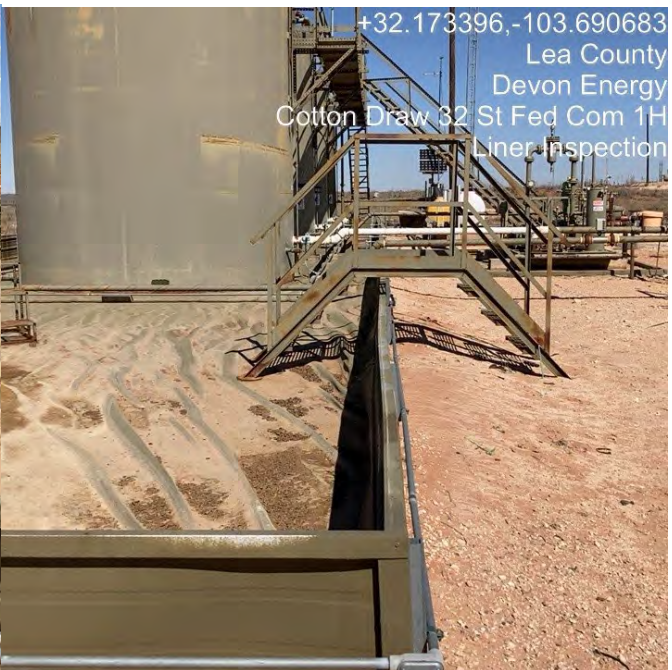
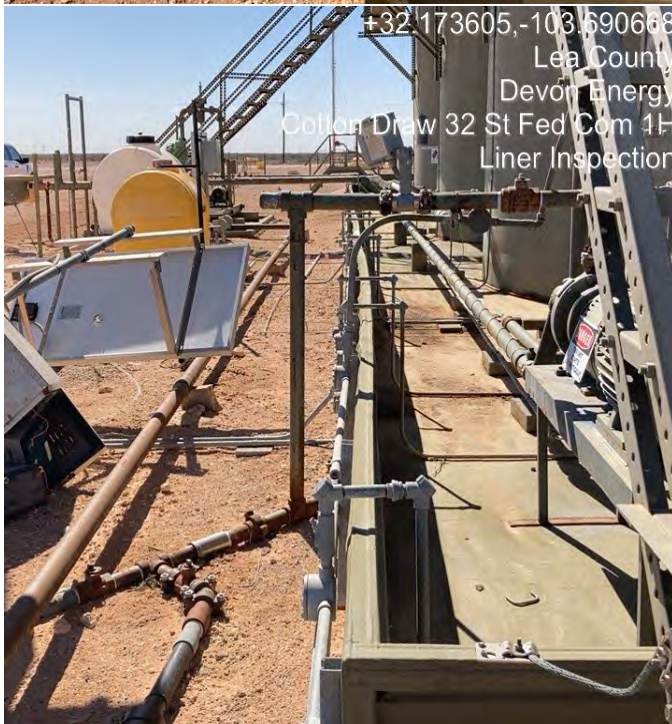
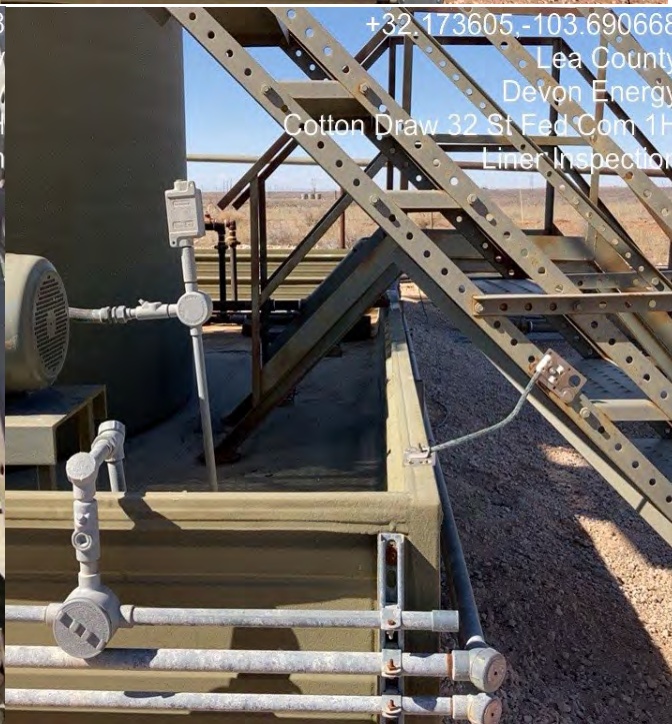
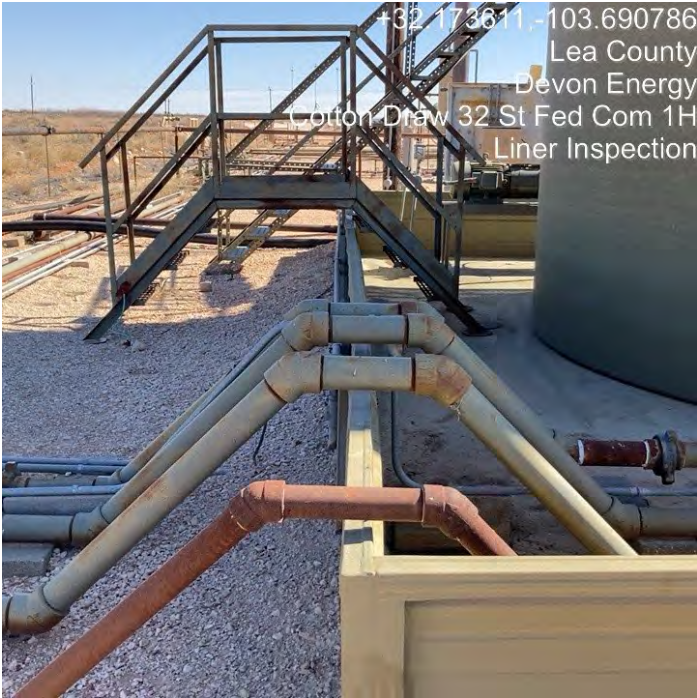
SITE PHOTOGRAPHS
DEVON ENERGY – LINER INSPECTION
COTTON DRAW 32 ST FED COM #001H

On February 18, 2023, after sending the 48-hour notification via email, Pima Environmental conducted a liner inspection at this location. We concluded that this liner and containment maintained its integrity and was able to retain the fluids. The liner inspection form and photographic documentation can be found in Appendix C.

Visualization	Yes	No	Comments
Is there a tear in the liner?		X	
Are there holes in the liner?		X	
Is the liner retaining any fluids?		X	
Does the liner have integrity to contain a leak?	X
