Re: Site Assessment, Liner Inspection, and Closure Report
Arkansas St. 23 Tank Battery
API No. N/A
GPS: Latitude 32.64708 Longitude 104.45659
UL "F", Sec. 23, T19S, R25E
Eddy County, NM
NMOCD Ref. No. NAPP2224928619

Paragon Environmental, LLC (Paragon) has been contracted by Spur Energy Partners (Spur) to perform a site assessment, conduct a liner inspection, and write a closure report for the release site known as the Arkansas St. 23 Tank Battery (Arkansas). Details of the release are summarized below:

Liner Inspection Form

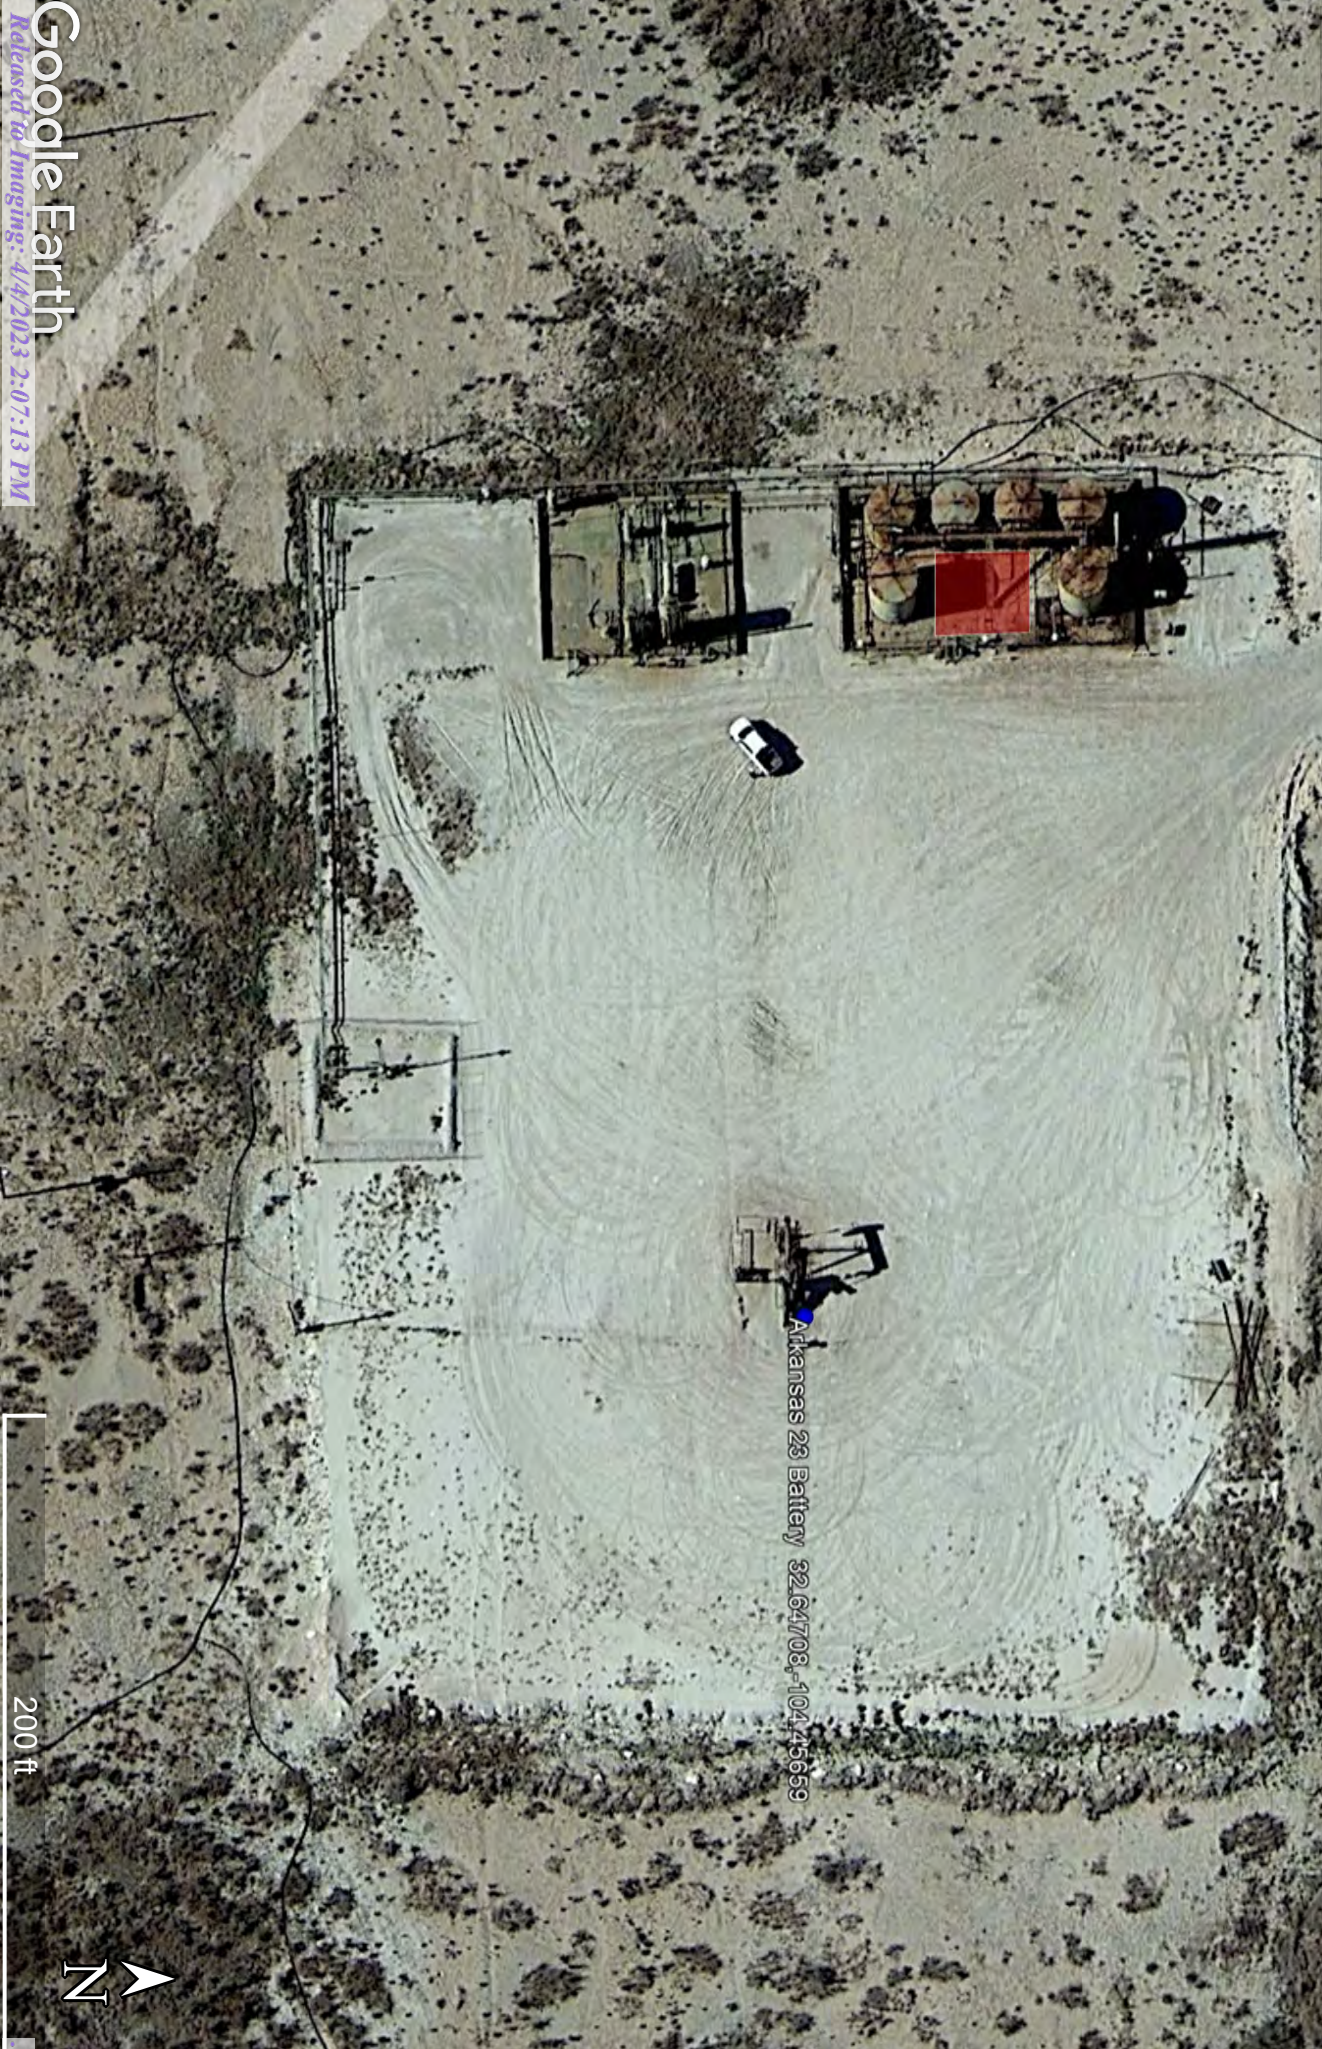
Arkansas St. 23 Tank Battery
Facility# FAPP2127232896
Eddy County, NM
Site Map

Spill area

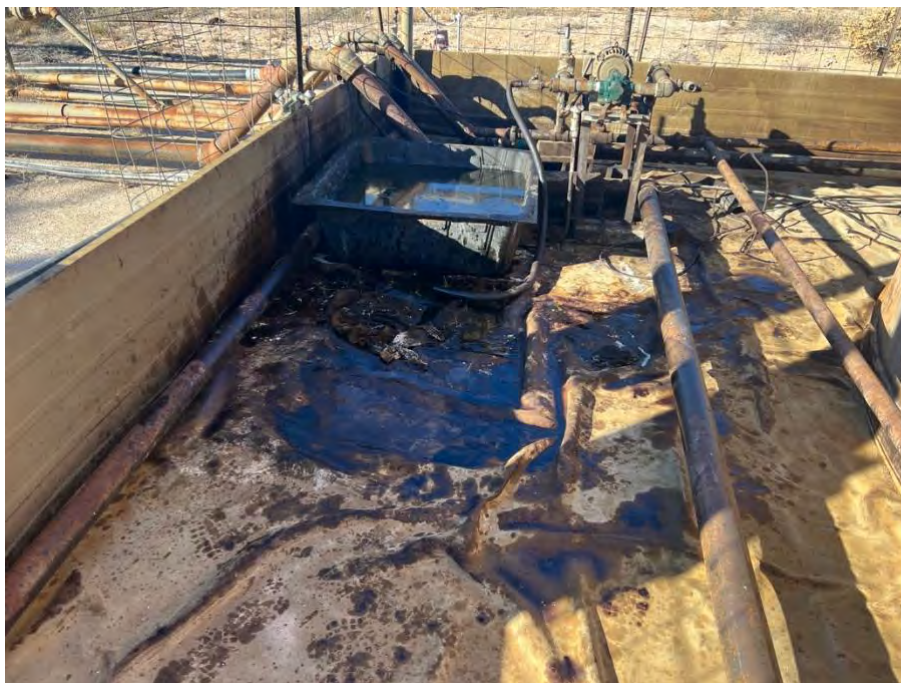
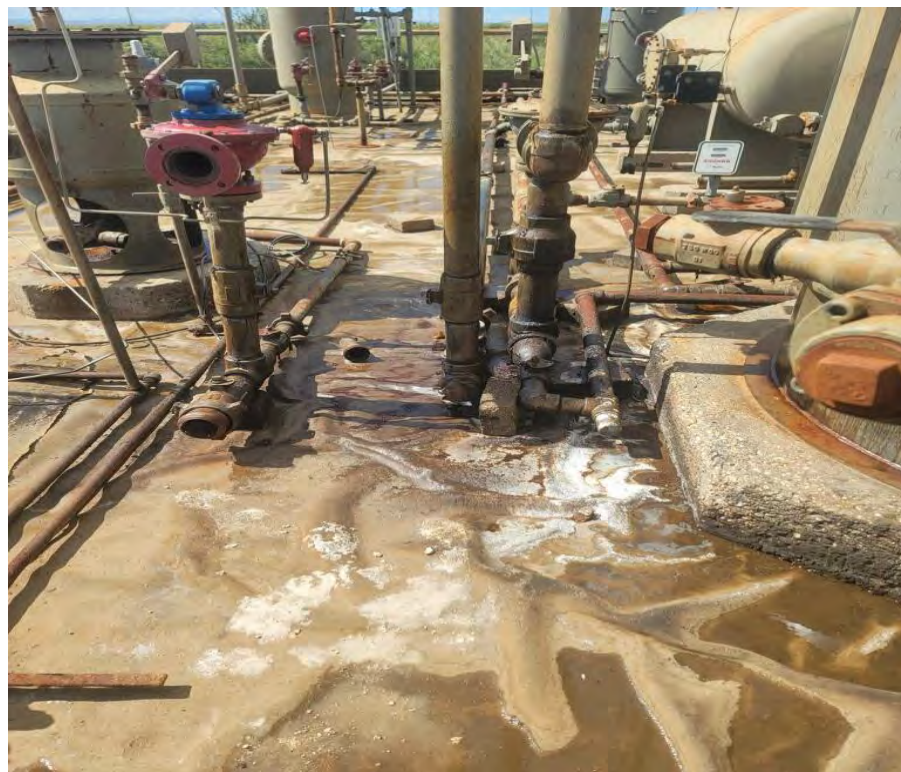
Before

Release Details			
Type of Release:	Produced Water	Volume of Release:	20 bbls
		Volume Recovered:	19 bbls
Source of Release:	Water Leg	Date of Release:	09/01/22
Was Immediate Notice Given?	No	If, Yes, to Whom?	N/A
Was a Watercourse Reached?	No	If Yes, Volume Impacting Watercourse:	N/A
Surface Owner:	Private	Mineral Owner:	
The 4" water leg developed a hole from corrosion causing a spill.

Paragon dispatched a tech to conduct an initial assessment to determine what was needed to draw this incident to closure. Upon arrival, it was determined that the liner needed to be cleaned. No evidence was found that the spill breached the containment. The Liner was cleaned utilizing a degreaser and a steam power washer. It was then determined that nothing else was needed here, and we could move toward closure.

On September 1, 2022, Spur mobilized a vacuum truck to recover the produced water. After cleaning the liner and performing the inspection, it was determined that no further remediation was needed.

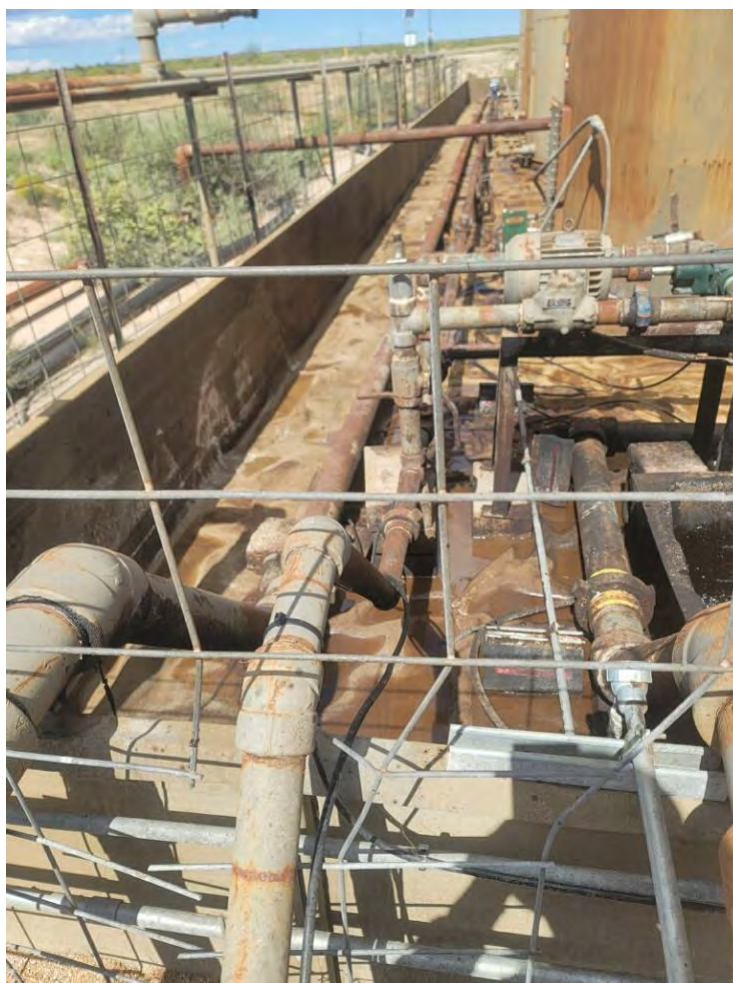
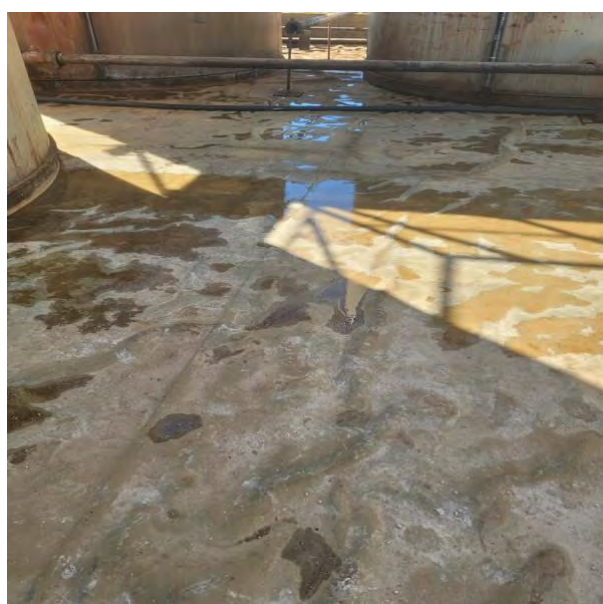
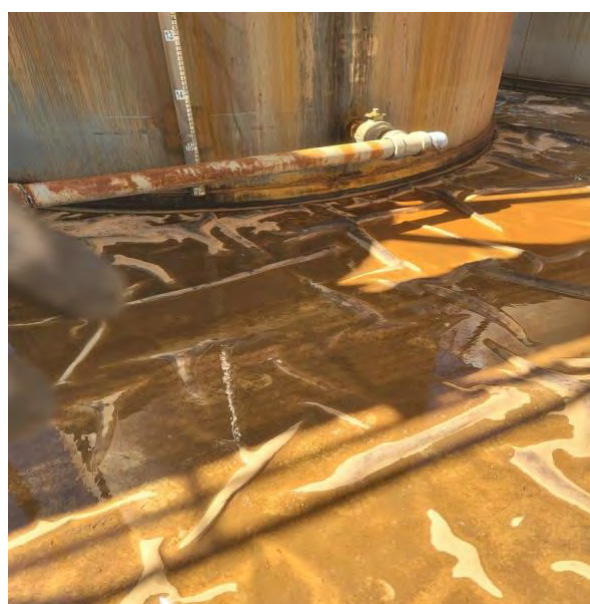
After

During the Liner Inspection, it was determined that it had the integrity to hold fluids. A copy of the liner inspection can be found in Appendix D.

Visualization	Yes	No	Comments
Is there a tear in the liner?		×	
Are there holes in the liner?		×	
Is the liner retaining any fluids?		×	
Does the liner have integrity to contain a leak?	×
