Incident ID	NAPP2118841297
District RP	
Facility ID	
Application ID

December 20, 2022

Re: Site Assessment, Liner Cleaning, Liner Inspection, and Closure Report
Empire St. SWD 15 #1
API No. 30-015-39771
GPS: Latitude 32.8343163 Longitude -104.06665
UL "K", Sec. 15, T17S, R29E
Eddy County, NM
NMOCD Ref. No. NAPP2118841297

Tristan Jones
Project Coordinator
Paragon Environmental, LLC

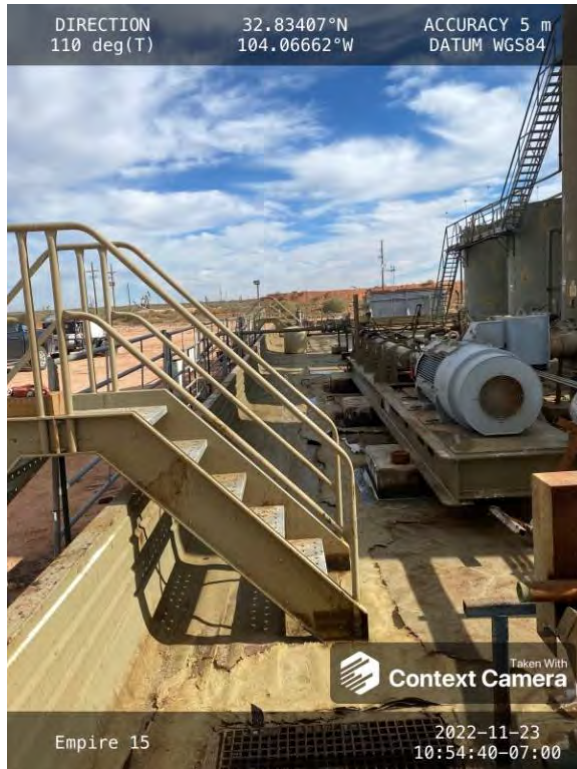
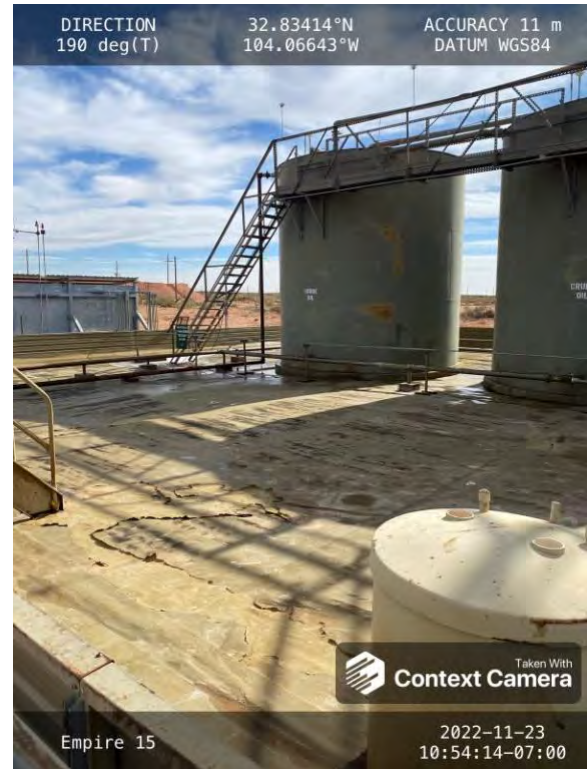
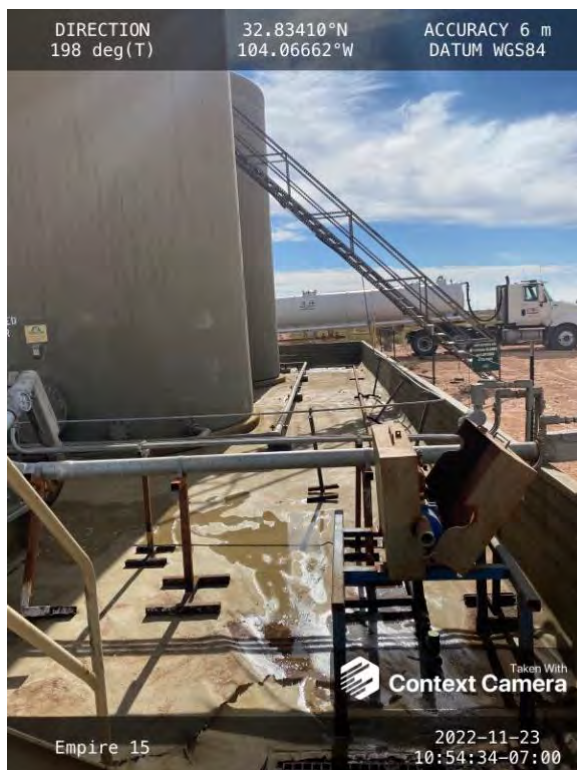
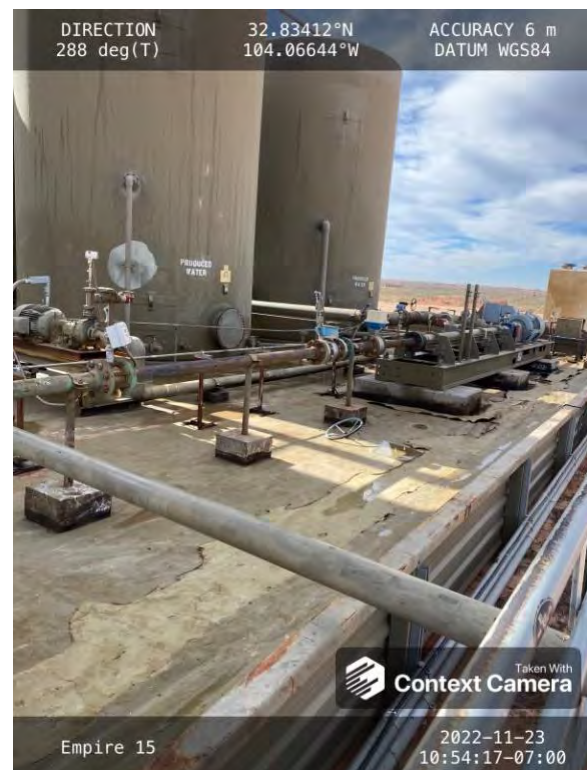
Liner Inspection Photos

During the Liner Inspection, it was determined that it had the integrity to hold fluids. A copy of the liner inspection can be found in Appendix D.

Visualization	Yes	No	Comments
Is there a tear in the liner?		✗	
Are there holes in the liner?		✗	
Is the liner retaining any fluids?		✗	
Does the liner have integrity to contain a leak?	✗

On June 22, 2021, Spur mobilized a vacuum truck to recover the produced water. After cleaning the liner and performing the inspection, it was determined that no further remediation was needed.

After careful review, Paragon requests that the incident, NAPP2118841297, be closed. Spur has complied with the applicable closure requirements outlined in rule 19.15.19.12 NMAC.
