# 2018 ANNUAL VEGETATION MONITORING REPORT

CVU 106/136

Lea County, New Mexico

1RP-2642-0 and 1RP-3244

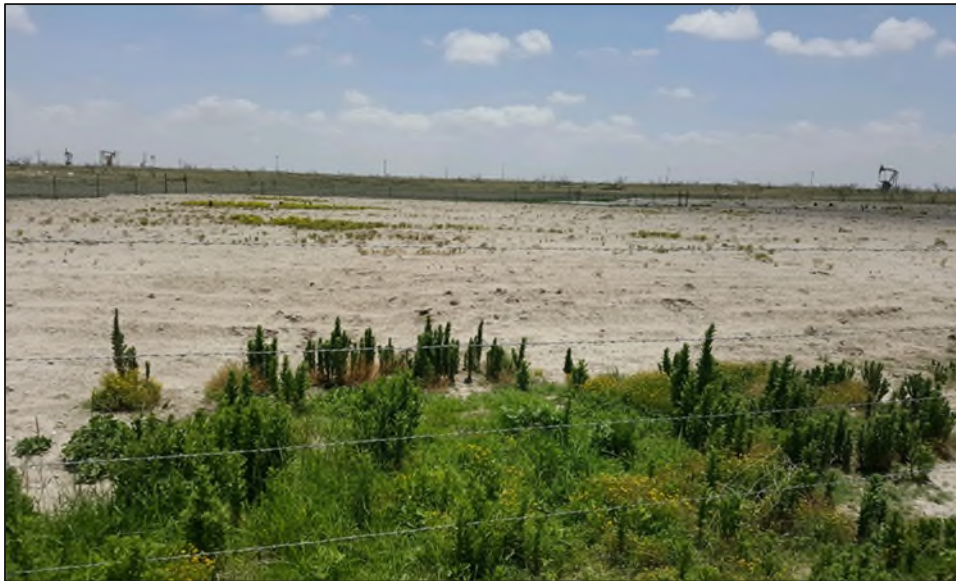
**Photo: 1**

The first half vegetation-monitoring event occurred on June 26, 2018 (eight months following the initial reseeding activities). Grasses and flowering shrubs had just begun surfacing through the topsoil. Those that had appeared were green and thriving on the Site (Appendix A: Photos 1 and 2). The vegetation is patchy, but otherwise appears to be in the same condition as within the surrounding area. Regional water conditions are moderate to severe drought based on the USGS Vegetation Drought Response Index for June 2018 (Figure 2).

First vegetation-monitoring event that occurred on June 26, 2018 (eight months after reseeding which occurred in October 2017). Plants have begun growing on-Site. Site vegetation is green and active similar to the surrounding vegetation.

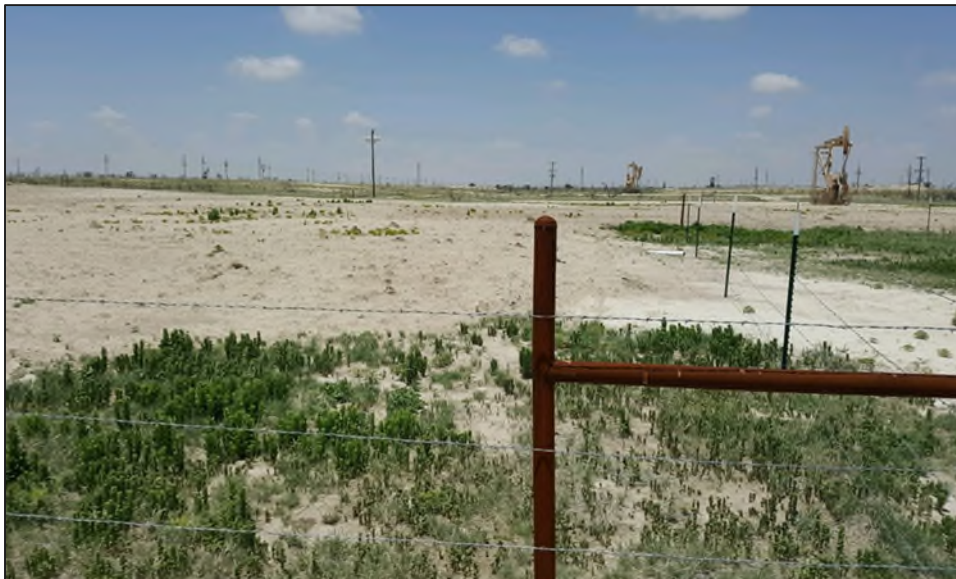
**Photo: 2**

Additional view of first vegetation monitoring event (June 26, 2018). Both grass and flowering shrubs have begun to grow within the remediated area on the Site.
