December 16, 2022

Vertex Project #: 22E-04122

Spill Closure Report: Jimmy Kone Tank Battery
Section 5, Township 24 South, Range 28 East
County: Eddy
Incident Report: nAPP2203247689

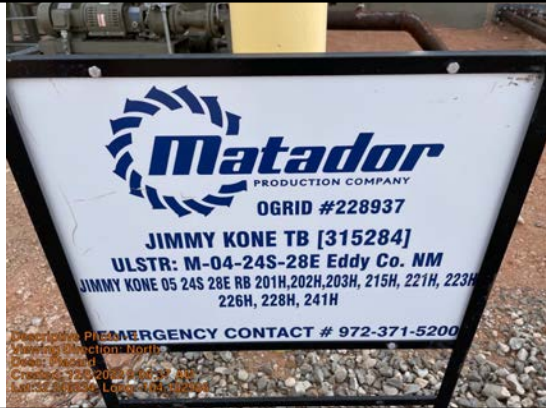
Placard

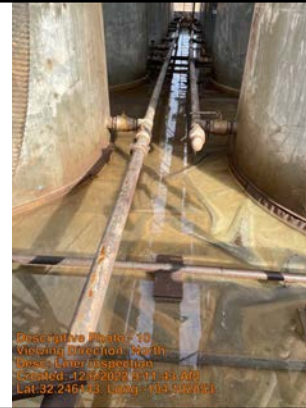
10:14 Performed a liner inspection. There was a couple of inches of water in the liner, but was very clear and was still able to accurately inspect the liner for any damage.

10:14 The liner looked great, no tears or abrasion was noted. Standing water from rain event that occurred day prior to inspection.

Liner inspection

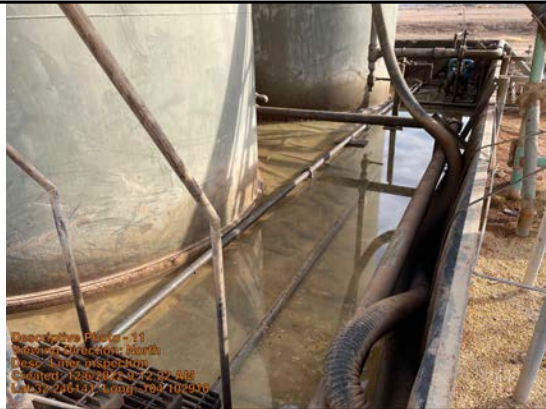
Liner inspection

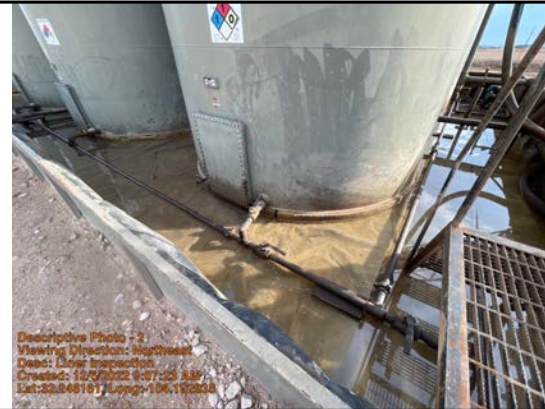
Liner inspection

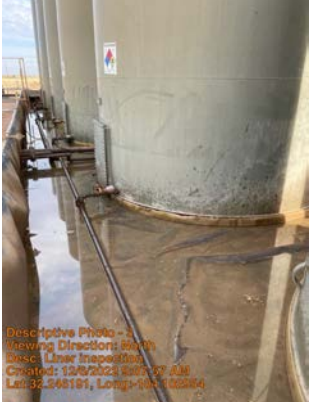
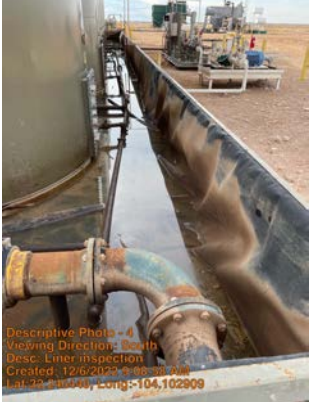
| <p>Viewing Direction: North</p> <p>Descriptive Photo - 4 Viewing Direction: North Desc: Liner inspection Created: 12/6/2022 8:07:27 AM Lat:32.246181, Long:-104.102864</p> <p>Liner inspection</p> | <p>Viewing Direction: South</p> <p>Descriptive Photo - 4 Viewing Direction: South Desc: Liner inspection Created: 12/6/2022 8:08:38 AM Lat:32.246408, Long:-104.102809</p> <p>Liner inspection</p> |

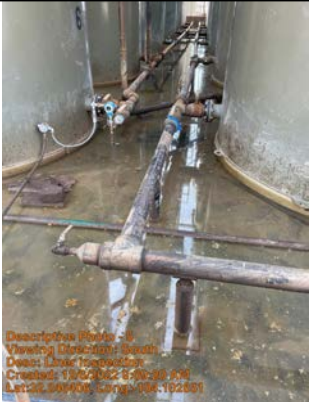
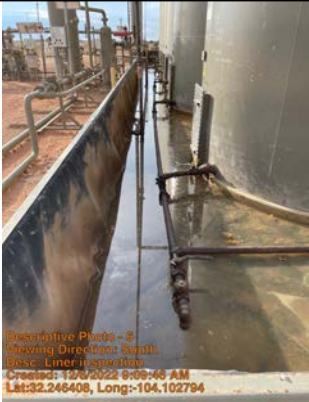
| <p>Viewing Direction: South</p> <p>Descriptive Photo - 5 Viewing Direction: South Desc: Liner inspection Created: 12/6/2022 8:09:38 AM Lat:32.246408, Long:-104.102801</p> <p>Liner inspection</p> | <p>Viewing Direction: South</p> <p>Descriptive Photo - 5 Viewing Direction: South Desc: Liner inspection Created: 12/6/2022 8:09:46 AM Lat:32.246408, Long:-104.102794</p> <p>Liner inspection</p> |

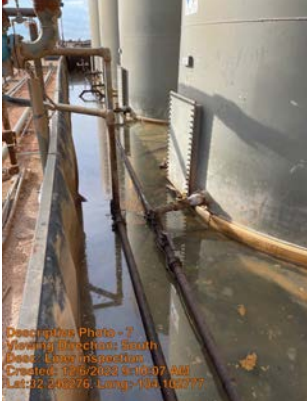
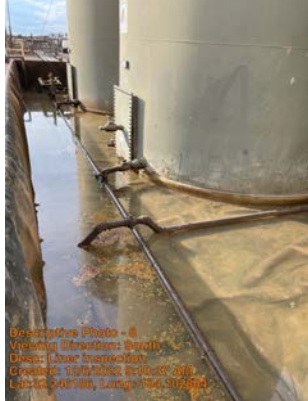
| <p>Viewing Direction: South</p> <p>Descriptive Photo - 7 Viewing Direction: South Task: Liner Inspection Created: 12/6/2022 4:10:07 AM Lat:32.56876, Long:-104.10277</p> | <p>Viewing Direction: South</p> <p>Descriptive Photo - 8 Viewing Direction: South Task: Liner Inspection Created: 12/6/2022 4:10:07 AM Lat:32.56876, Long:-104.10277</p> |
| Liner inspection | Liner inspection |

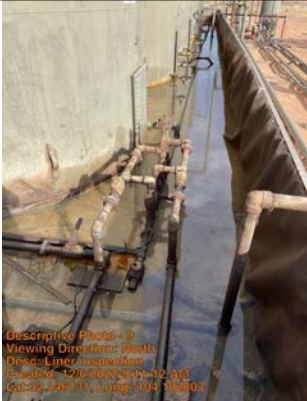
| <p>Viewing Direction: North</p> <p>Descriptive Photo - 9 Viewing Direction: North Task: Liner Inspection Created: 12/6/2022 4:11:12 AM Lat:32.56876, Long:-104.10277</p> | |
| Liner inspection | |
