**Re: Chevron Central Vacuum Unit 106/136
2017 Interim Remediation and Reclamation Report
Case No. 1RP-2642-0
Lea County, New Mexico**

2017 Interim Remediation and Reclamation Report

CVU 106/136

1R-2642-0

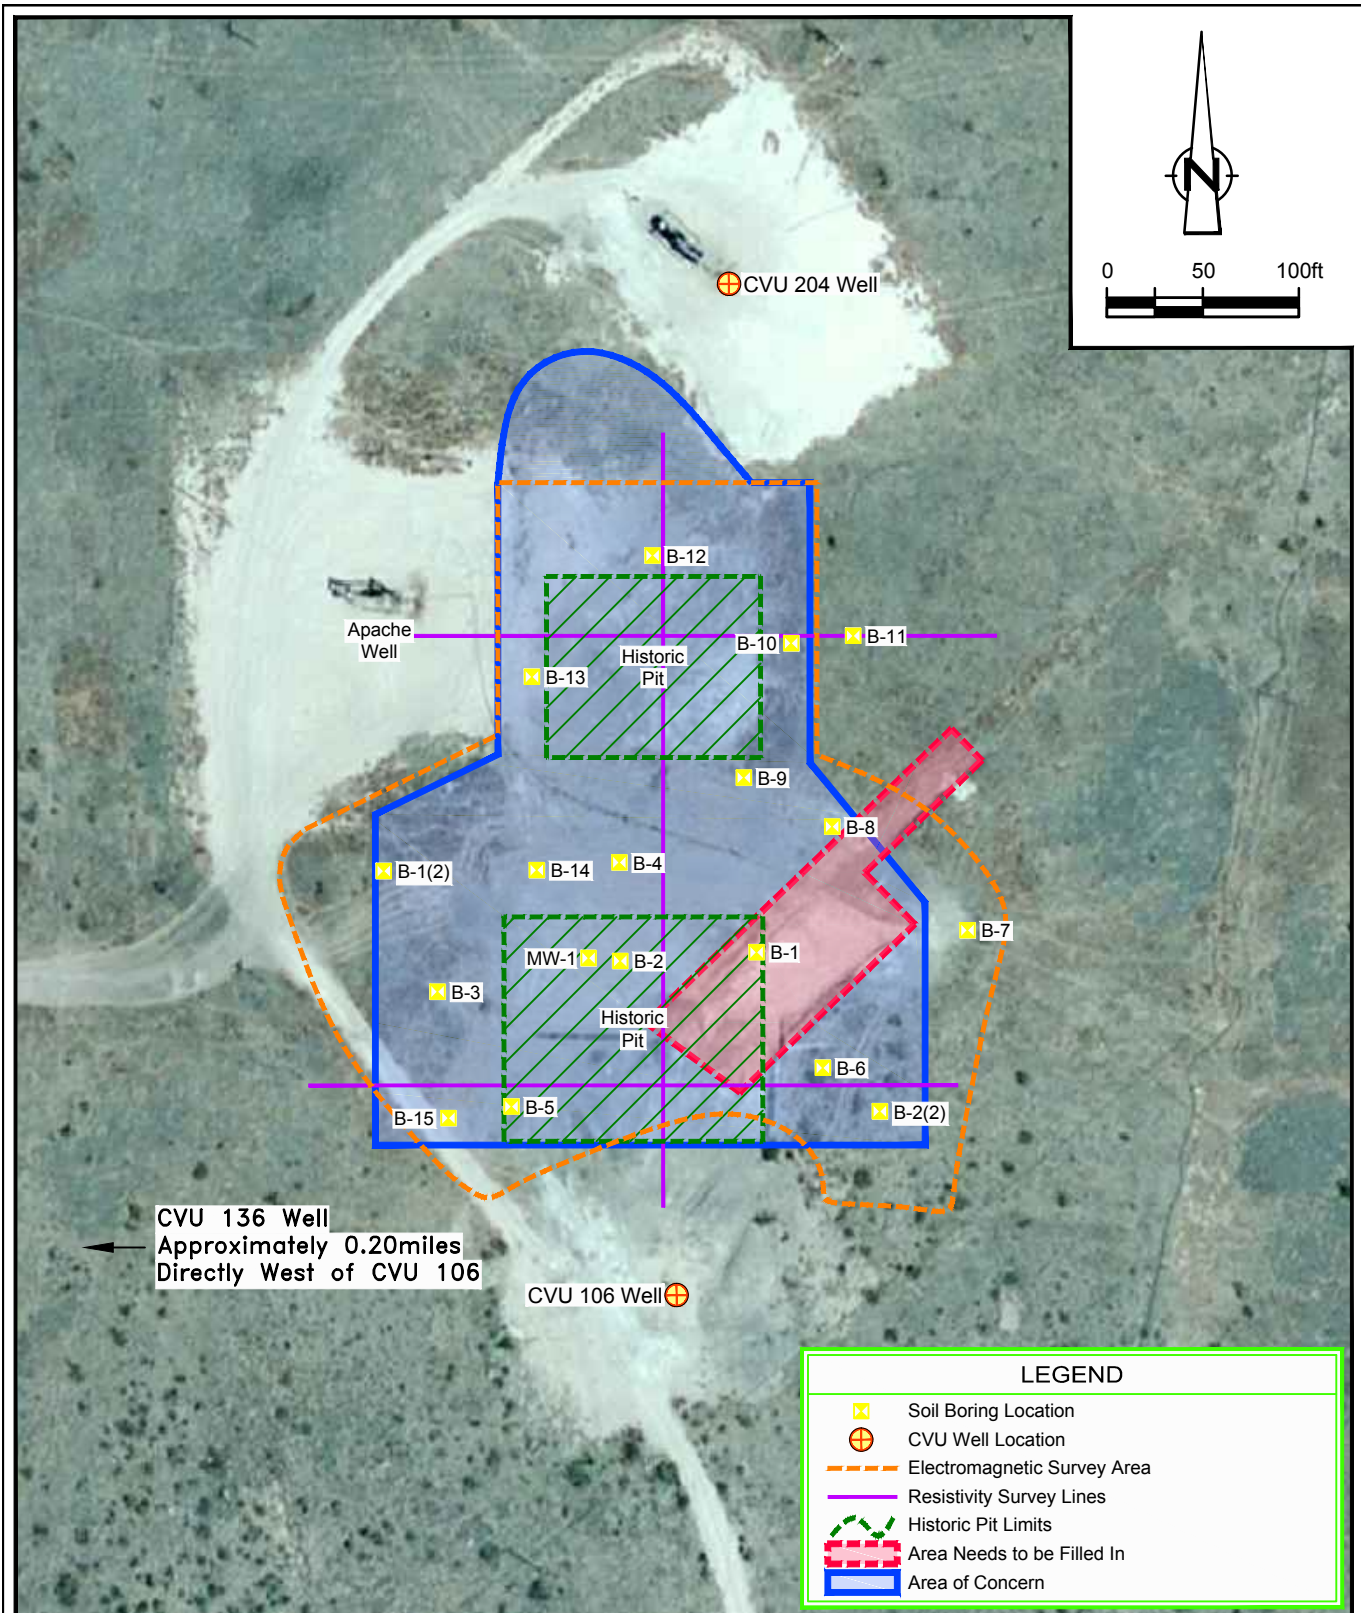
Figure 2

PROPOSED REMEDIATION ACTIVITY MAP
CVU No.136 AND CVU No.106
LEA COUNTY, NEW MEXICO

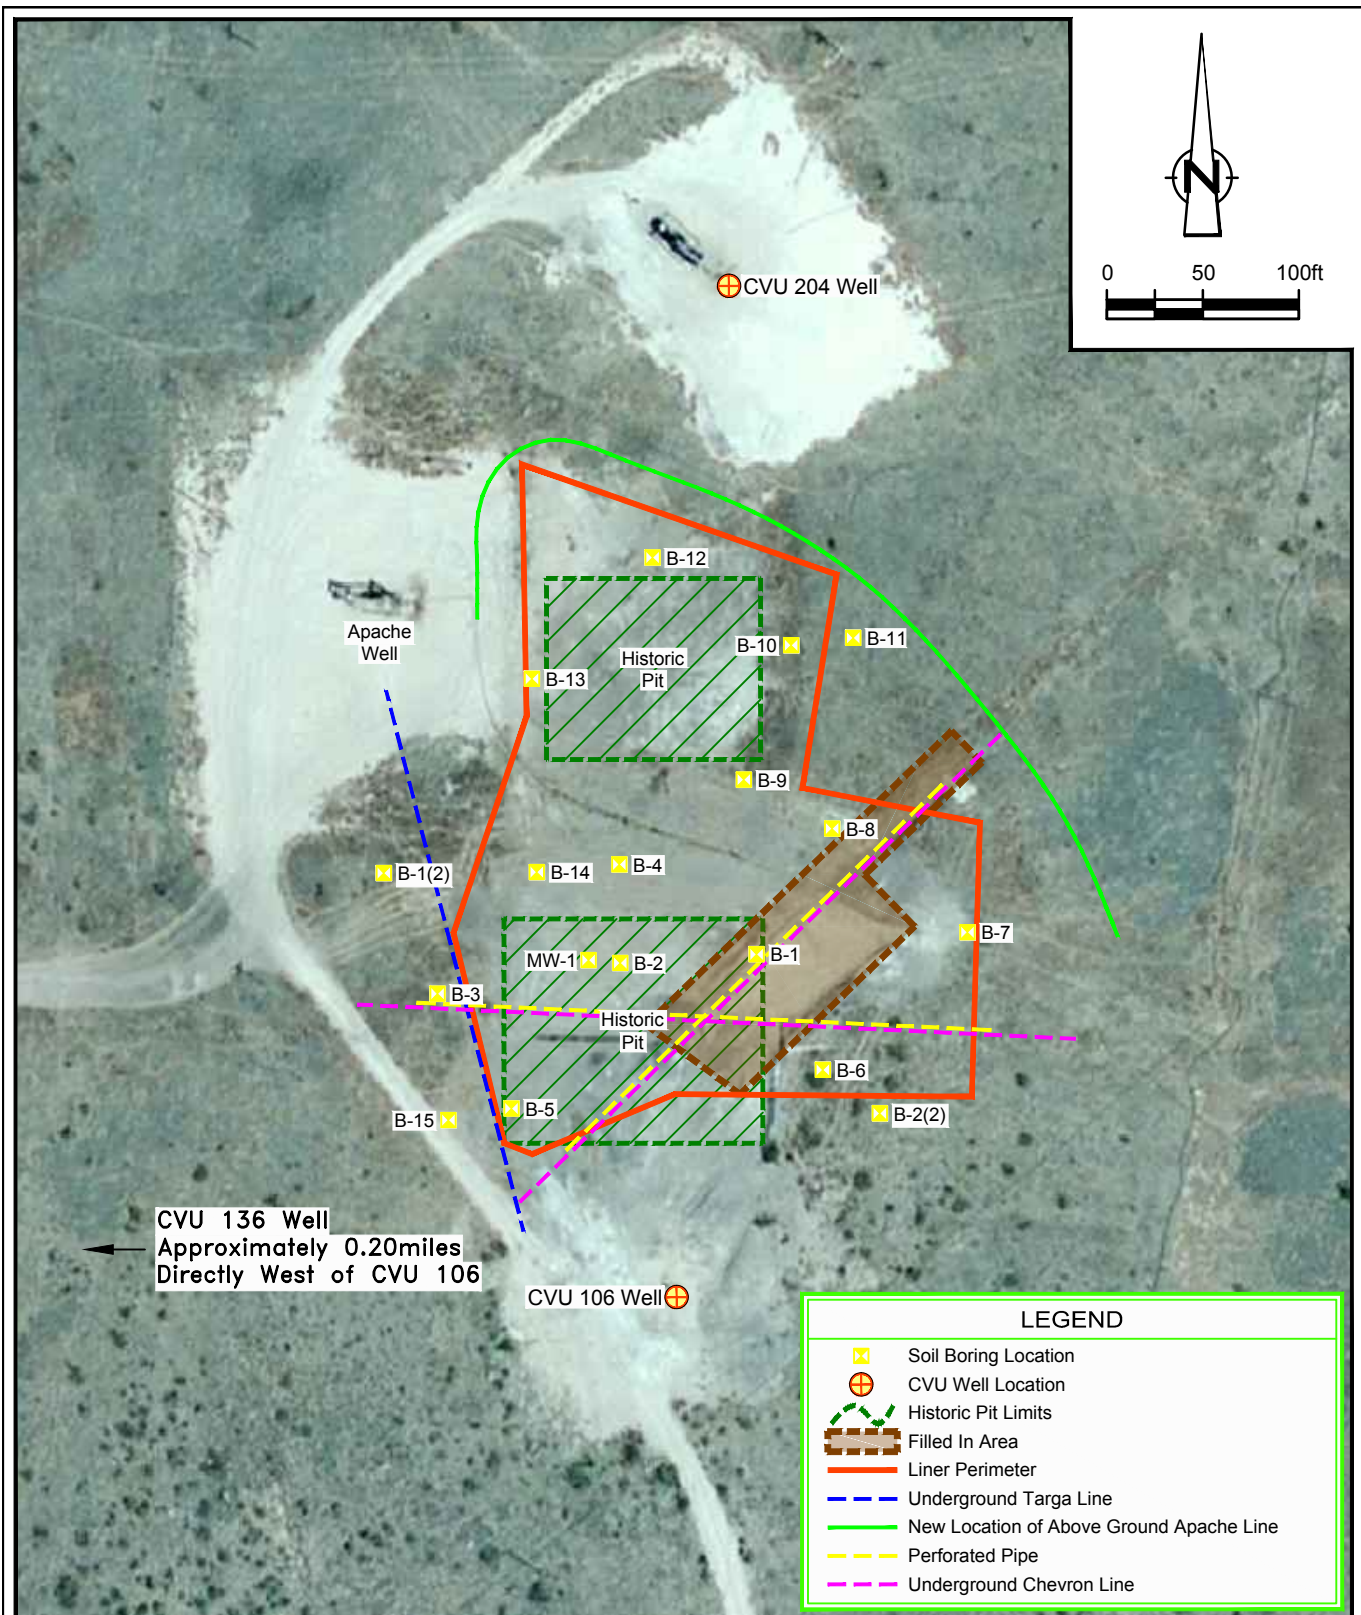
Figure 3

REMEDATION ACTIVITY MAP CVU No. 136 AND CVU No. 106 LEA COUNTY, NEW MEXICO

- An application for a Right of Entry (ROE) for Remediation permit to the NMSLO was completed and submitted prior to the start of work.
- The area to be lined (see Figure 3) was marked on the ground with flagging and NM811 was contacted to have underground utilities in the area pre-marked prior to physically locating the lines. Active lines in the vicinity were depressurized/shut down prior to being located by means of ground penetrating radar and day lighted by hydro excavation. Soils generated from hydro excavation were thin spread on site. Located lines can be referenced on Figure 3. All physical line locating was completed by September 14, 2017.

- The identified area of impact was lined with 20 mil polyethylene. The liner was placed to overlap the impacted area approximately ten feet at the edges. Once the area was lined, approximately one foot of caliche was placed to hold the liner down. Approximately one foot of topsoil was placed above the caliche to allow for reseeding of the area. Approximately 2,680 yards of caliche and 1,720 yards of topsoil were placed on top of the liner. Placement of the cover soil was completed on September 22, 2017.

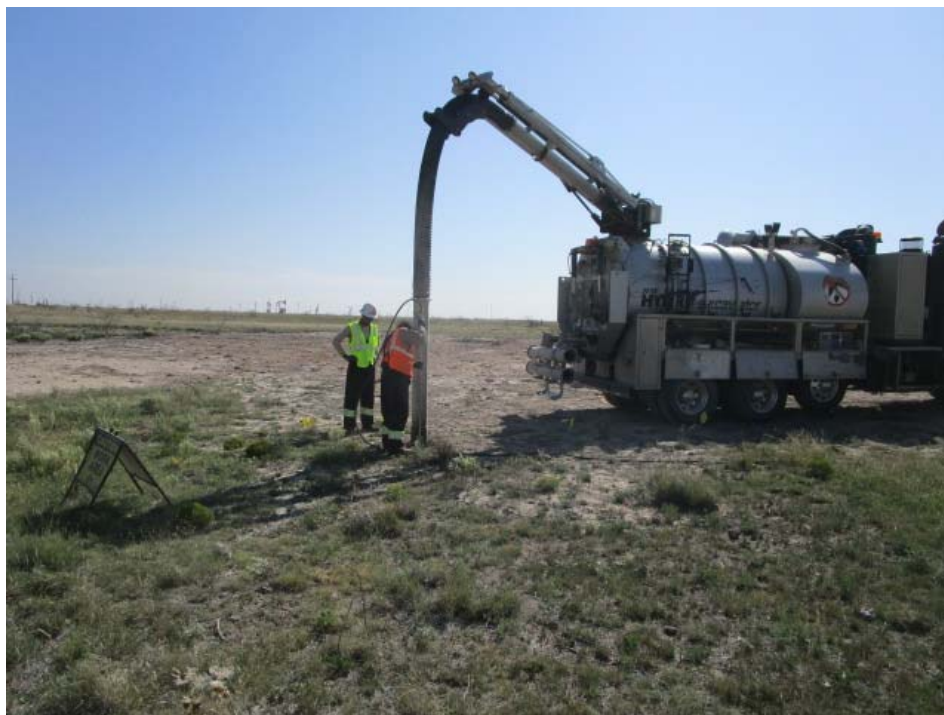
Photo 1 - Locating underground pipelines via hydrovac

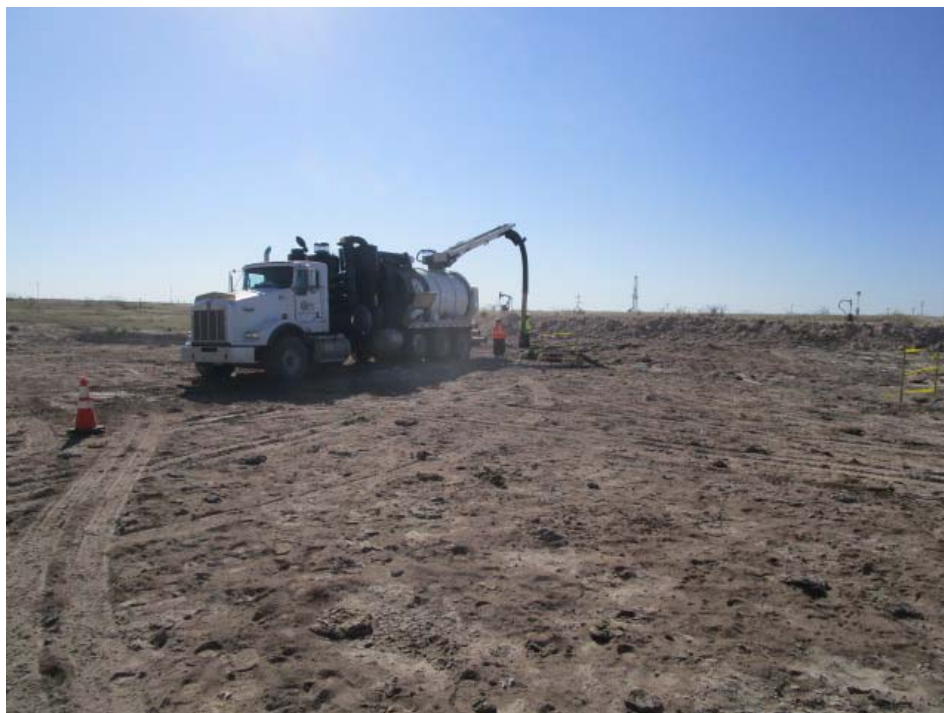
Photo 2 - Locating underground pipelines via hydrovac

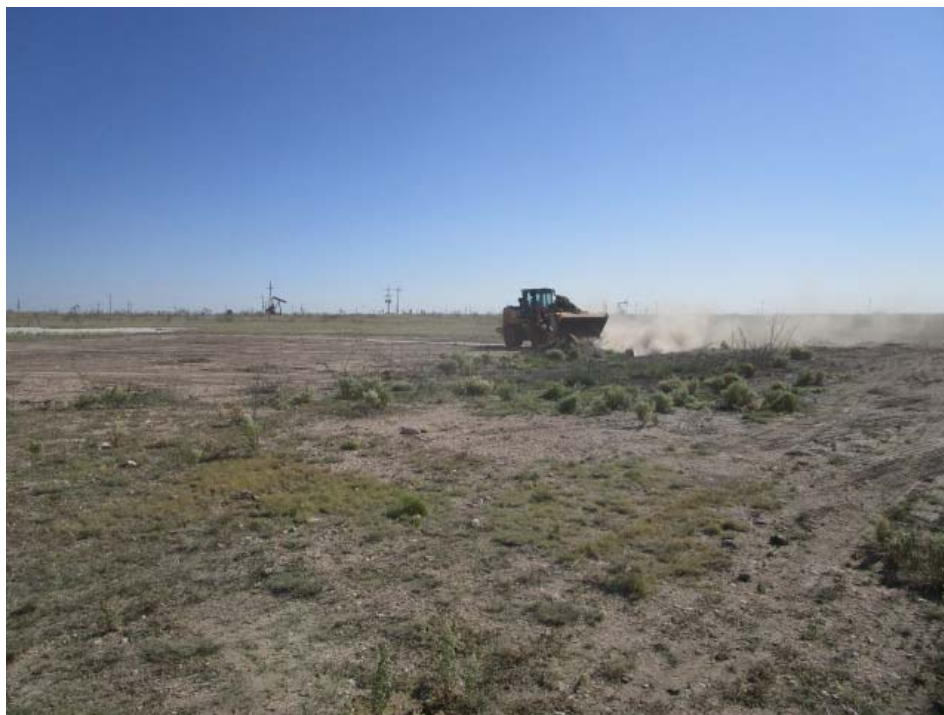
Photo 3 - Clearing, grubbing, and leveling the area to be lined

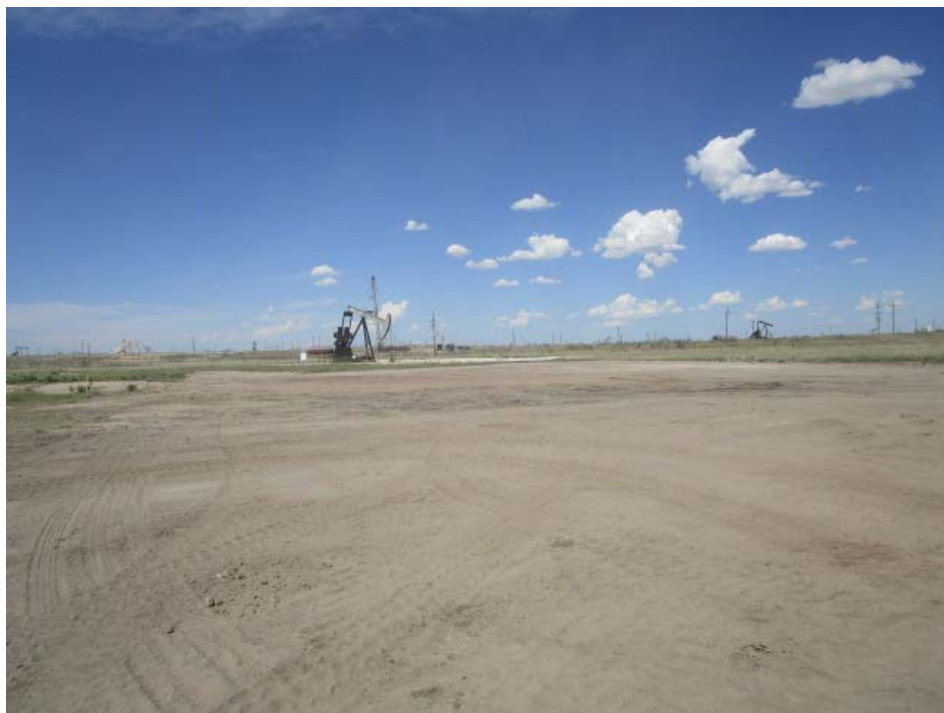
Photo 4 - Area to be lined is cleared and leveled

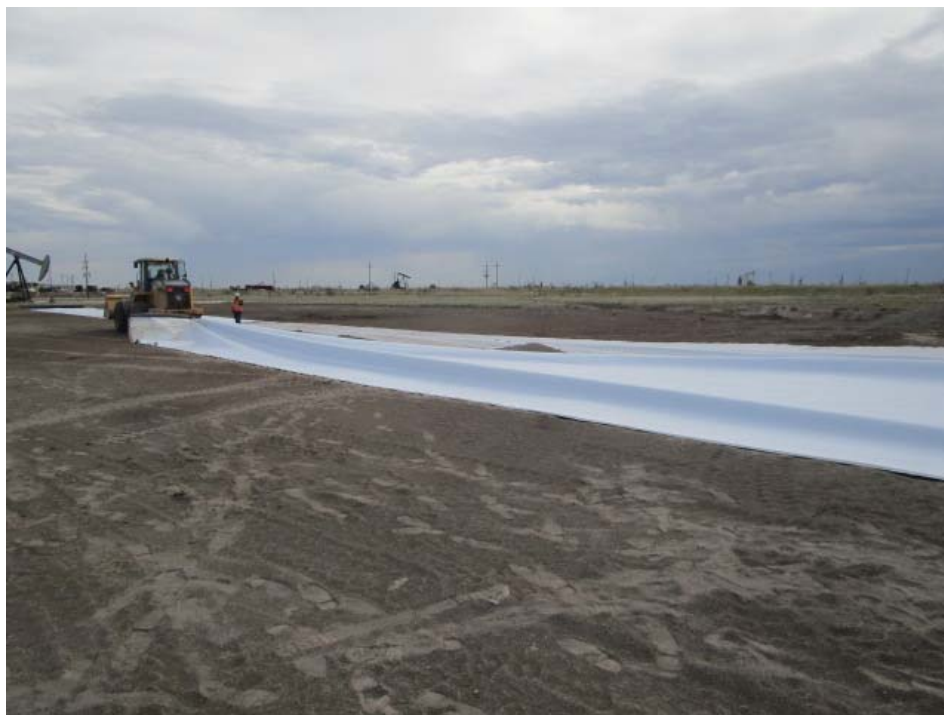
Photo 5 - Liner being placed

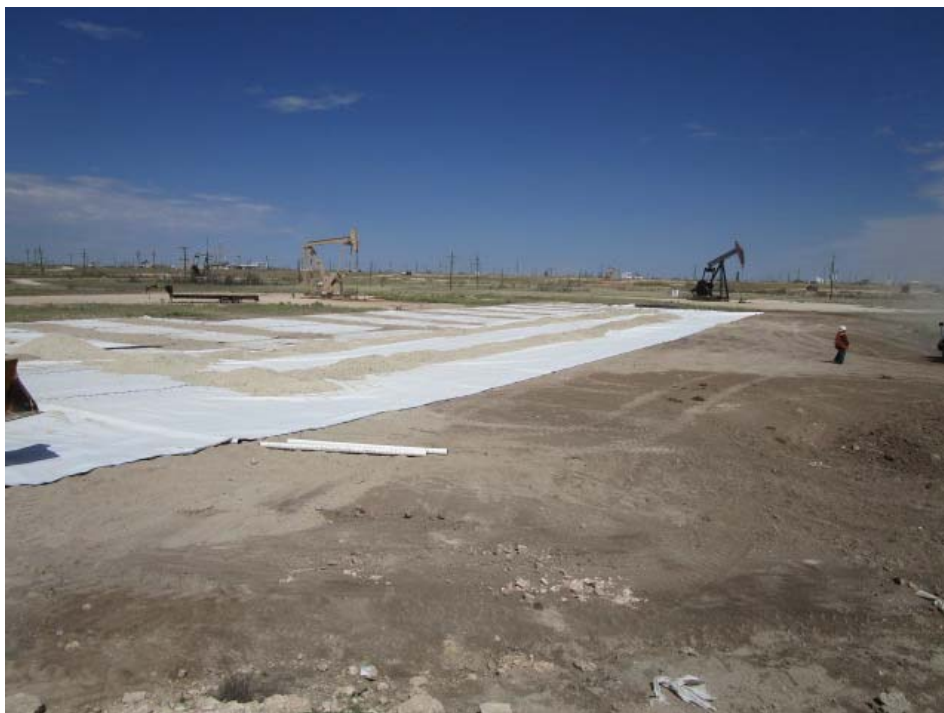
Photo 6 - Perforated pipe placed on top of underground pipelines and underneath the liner for leak detection

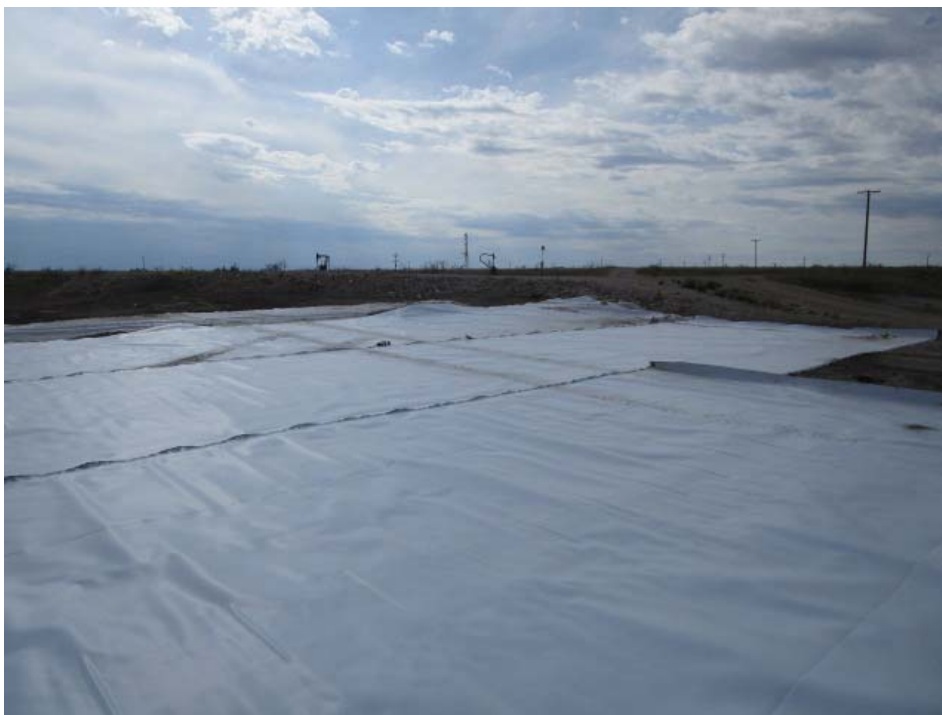
Photo 7 - Liner is placed over the entire cleared area

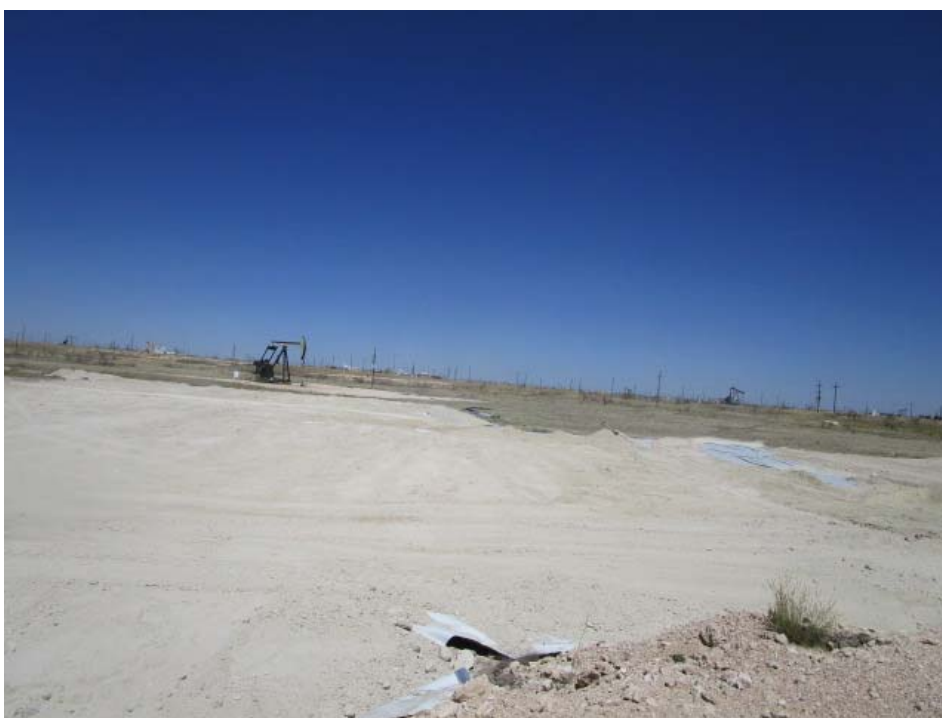
Photo 8 - Caliche placed on top of the liner to secure in place

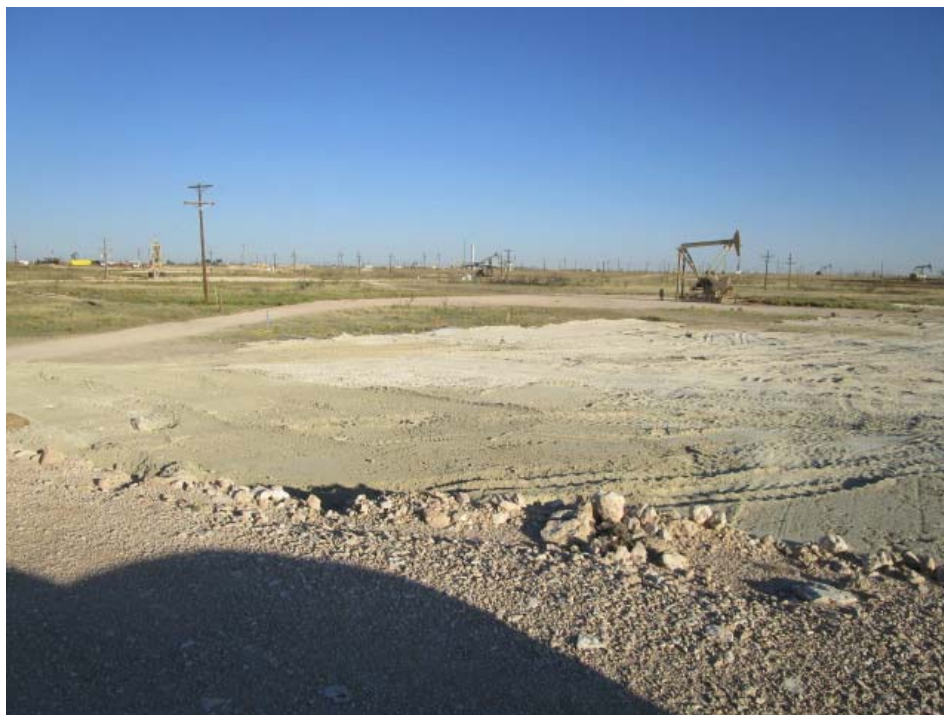
Photo 9 - Approximately one foot of caliche placement complete

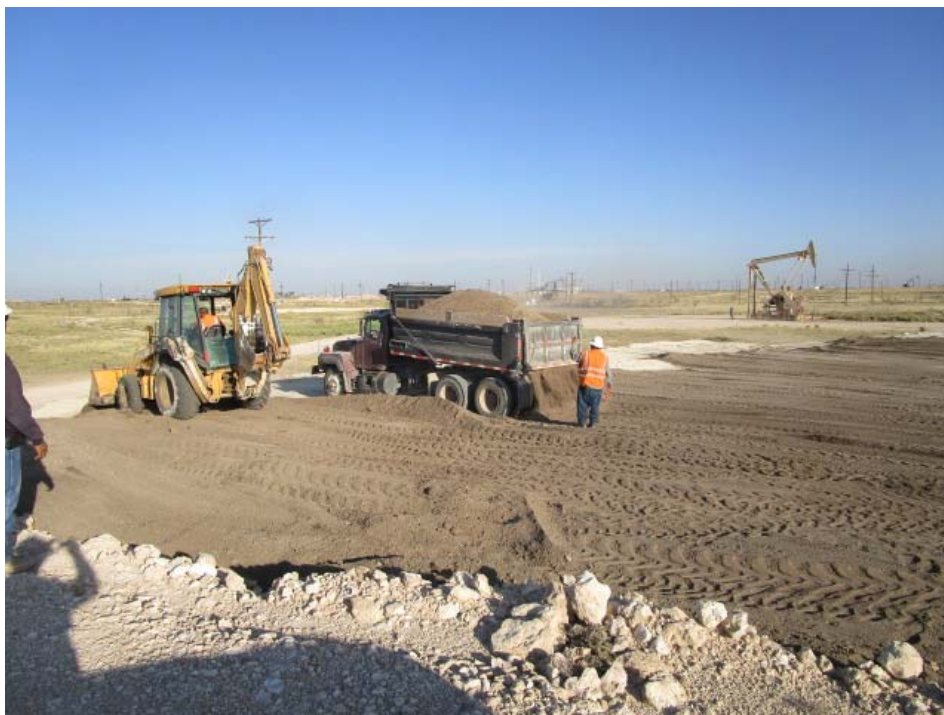
Photo 10 - Placement of topsoil on caliche

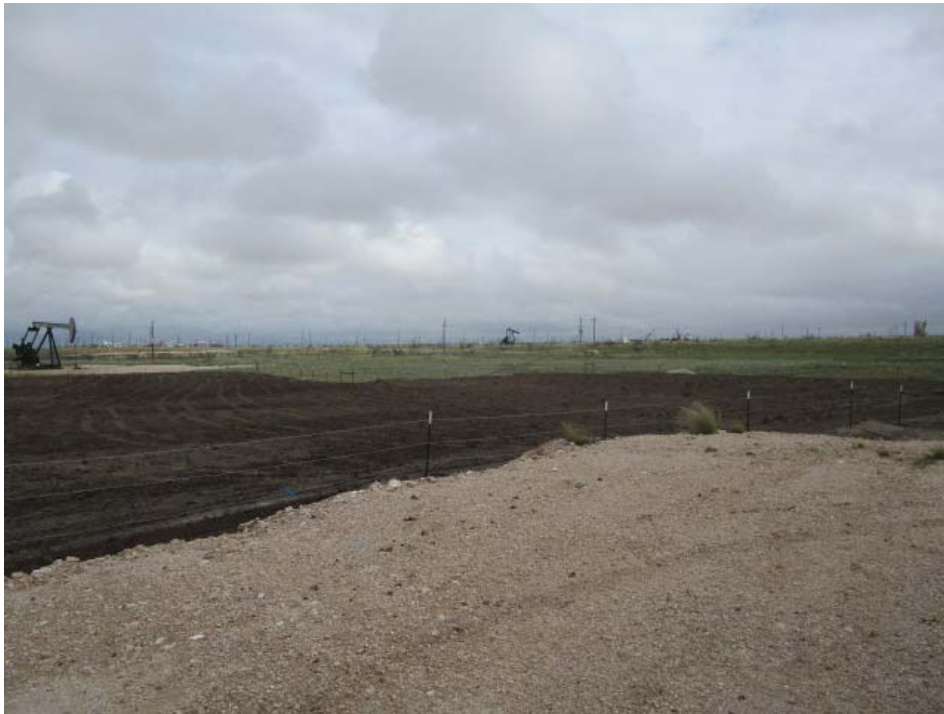
Photo 11 - A foot of topsoil placed and reclaimed area fenced off for seeding

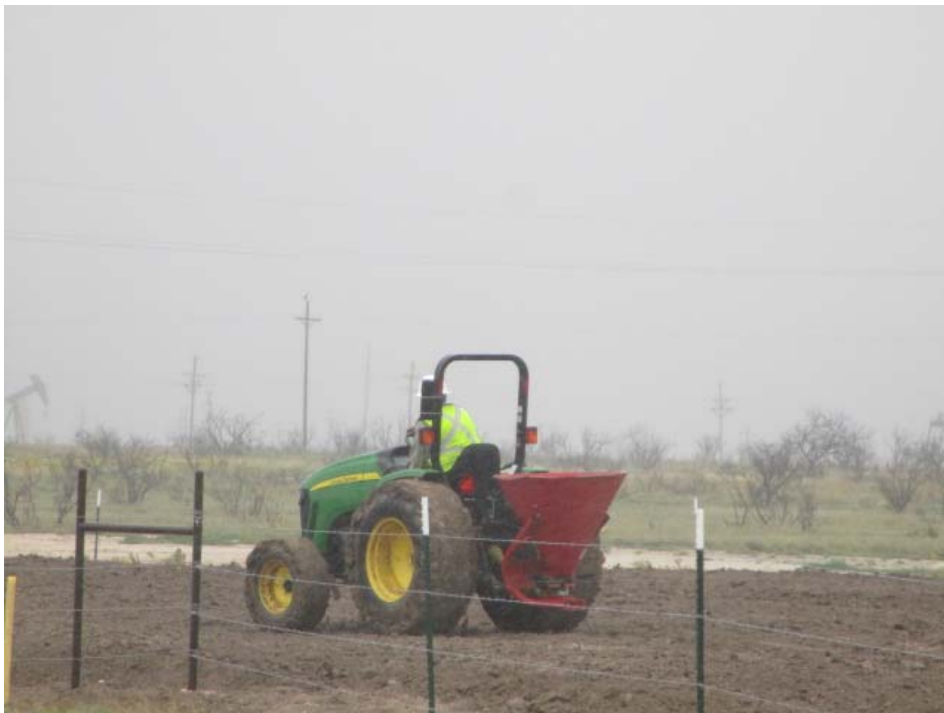
Photo 12 - Native seed mix BLM #2 broadcasted across the reclaimed area
