Pima Environmental Services 5614 N. Lovington Highway Hobbs, NM 88240 575-964-7740

RE: Liner Inspection and Closure Report

Seawolf 1-12 CBT 1

NMOCD Reference No. NAPP2133355460

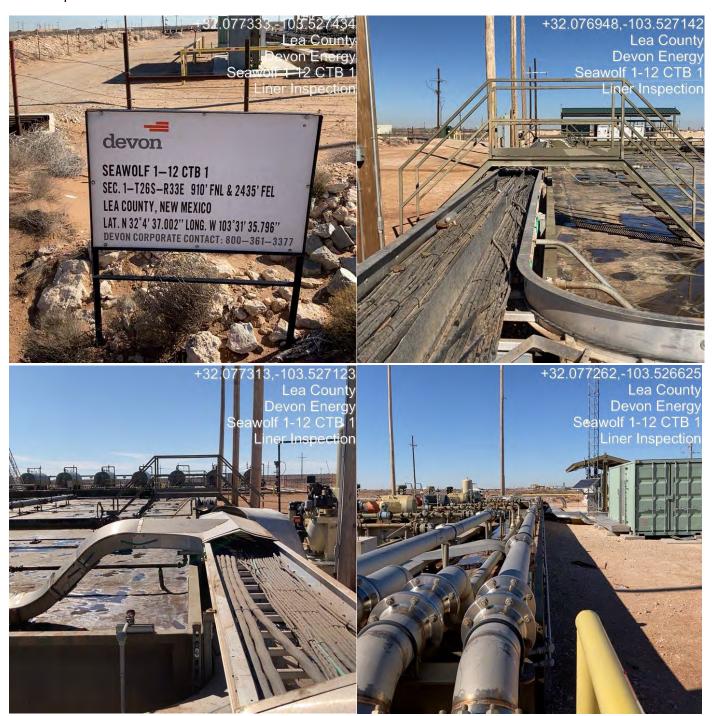
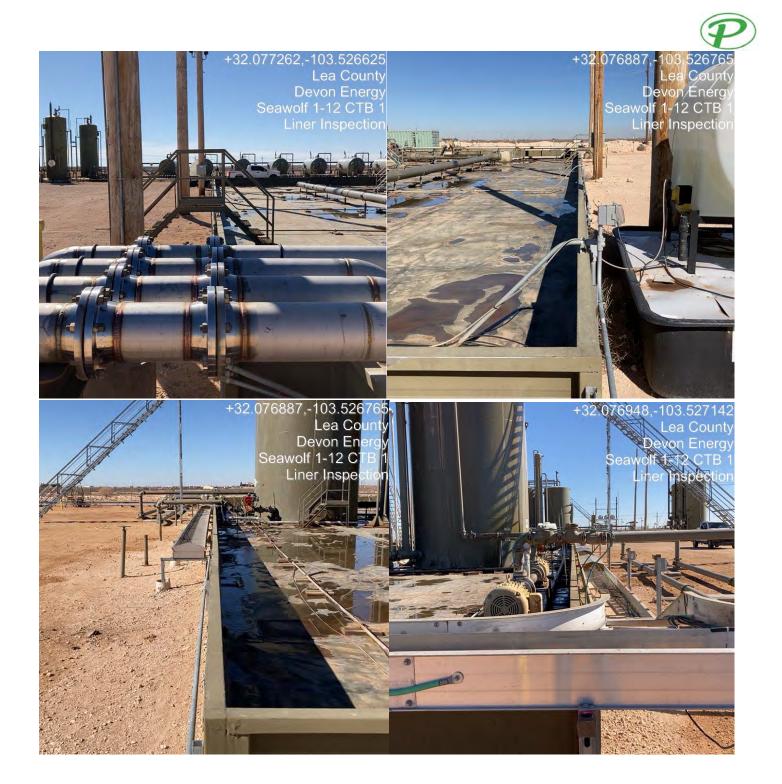
Liner Inspection

On January 19, 2023, after sending the 48-hour notification via email, Pima Environmental conducted a liner inspection at this location. We concluded that this liner and containment maintained its integrity and was able to retain the fluids. The liner inspection form and photographic documentation can be found in Appendix C.
