Pima Environmental Services 5614 N. Lovington Highway Hobbs, NM 88240 575-964-7740

January 11, 2023

**RE:** Liner Inspection and Closure Report

Maldives 15 CTB 1 API No. N/A

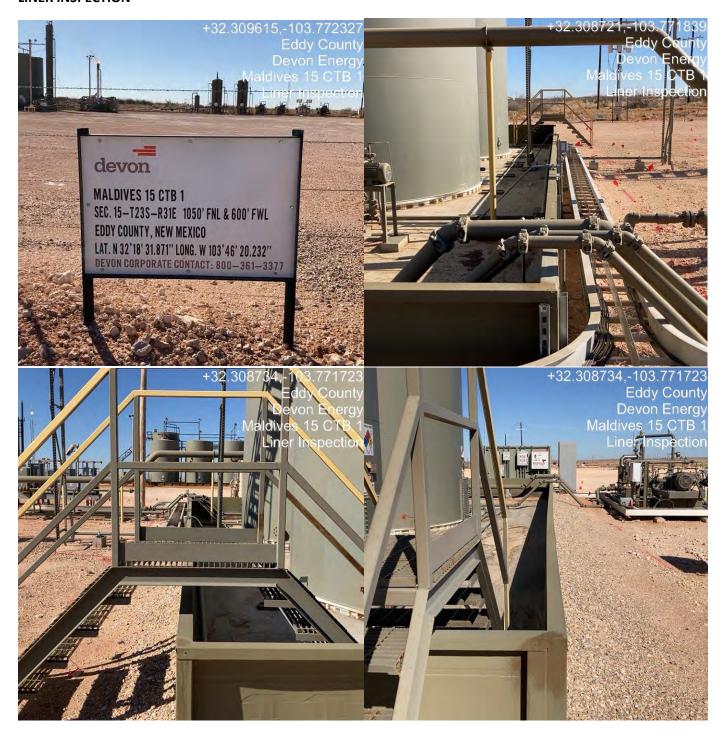
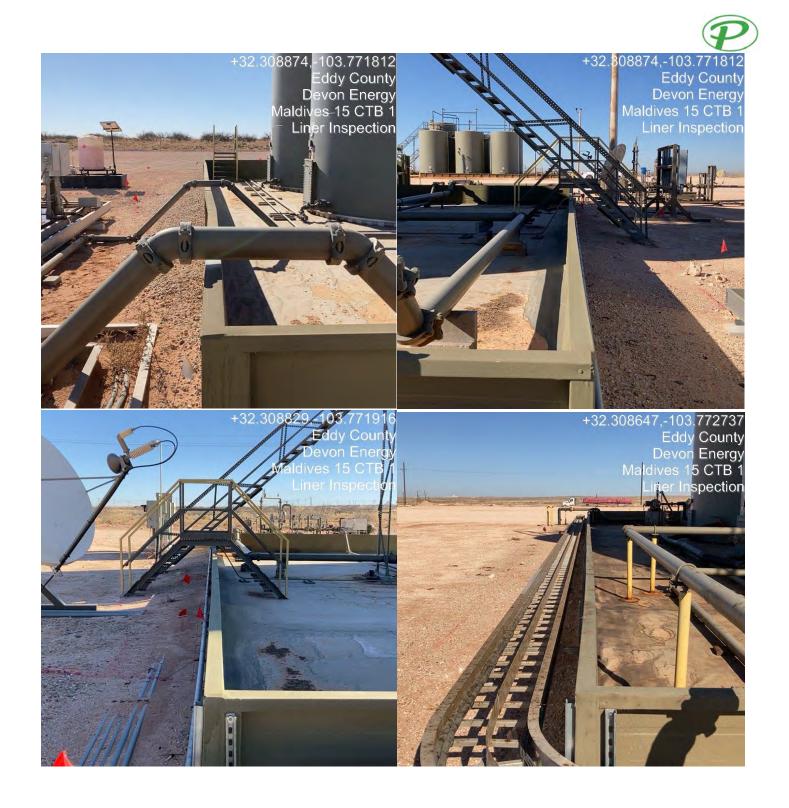
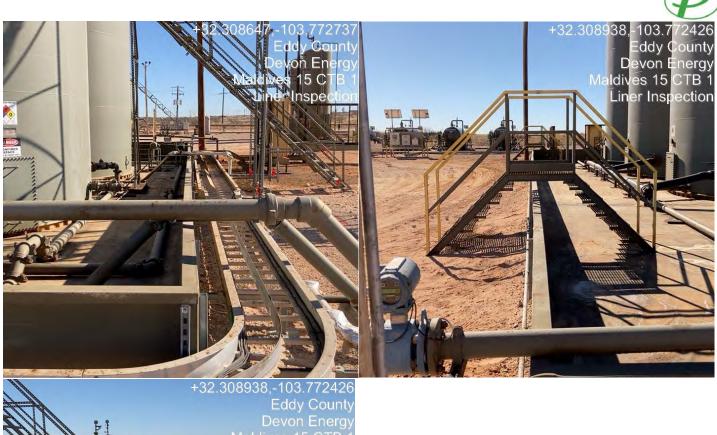
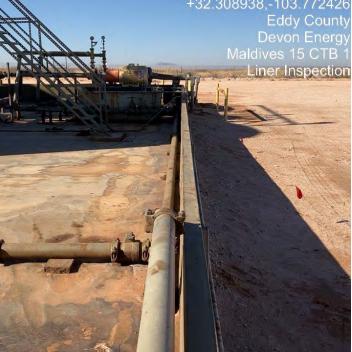
On December 30, 2022, after sending the 48-hour notification via email, Pima Environmental conducted a liner inspection at this location. We concluded that this liner and containment maintained its integrity and was able to retain the fluids. The Liner Inspection Form and Photographic Documentation can be found in Appendix C.

Company Name:	Devon I	nergy				
Site:	<u>M</u>	Maldives 15 CTB 1				
Lat/Long:	32.3	08580	, -103.772360			
NMOCD Incident ID & Incident Date:	<u>NA</u>	<u>.PP223</u>	0964903 11/4/2022			
2-Day Notification Sent:	via E	mail by	y Gio Gomez 12/28/2022			
Inspection Date:	12/3	0/2022				
Liner Type:	Earthen	w/line	Earthen no liner	Polystar		
	Steel w/	poly lii	ner Steel w/spray epoxy	No Liner		
Other:						
Visualization	Yes	No	Comments			
Is there a tear in the liner?		X				
Are there holes in the liner?	e	X				
Is the liner retaining any fluids?		X				
Does the liner have integrity to contain a leak?	X					
Comments:	•					
Inspector Name: <u>Ne</u>	ed Roger	<u>s</u>	Inspector Signature:Ned Roger	હ
