Closure Report Graham Nash State 6H (06.27.22) Incident #: NAPP2218849935 Eddy County, New Mexico Unit G Sec 33 T26S R28E 32.001814°, -104.09056°

Produced Water Release
Point of Release: Tank Overflow
Release Date: 06/27/2022

Volume Released: 7.313 barrels of Produced Water Volume Recovered: 4 barrels of Produced Water

**Re:** Closure Report

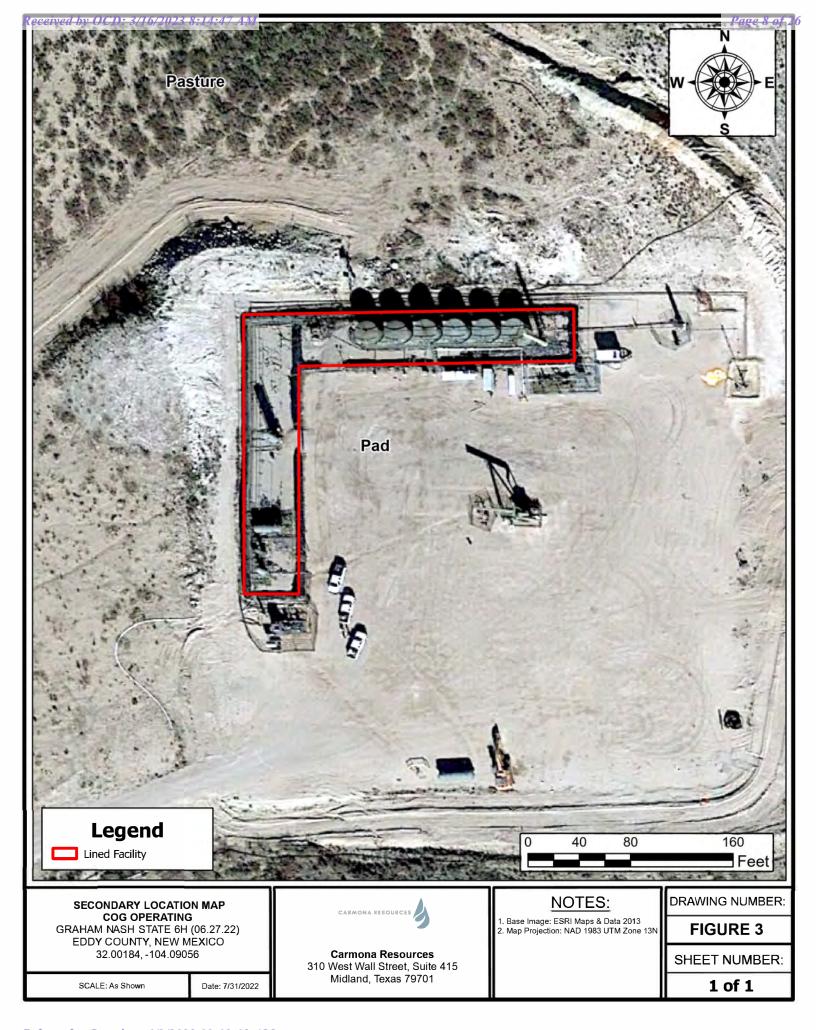
FIGURE 3 SECONDARY CONTAINMENT MAP

Based on the initial C-141 obtained from the New Mexico Oil Conservation Division (NMOCD), the release was discovered on June 27, 2022, due to a water transfer pump going down, causing tanks to overflow inside the secondary containment. It resulted in approximately seven point three one three (7.313) barrels of produced water and four (4) barrels of produced water recovered. See figure 3. The initial C-141 form is attached in Appendix B.

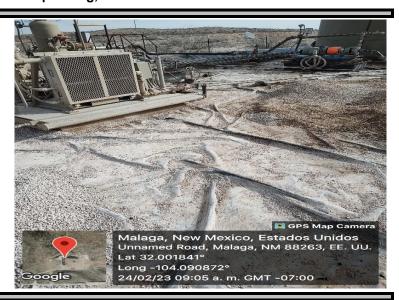
#### Photograph No. 1

View East of lined facility.

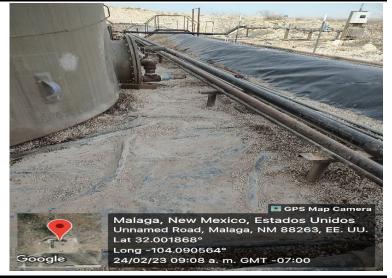
#### Photograph No. 2

View East of lined facility.

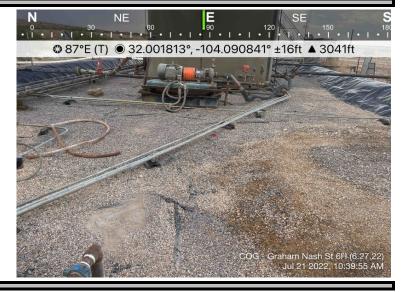
#### Photograph No. 3

View East of lined facility.

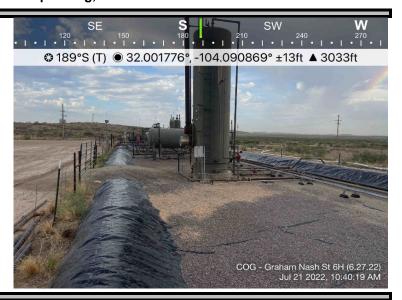
#### Photograph No. 4

View South of lined facility.

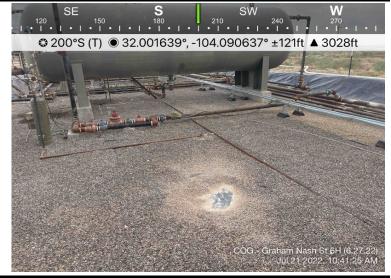
#### Photograph No. 5

View South of lined facility.

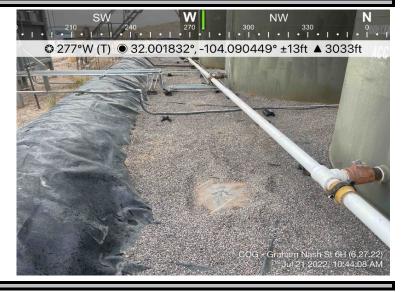
#### Photograph No. 6

View West of lined facility.
