Re: Site Assessment, Liner Inspection, and Closure Report
Patton 5 Fee #8H
API No. 30-015-39641
GPS: Latitude 32.6839372 Longitude -104.4120317
UL "M", Sec. 05, T19S, R26E
Eddy County, NM
NMOCD Ref. No. NAPP2229739197

Paragon Environmental, LLC (Paragon) has been contracted by Spur Energy Partners (Spur) to perform a site assessment, conduct a liner inspection, and write a closure report for the release site known as the Patton 5 Fee #8H. Details of the release are summarized below:

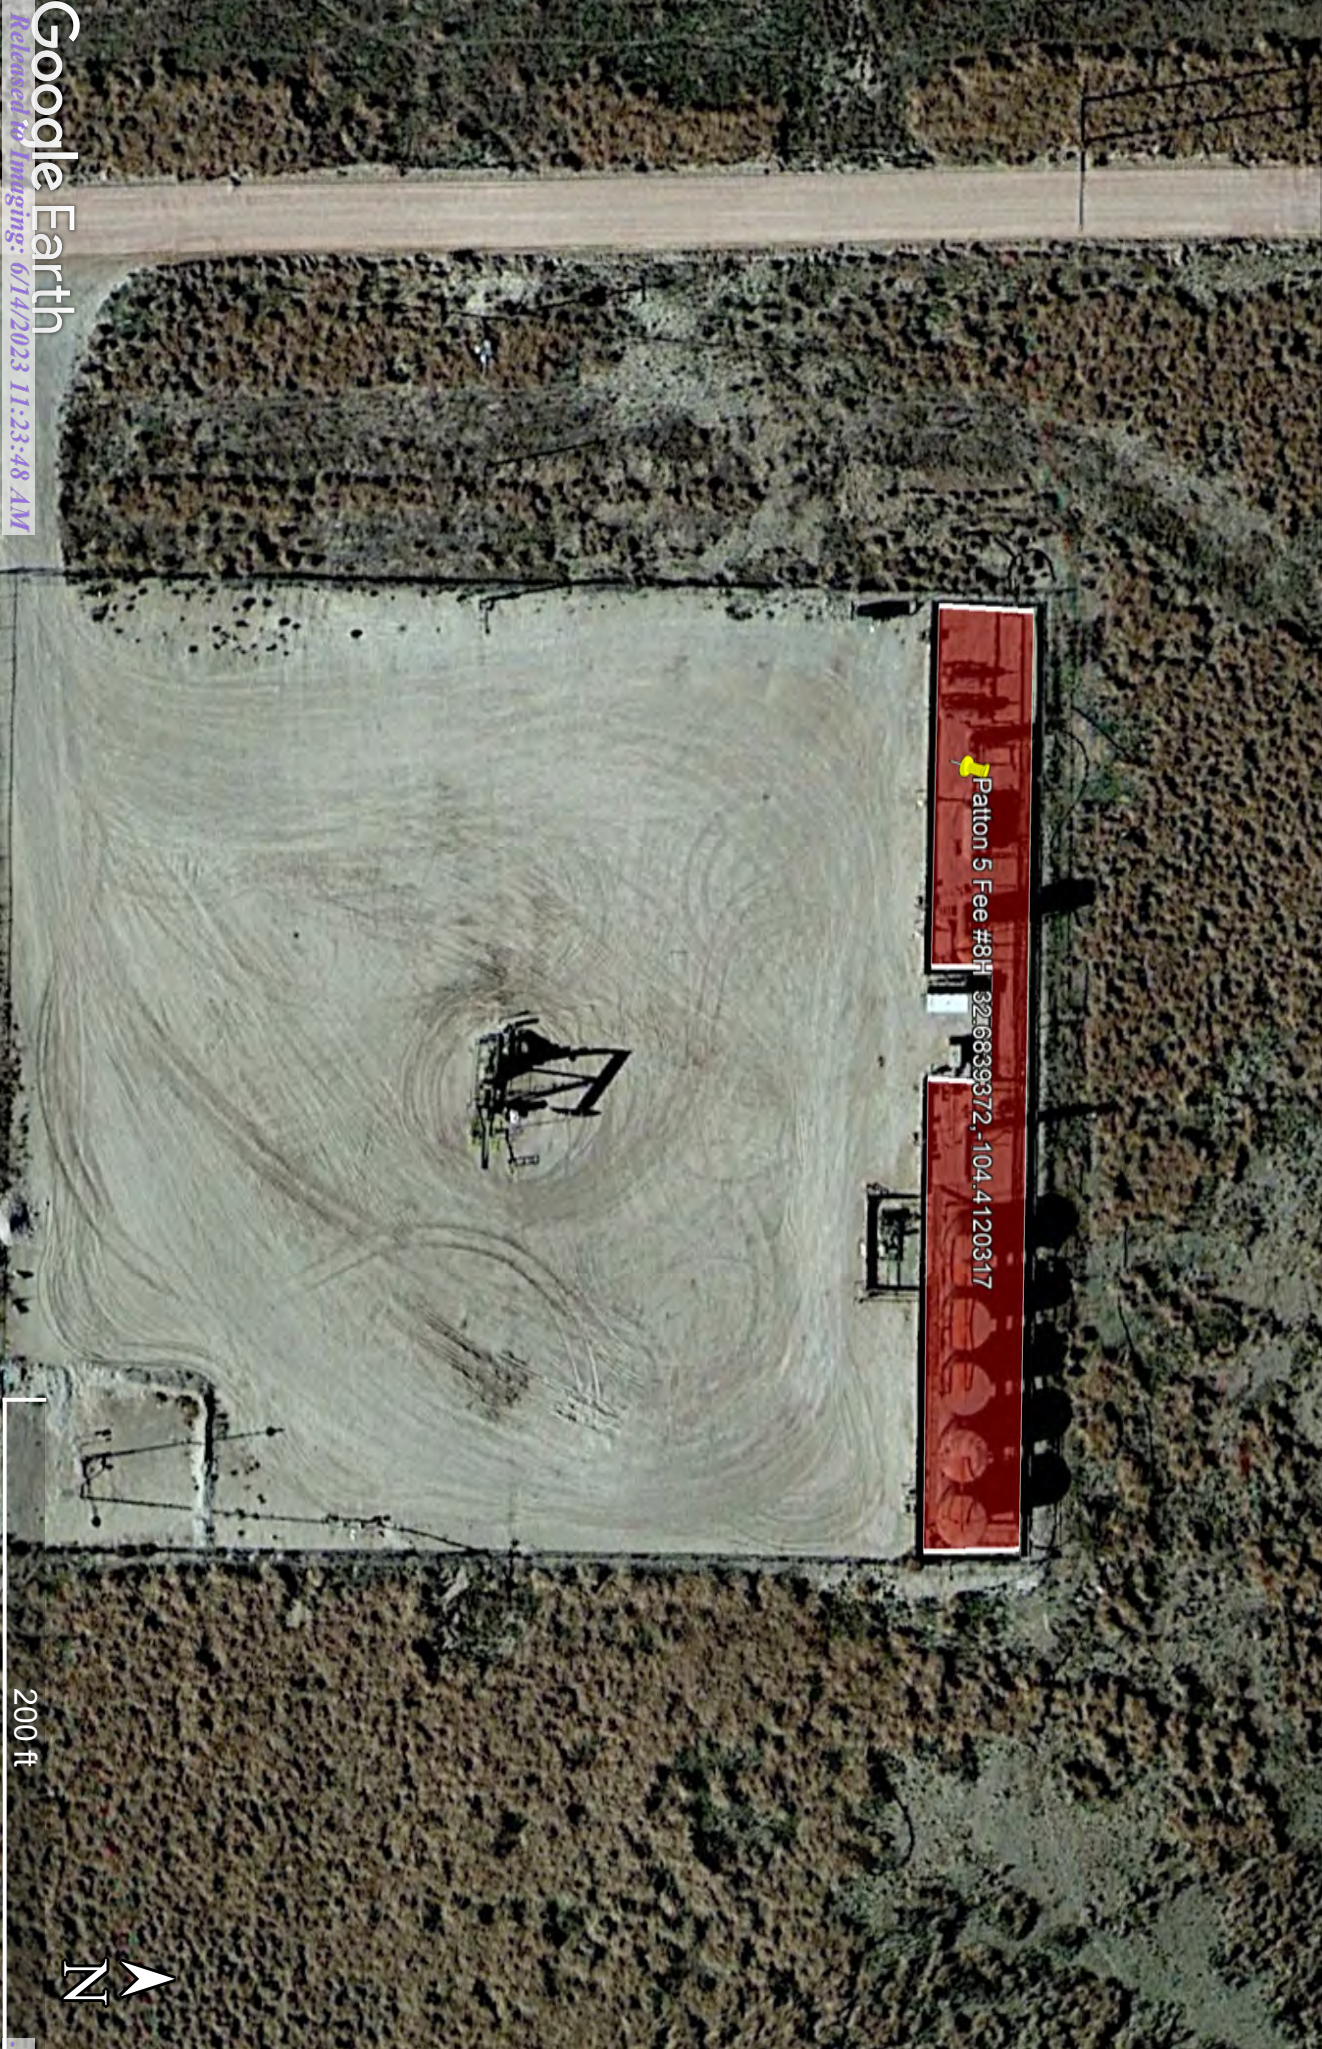
Patton 5 Fee #8H
AP# 30-015-39641
Eddy County, NM
Site Map

Spill Area

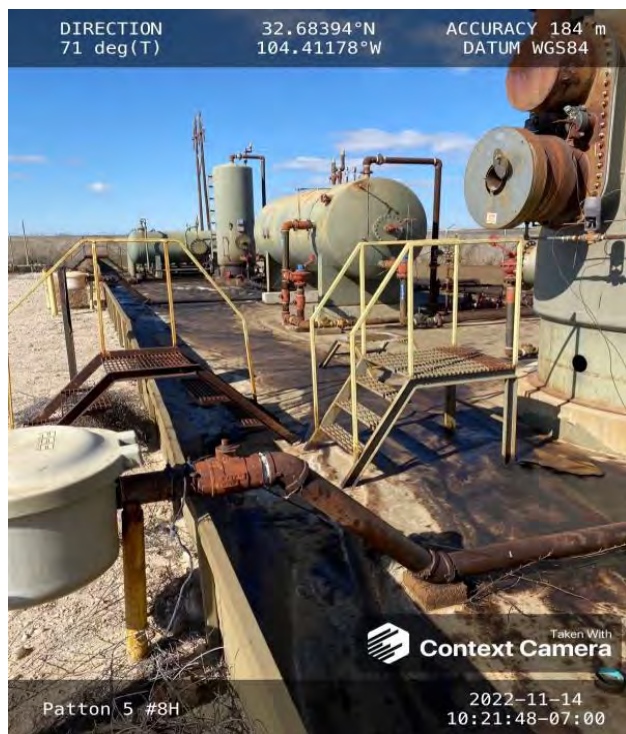
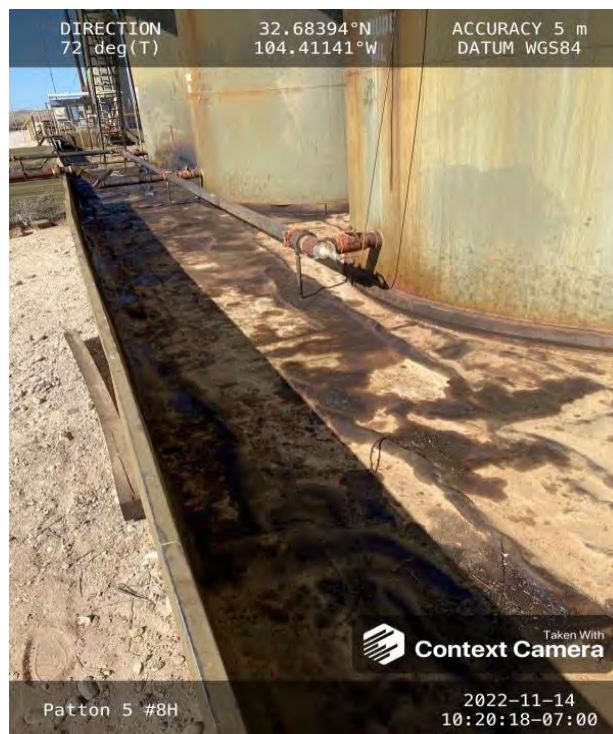
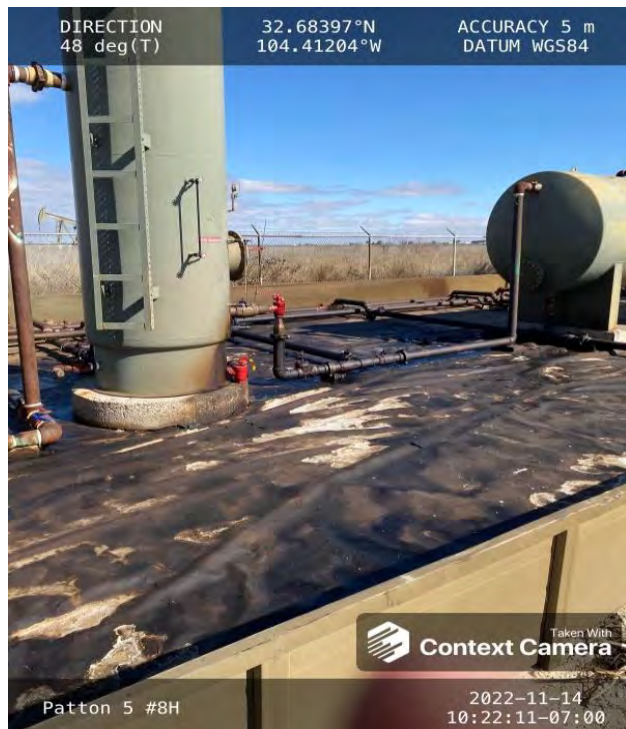
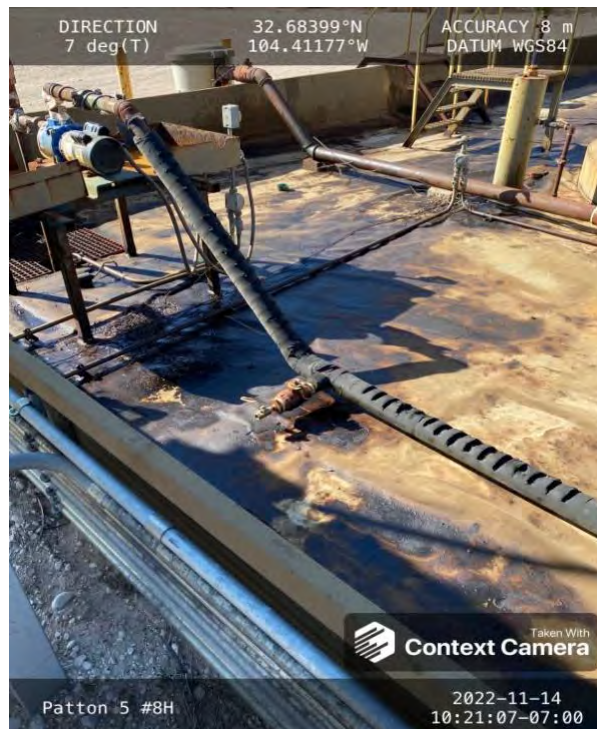
Before Remediation

On November 10th, 2022, Paragon mobilized a tech to go and assess the Patton. Staining inside of the containment was noticed, and all standing fluids had been removed.

On November 14th, Paragon sent out a crew with a steamer and a vac truck to go clean the containment. We used a mixture of pressure, heat, and degreaser to clean up the staining.

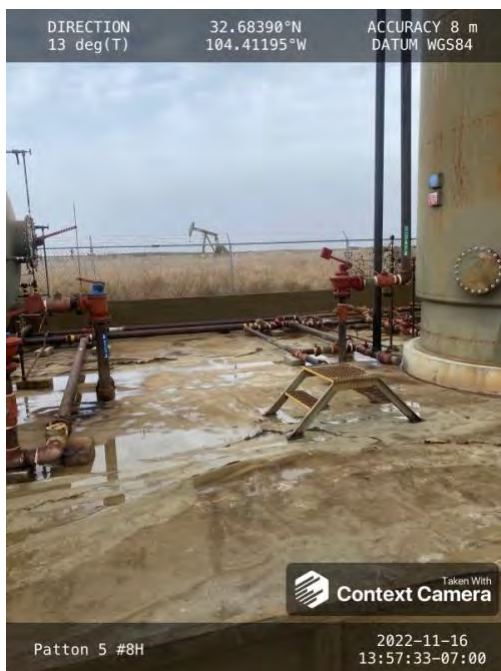
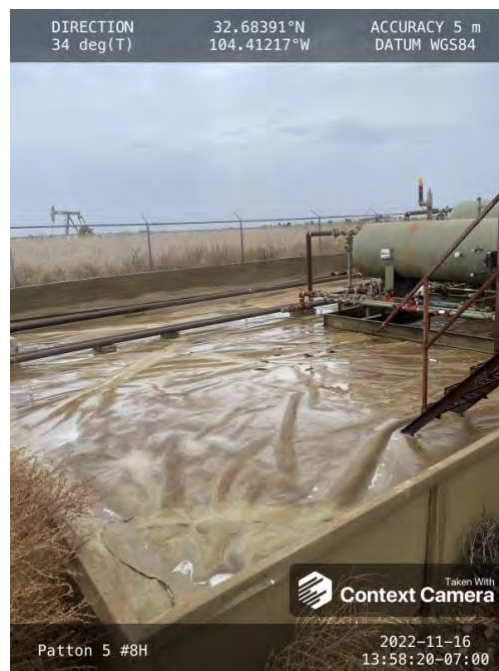
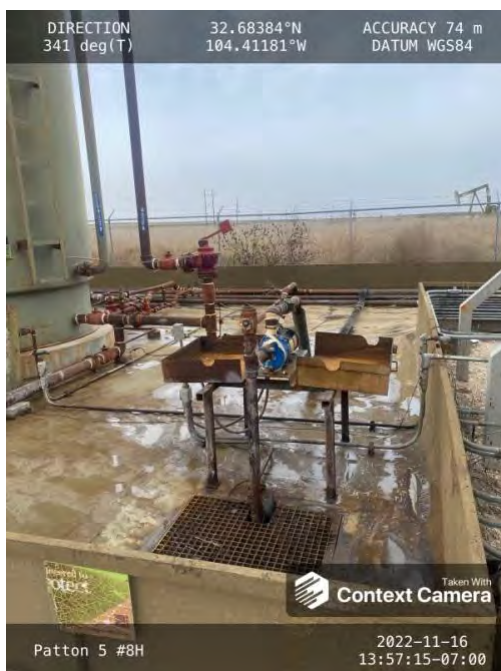
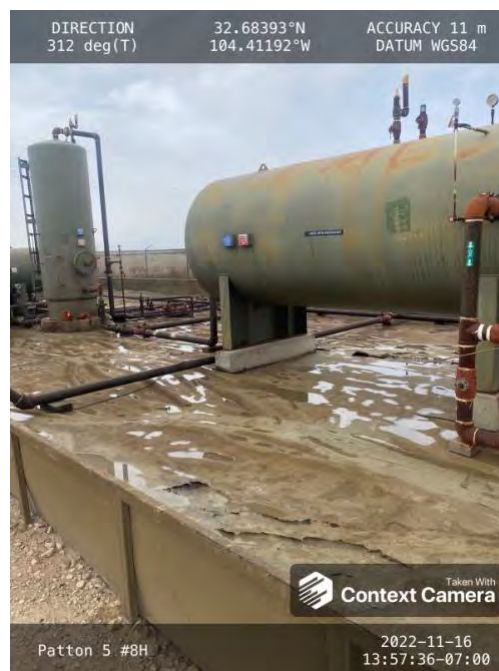
Post Remediation

On December 15, 2022, Paragon sent email notification to the NMOCD that we would conduct a liner inspection on December 20, 2022. While conducting the inspection, there were no holes or tears, and had the integrity to contain a spill. The Photographic Documentation and Liner Inspection sheet can be found in Appendix D.
