LINER INSPECTION AND CLOSURE REPORT REPORTABLE RELEASE

Spur Energy Partners

Big N Tasty St Com Tank Battery Incident ID: NAPP2226329911 Eddy County, NM

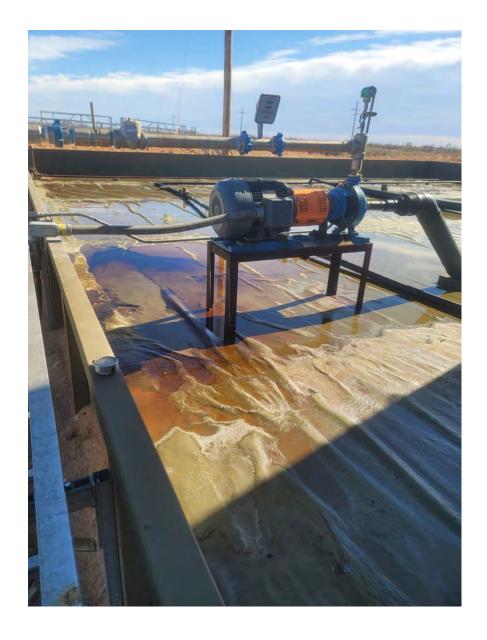
Before Cleaning

This release was due to equipment failure. The plug on top of a 4-inch check valve blew off. This resulted in the release of 8 bbls of produced water contained in the Falcon Lined Containment. A vacuum truck was dispatched and recovered 8 bbls of the fluids.

On January 11, 2023, Paragon went to the Big N Tasty and conducted an initial assessment. There was obvious staining on the liner from the spill. There were no signs outside the containment that the liner had been breached. Therefore, no samples were taken.

On January 12, 2023, Paragon returned to the site with equipment and personnel to conduct cleanup activities. We initially sprayed the affected area with surface cleaner. We then power washed and squeegeed the runoff to where the vacuum truck could capture the fluids.

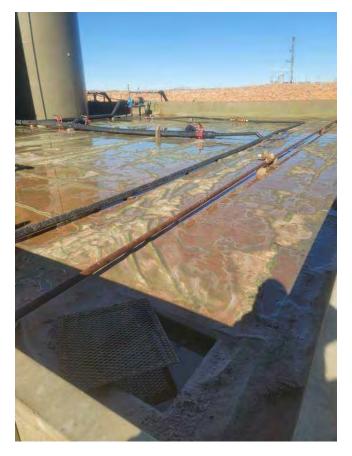
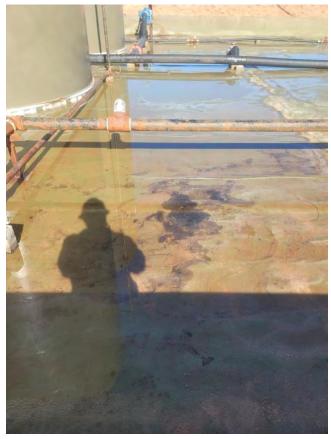
After Cleaning

On February 6, 2023, Paragon returned to the site to conduct a liner inspection. A 48-hour notification was sent out to the NMOCD on February 6, 2023. The liner inspection concluded that the liner was all intact and in good condition. The integrity of the liner appears to have the ability to contain spills. See Appendix D for the email notification and liner report.
