Incident ID	nAPP2218625686, nAPP2226926129
District RP	
Facility ID	30-015-45643
Application ID

The release occurred on July 4, 2022, when the tanks overflowed due to an equipment failure. The spill was reported on July 4, 2022, and involved the release of approximately 553 barrels (bbl) of produced water into the lined containment of the tank battery. The release volume was initially reported as 633 bbl based on the depth of produced water in the containment; however, the initial calculation did not take the volume of equipment and tanks within the containment into account and the corrected calculated release volume was determined to be 552.78 bbl. Approximately 550 bbl of free fluid were recovered during initial spill clean-up. No produced water was released into undisturbed areas or waterways. The daily field reports (DFRs) and site photographs are included in Attachment 2.

The release occurred on September 25, 2022, due to a broken nipple fitting on the top of the water transfer pump. The spill was reported on September 25, 2022, and involved the release of approximately 5 bbl of produced water into the lined containment of the tank battery. Approximately 5 bbl of free fluid

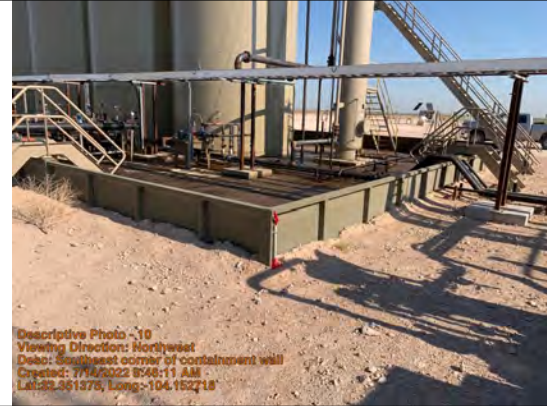
Southeast corner of containment wall

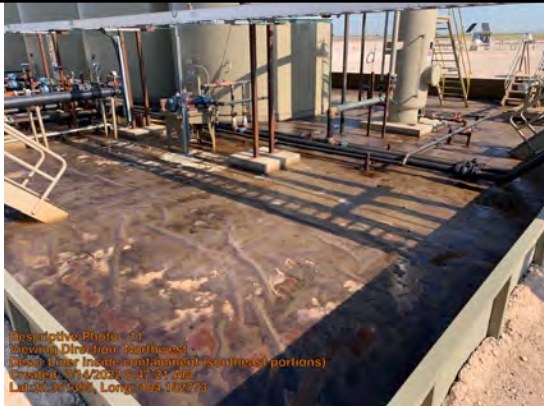
Liner inside containment (southeast portions)

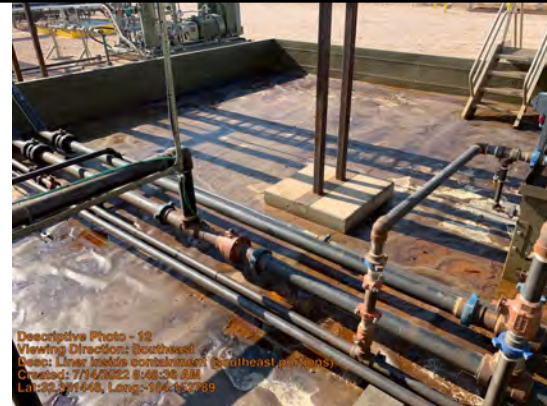
Liner inside containment (southeast portions)

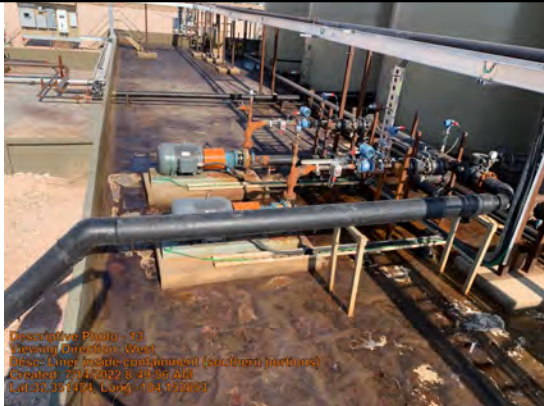
Liner inside containment (southern portions)

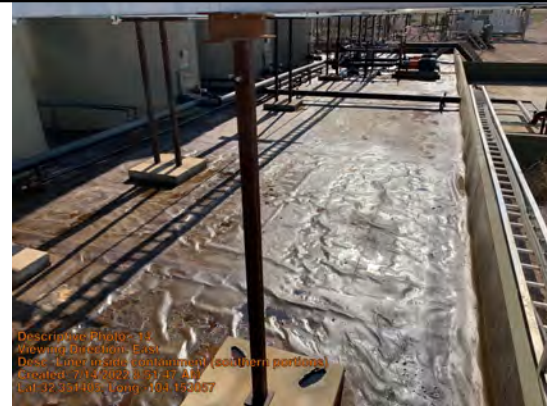
Liner inside containment (southern portions)

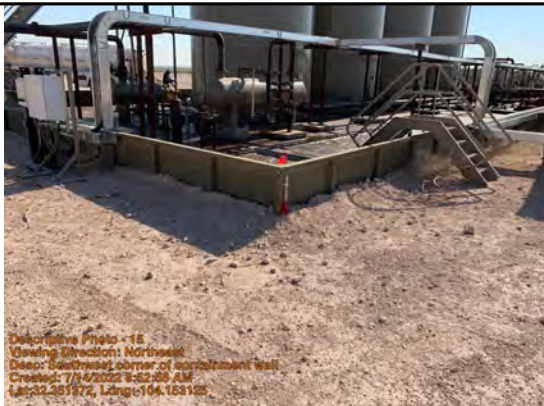
Southwest corner of containment wall

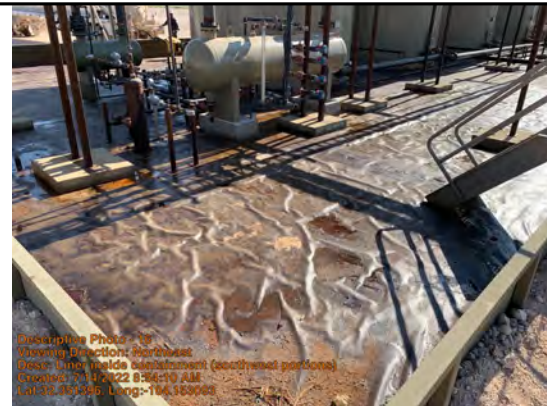
Liner inside containment (southwest portions)

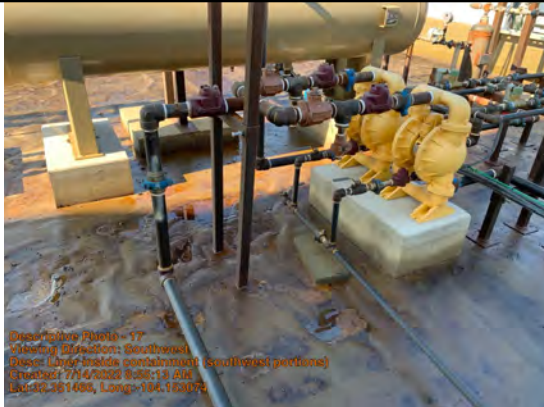
Liner inside containment (southwest portions)

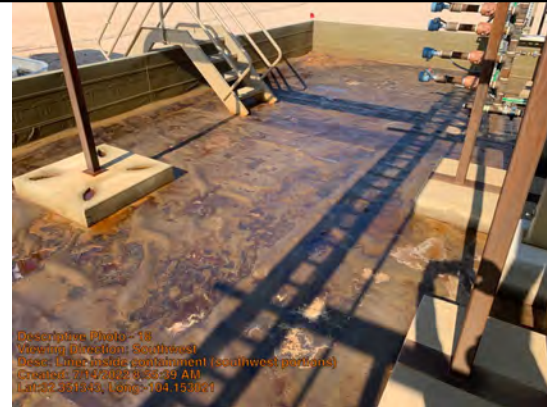
Liner inside containment (southwest portions)

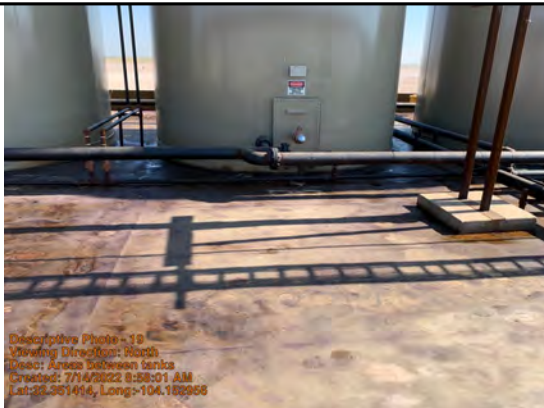
Areas between tanks

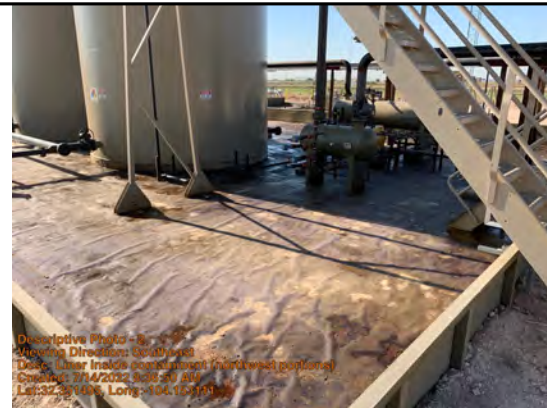
Liner inside containment (northwest portions)

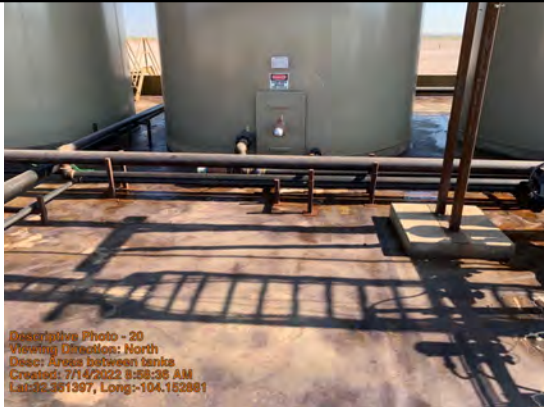
Areas between tanks

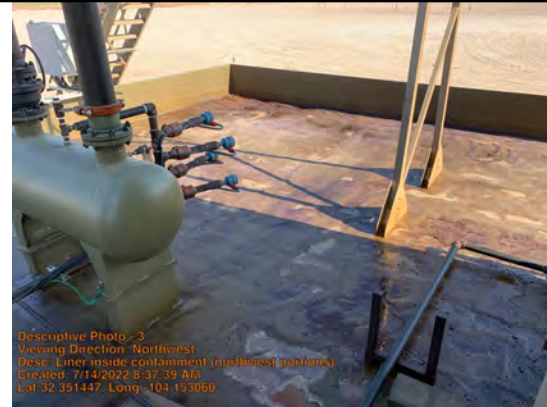
Liner inside containment (northwest portions)

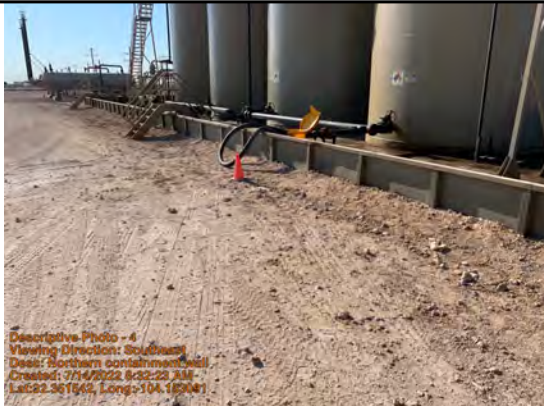
Northern containment wall

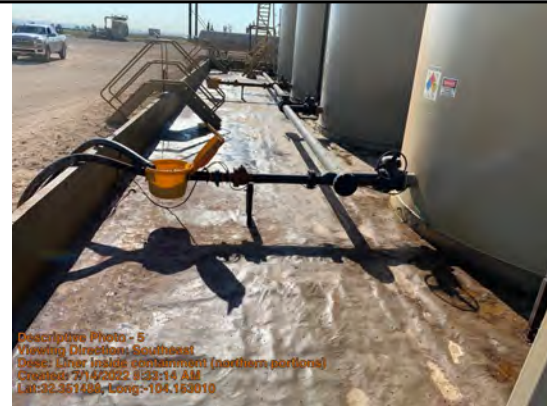
Liner inside containment (northern portions)

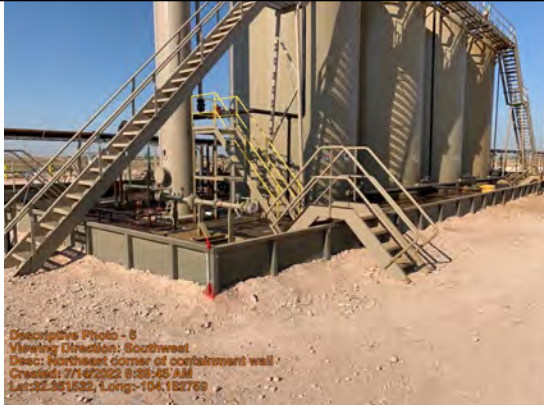
Northeast corner of containment wall

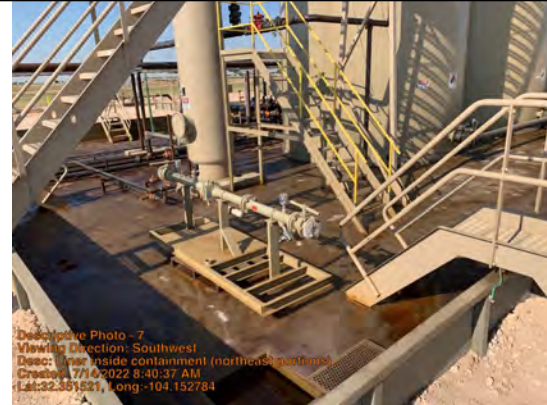
Liner inside containment (northeast portions)

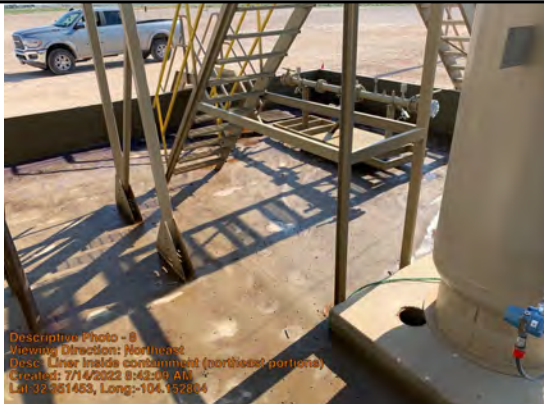
Liner inside containment (northeast portions)

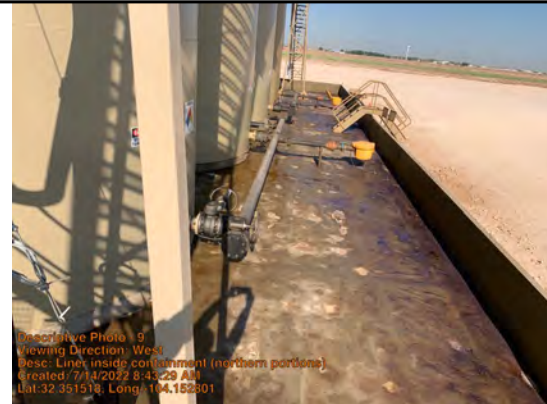
Liner inside containment (northern portions)
