Incident ID	nAPP2218625686, nAPP2226926129
District RP	
Facility ID	30-015-45643
Application ID

The release occurred on July 4, 2022, when the tanks overflowed due to an equipment failure. The spill was reported on July 4, 2022, and involved the release of approximately 553 barrels (bbl) of produced water into the lined containment of the tank battery. The release volume was initially reported as 633 bbl based on the depth of produced water in the containment; however, the initial calculation did not take the volume of equipment and tanks within the containment into account and the corrected calculated release volume was determined to be 552.78 bbl. Approximately 550 bbl of free fluid were recovered during initial spill clean-up. No produced water was released into undisturbed areas or waterways. The daily field reports (DFRs) and site photographs are included in Attachment 2.

The release occurred on September 25, 2022, due to a broken nipple fitting on the top of the water transfer pump. The spill was reported on September 25, 2022, and involved the release of approximately 5 bbl of produced water into the lined containment of the tank battery. Approximately 5 bbl of free fluid

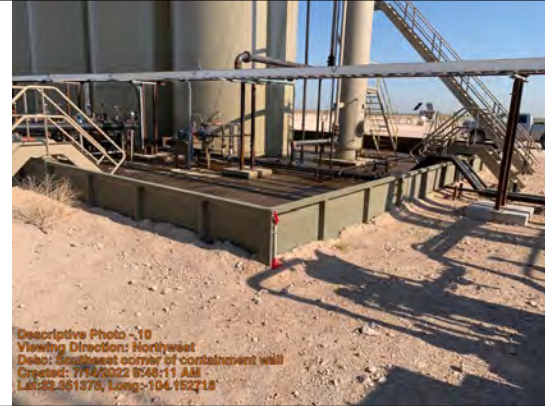
Southeast corner of containment wall

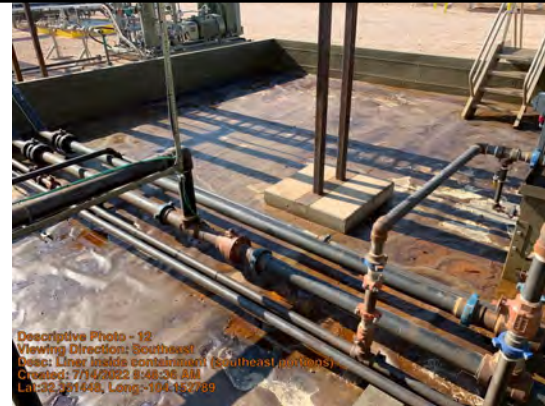
Liner inside containment (southeast portions)

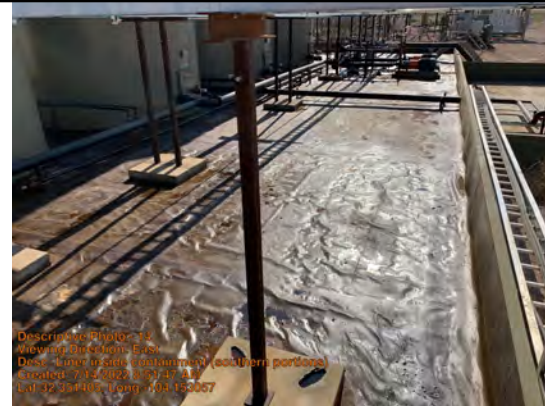
Liner inside containment (southern portions)

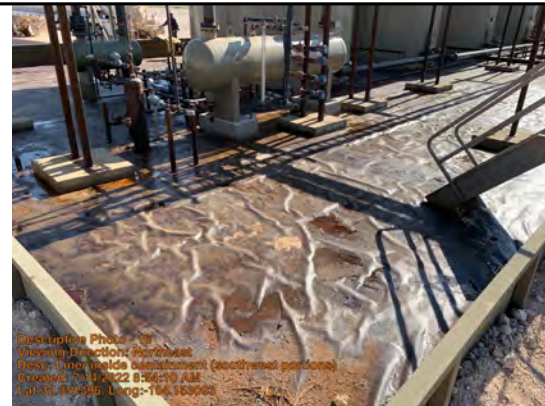
Liner inside containment (southwest portions)

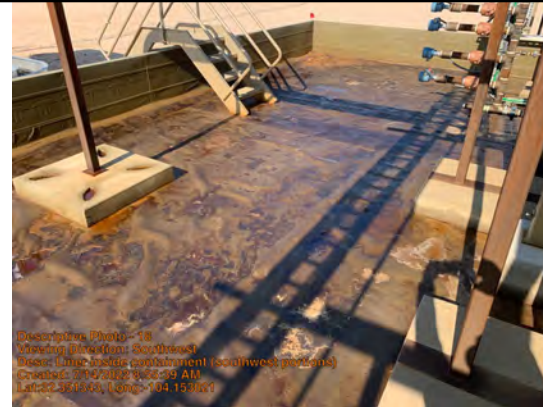
Liner inside containment (southwest portions)

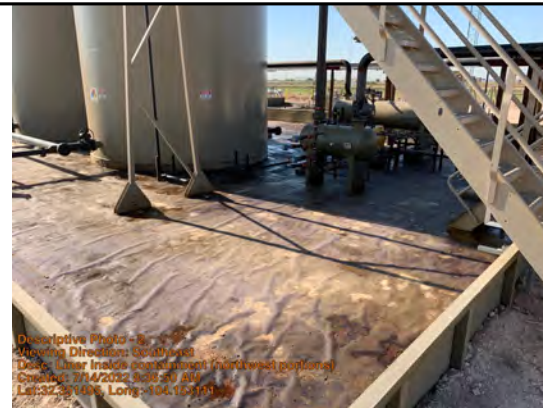
Liner inside containment (northwest portions)

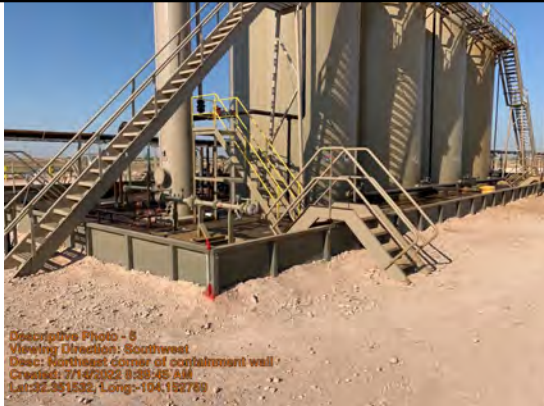
Northeast corner of containment wall

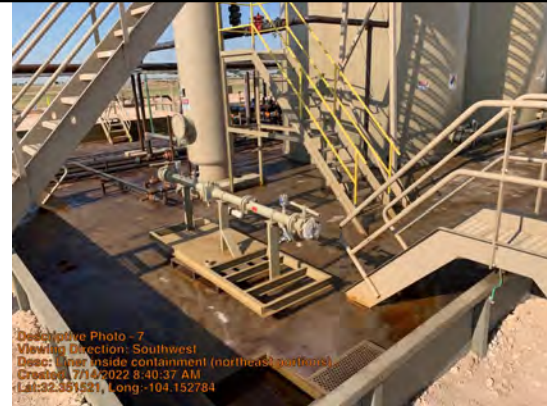
Liner inside containment (northeast portions)

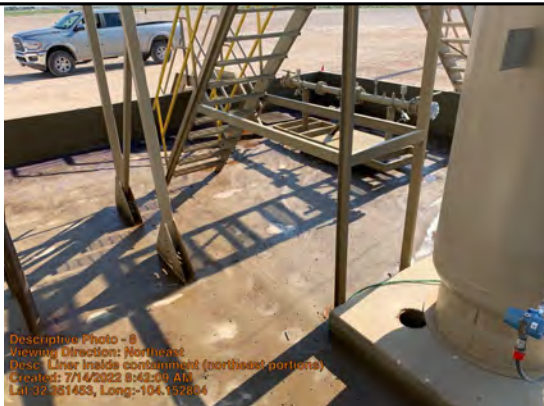
Liner inside containment (northeast portions)

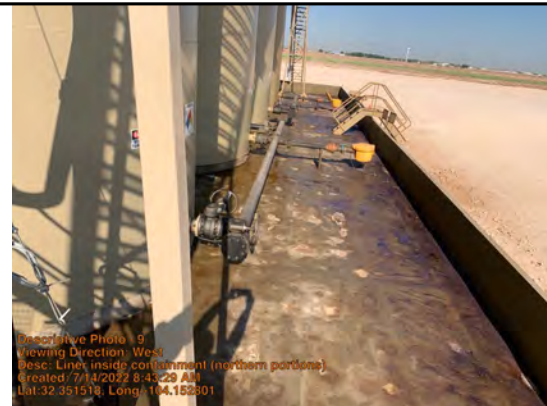
Liner inside containment (northern portions)

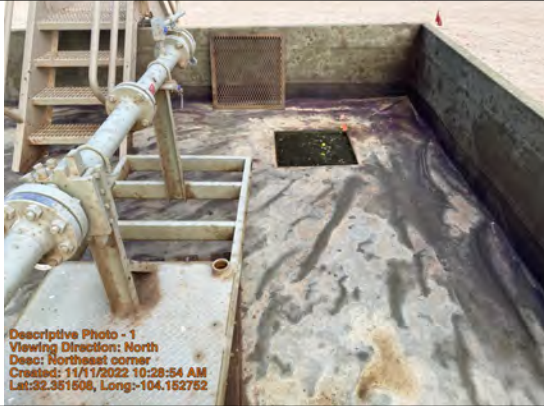
Northeast corner

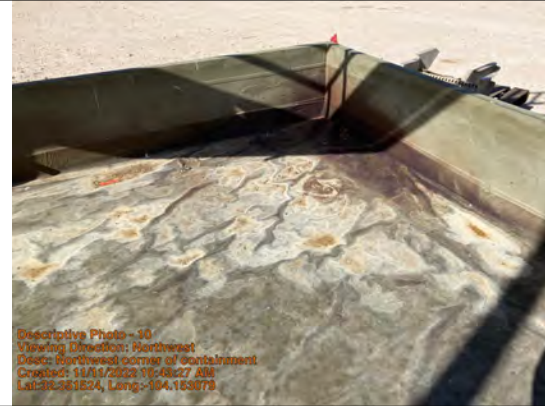
Northwest corner of containment

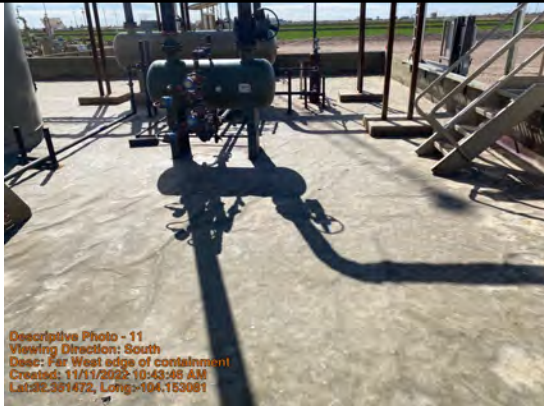
Far West edge of containment

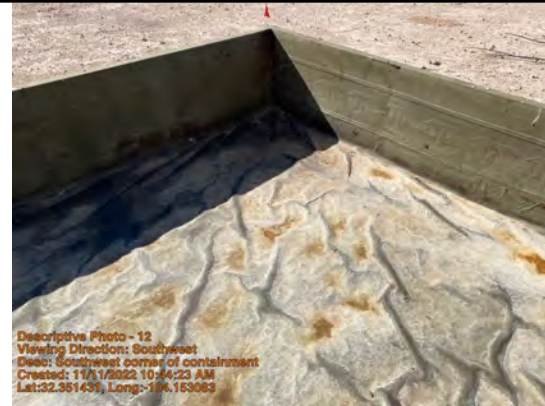
Southwest corner of containment

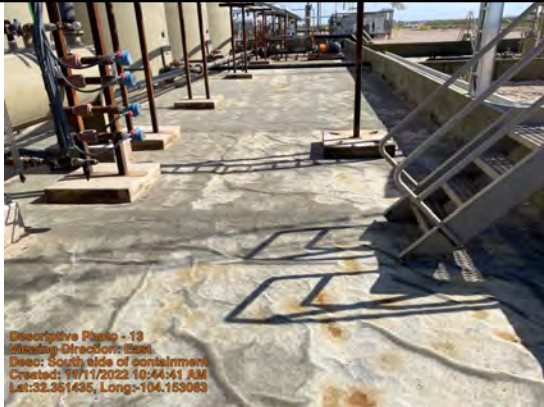
South side of containment

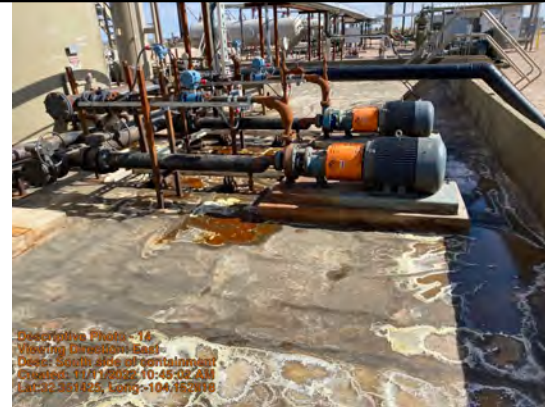
South side of containment

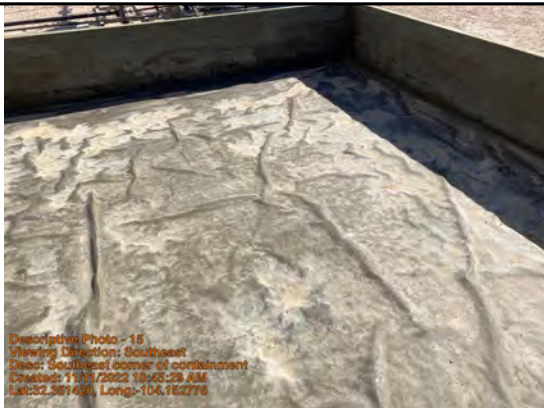
Southeast corner of containment

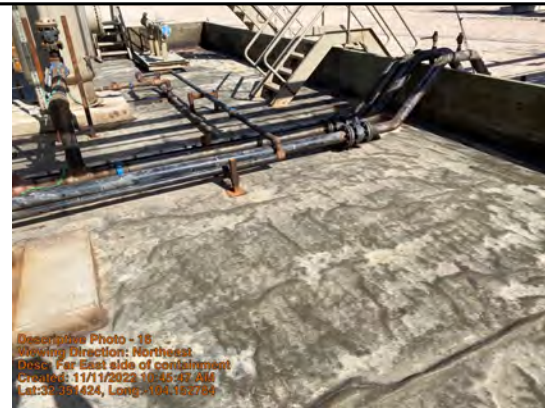
Far East side of containment

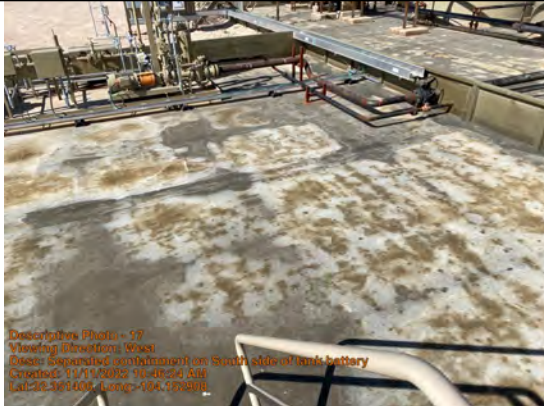
Separated containment on South side of tank battery

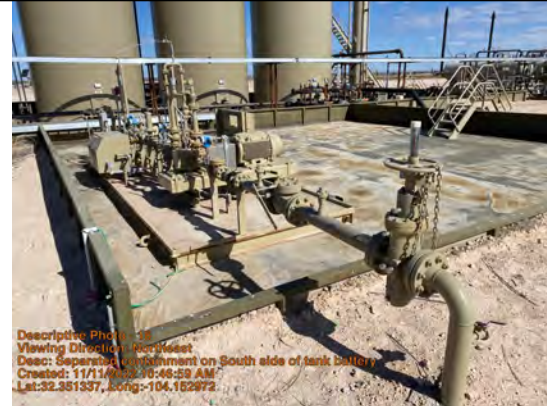
Separated containment on South side of tank battery

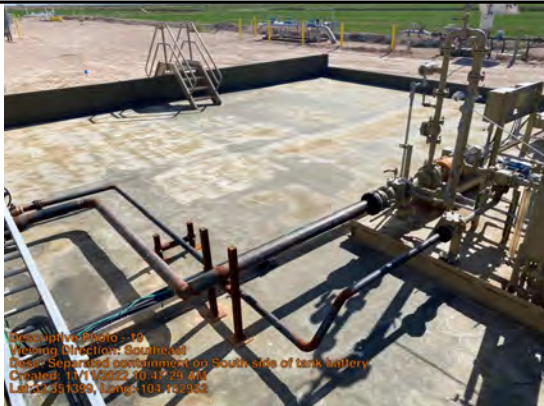
Separated containment on South side of tank battery

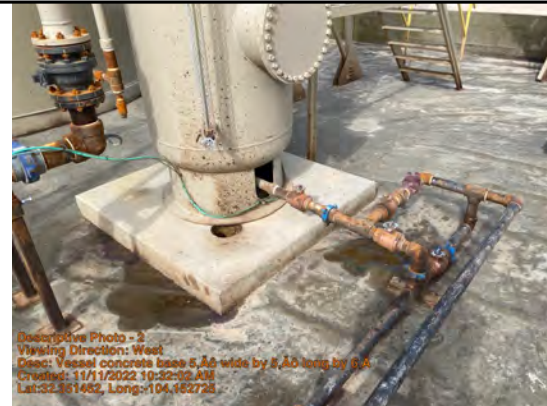
Vessel concrete base 5' wide by 5' long by 6" tall

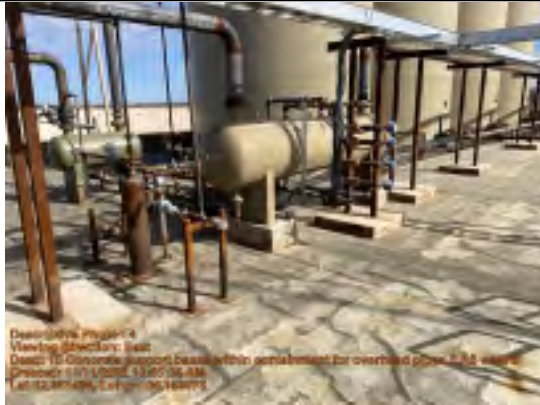
Concrete support bases within containment

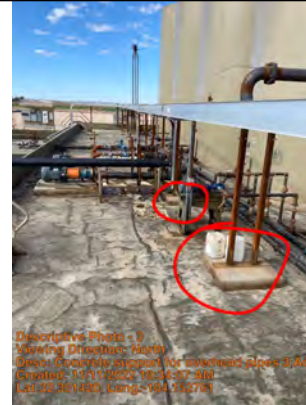
10 Concrete support bases within containment for overhead pipes 3' wide by 3' long by 6" tall

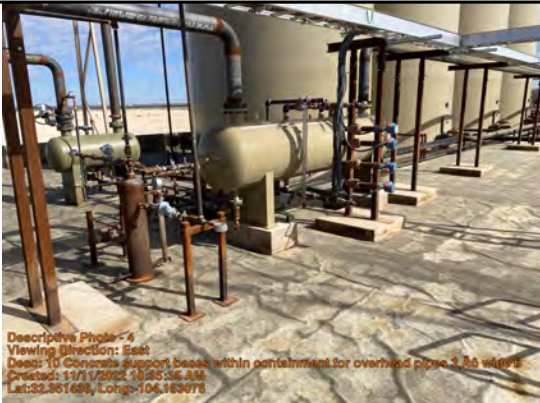
10 Concrete support bases within containment for overhead pipes 3' wide by 3' long by 6" tall

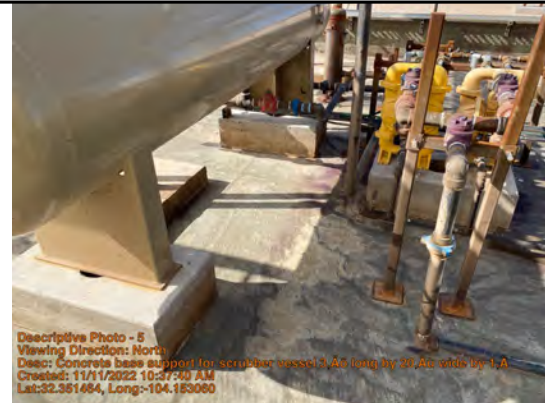
Three Concrete base support for scrubber vessel and yellow pneumatic pump. 3' long by 20" wide by 1' tall

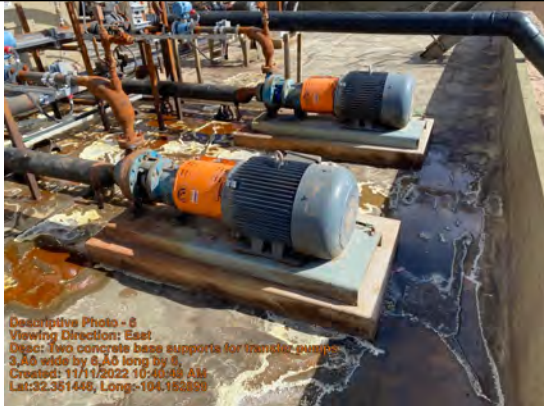
Two concrete base supports for transfer pumps.
3' wide by 6' long by 6" tall.

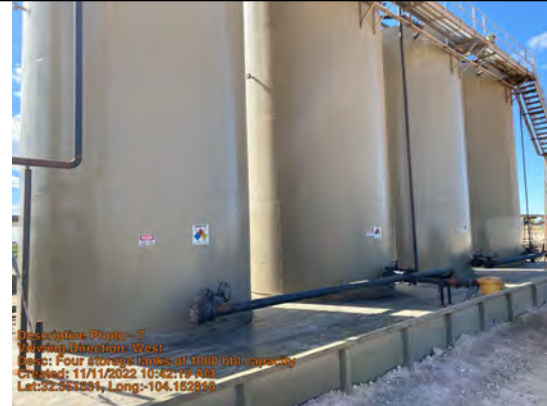
Four storage tanks of 1000 bbl capacity.
52 ft circumference.
15.5 ft diameter.
30 ft tall

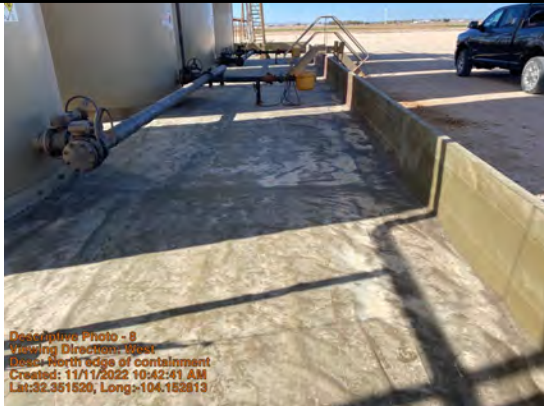
North edge of containment

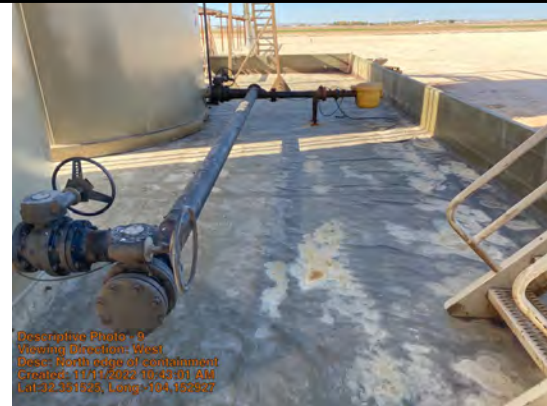
North edge of containment
