LINER INSPECTION AND CLOSURE REPORT REPORTABLE RELEASE

Spur Energy Partners Stonewall 9 Fee #1H Incident ID: nAPP2301134965 Eddy County, NM

Paragon Environmental LLC 1601 N. TURNER ST. STE.500 Hobbs, NM 88240 575-318-6841

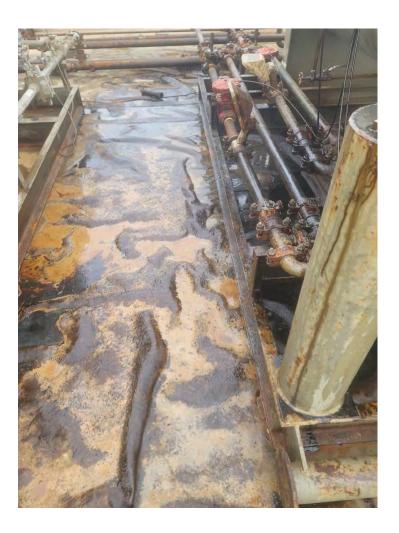
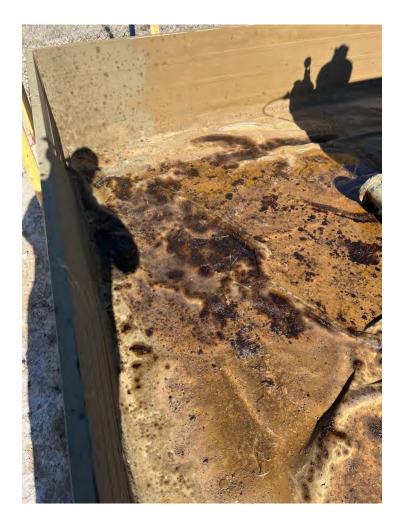
Before Remediation

On January 13, 2023, Paragon went to the Stonewall and conducted an initial assessment. There was obvious staining on the liner from the spill. There were no signs outside the containment that the liner had been breached. Therefore, no samples were taken.

On February 28, 2023, Paragon returned to the site with equipment and personnel to conduct cleanup activities. We initially sprayed the affected area with a degreaser. We then power washed and squeegeed the runoff to where the vacuum truck could capture the fluids.

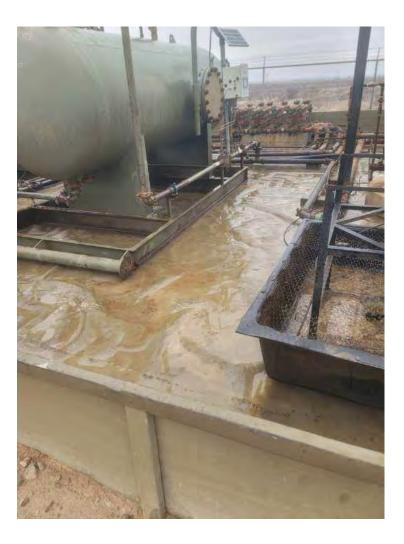
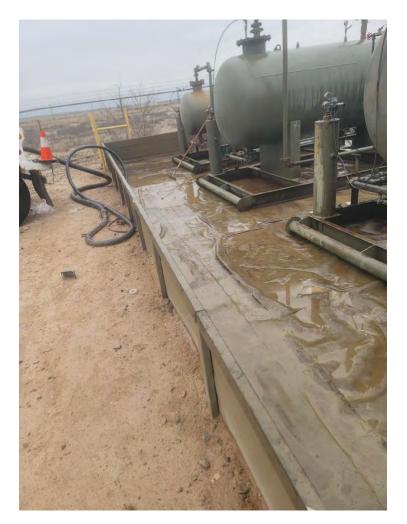
Post Remediation

On February 6, 2023, Paragon returned to the site to conduct a liner inspection. A 48-hour notification was sent out to the NMOCD on February 3, 2023. The inspection concluded that the liner was intact and in good condition. The integrity of the liner appears to have the ability to contain spills. See Appendix D for the email notification and liner report.
