LINER INSPECTION AND CLOSURE REPORT

Spur Energy Partners
Ouimet St Com #2H TB
Incident ID: nAPP2127755919
Eddy County, NM

Paragon Environmental LLC
1601 N. TURNER ST. STE.500
Hobbs, NM 88240
575-318-6841

Incident ID: nAPP2127755919

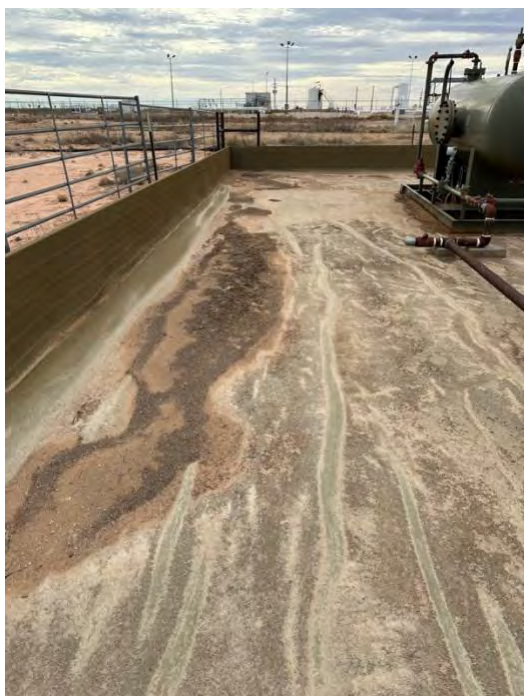
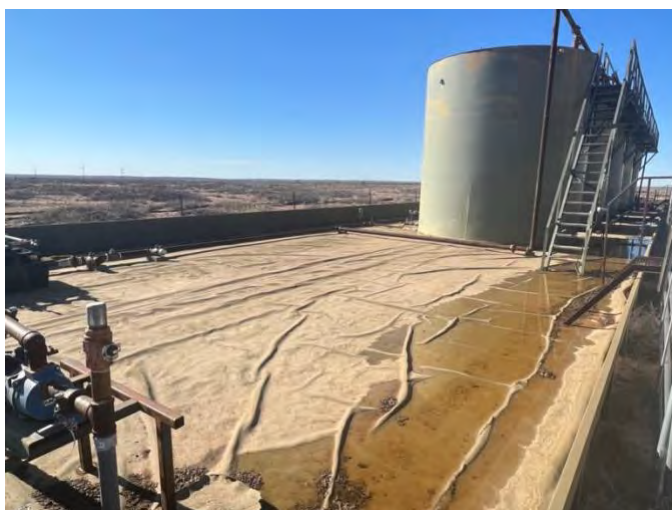
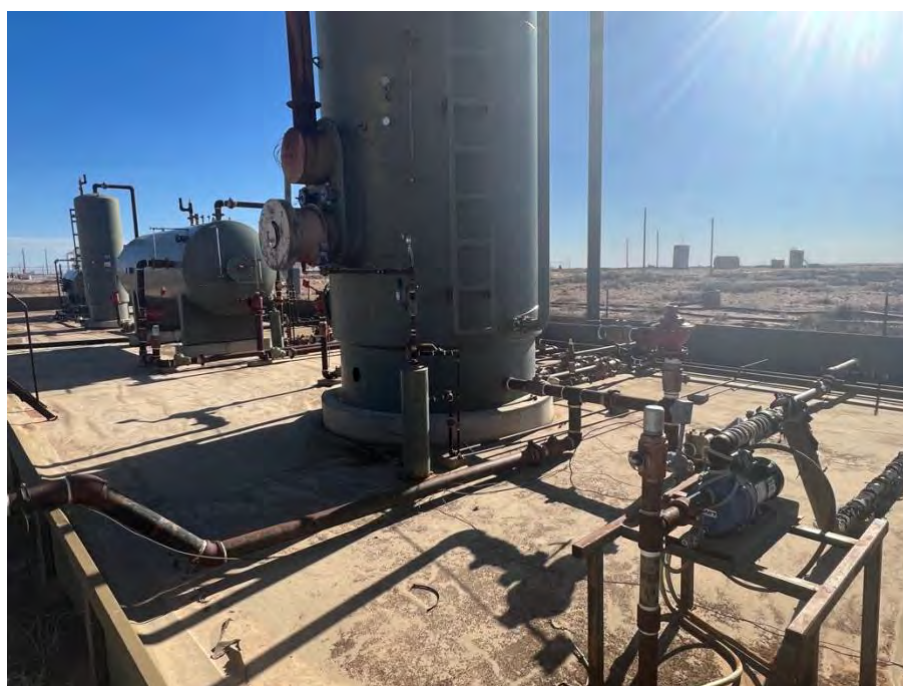
**Photographic Documentation
Liner Inspection**

On February 17, 2023, Paragon returned to the site to conduct a liner inspection. A 48-hour notification was sent out to the NMOCD on February 15, 2023. The liner inspection concluded that the liner's integrity was intact and in good condition. The liner appears to have the ability to contain spills. See Appendix D for the email notification and liner report.

Visualization	Yes	No	Comments
Is there a tear in the liner?		✓	
Are there holes in the liner?		✓	
Is the liner retaining any fluids?	✓		minor rain water
Does the liner have integrity to contain a leak?	✓

Comments: Containment is in good conditionInspector Name: Tristan Jones Inspector Signature: [Signature]

Created By	Condition	Condition Date
rhamlet	The Closure Report is Approved. All dried mud, trash, salt remnants, and sage brush should be removed so that the surface of the liner can be inspected. Please make sure this is accomplished in the future before any liner inspection is submitted.	7/21/2023
