LINER INSPECTION AND CLOSURE REPORT

Spur Energy Partners
McIntyre DK Fed #15 Battery
Incident ID: nAPP2317851907
Eddy County, NM

Paragon Environmental LLC
1601 N. TURNER ST. STE.500
Hobbs, NM 88240
575-318-6841

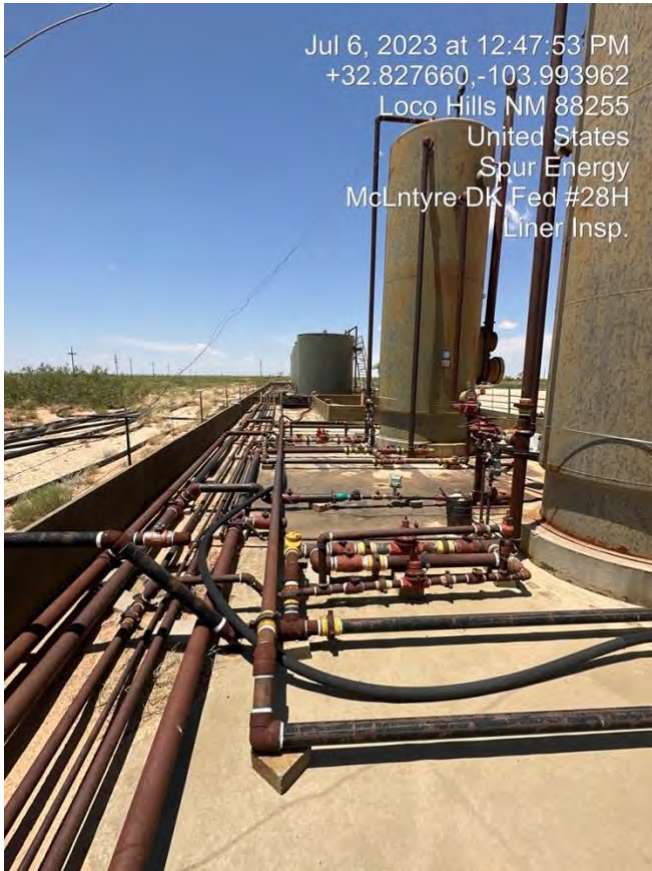
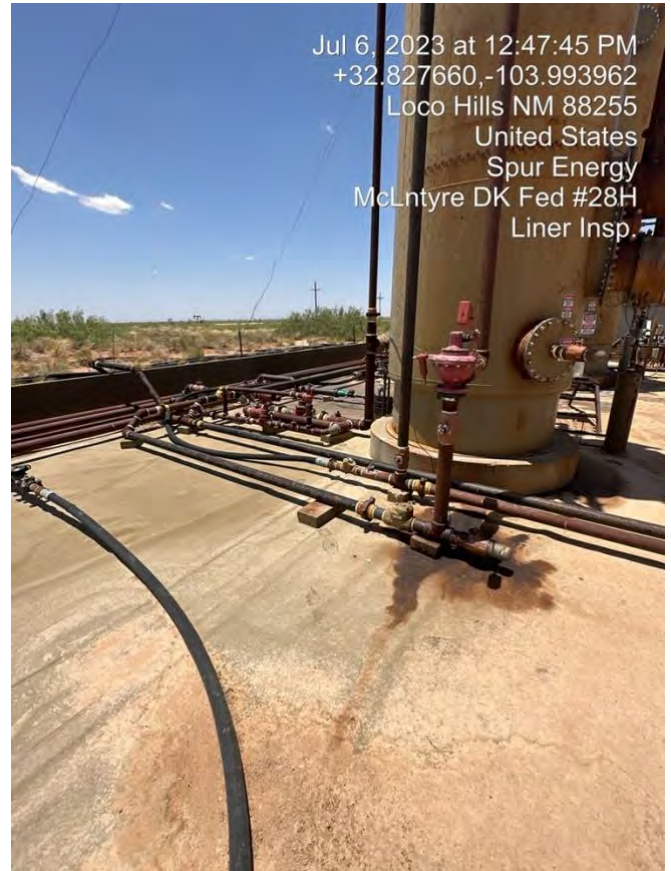
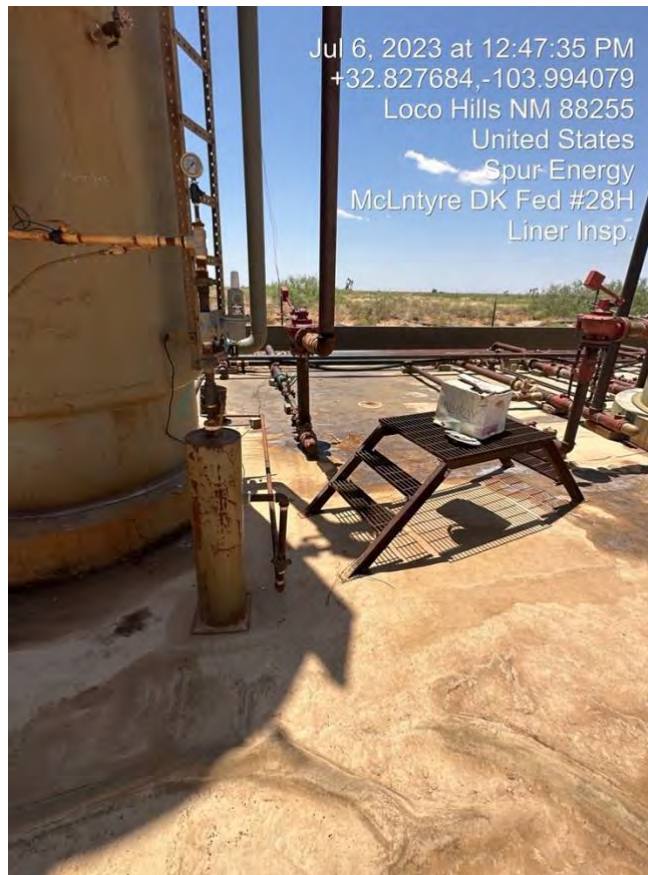
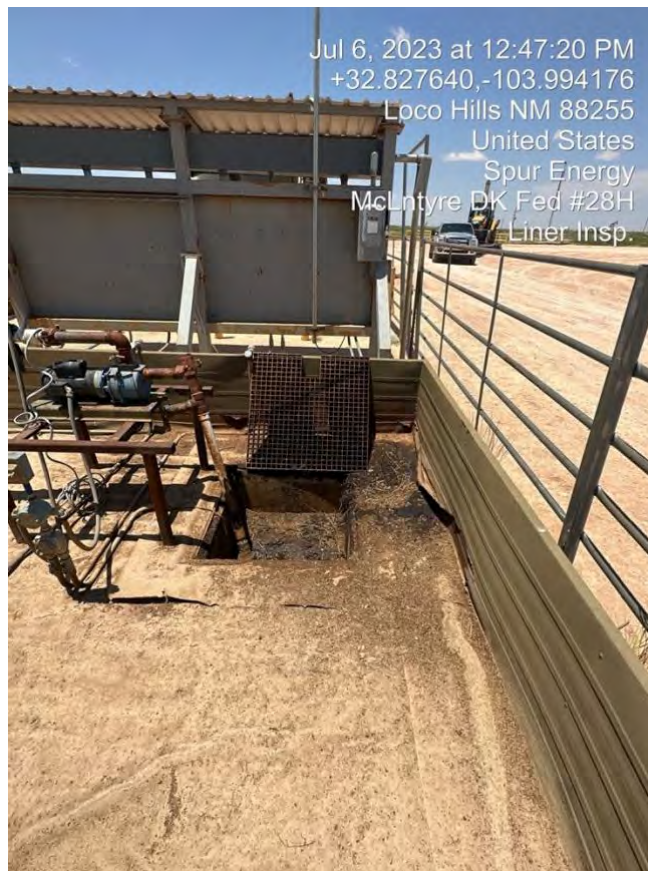
Before Cleaning

This release was due to equipment failure. The water transfer line fitting corroded. This resulted in the release of 134 bbls of produced water. All fluids were contained in the Falcon Lined Containment. A vacuum truck was dispatched and recovered 133 bbls of the fluids.

On June 28, 2023, Paragon went to the McIntyre and conducted an initial assessment. There was obvious staining on the liner from the spill. There were no signs outside the containment that the liner had been breached. Therefore, no samples were taken.

On July 6, 2023, Paragon returned to the site with equipment and personnel to begin cleanup activities. We initially sprayed the affected area with a degreaser. We then power washed and squeegeed the runoff to the vacuum truck, where we captured the fluids.

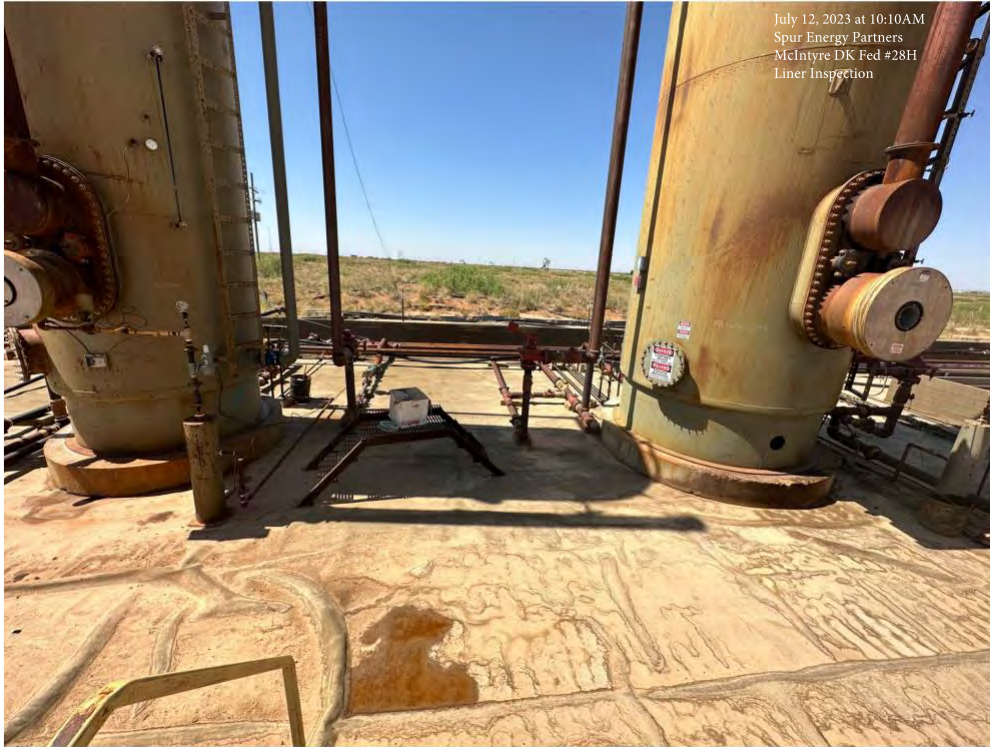
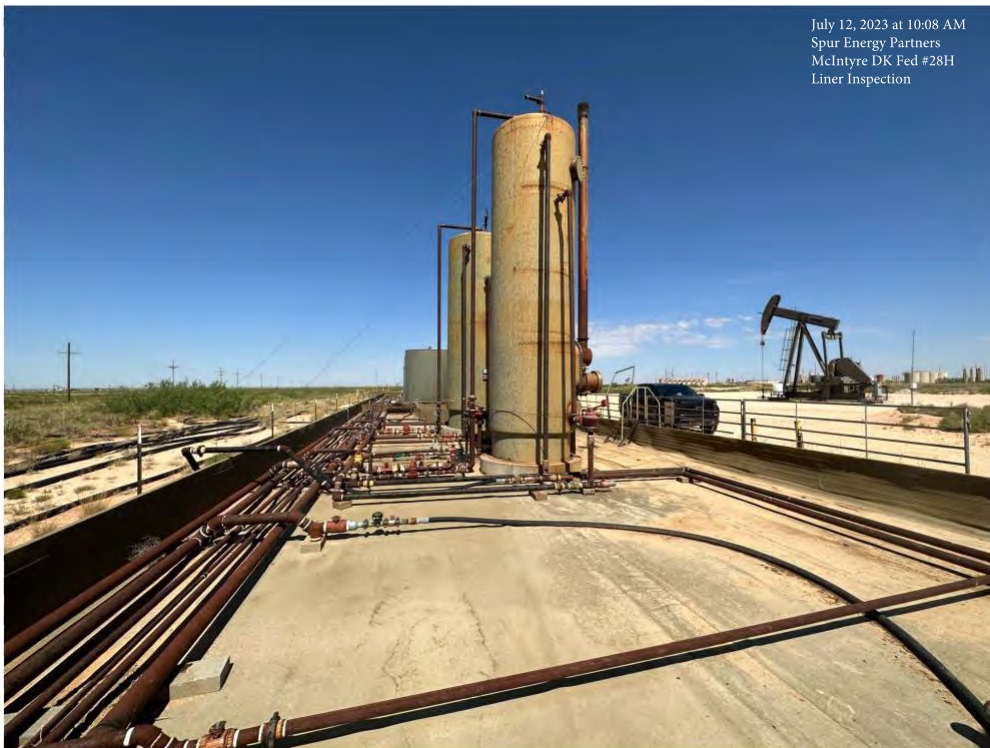
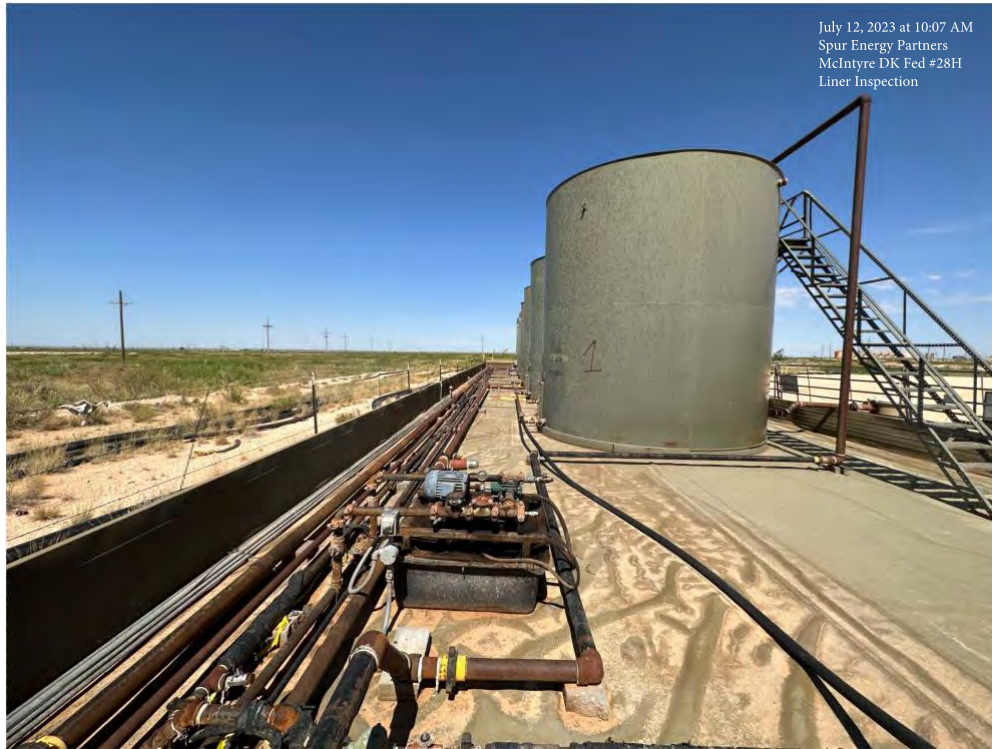
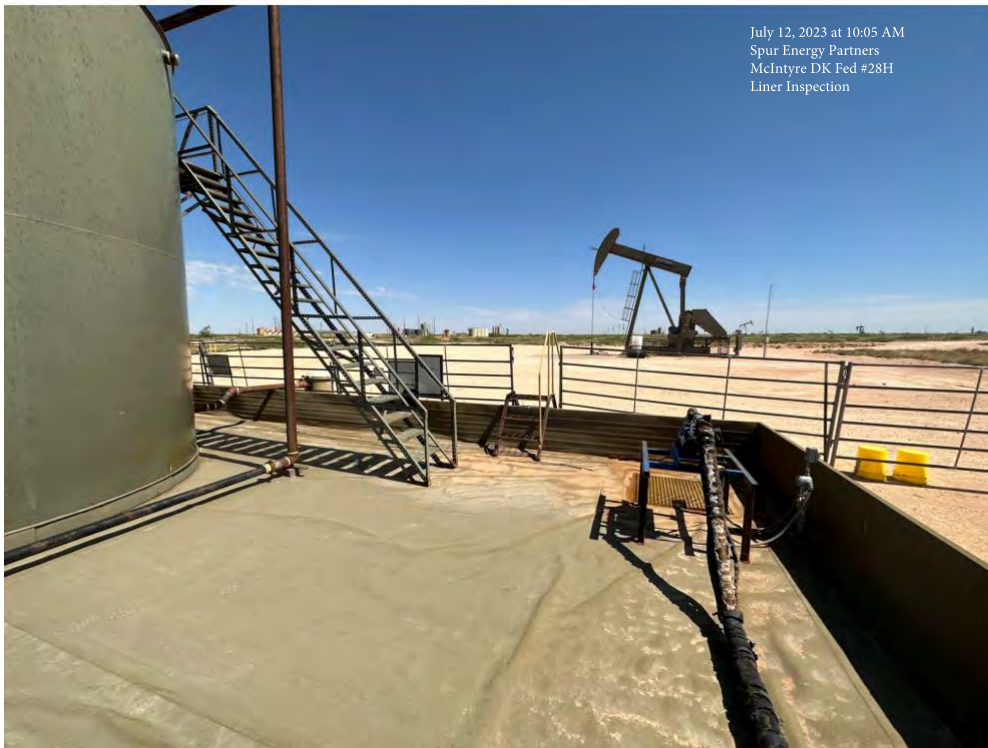
Liner Inspection

On July 12, 2023, Paragon returned to the site to conduct a liner inspection. A 48-hour notification was sent out to the NMOCD on July 7, 2023. The inspection concluded that the liner was intact and in good condition. The integrity of the liner appears to have the ability to contain spills. See Appendix D for the email notification and liner report.

Visualization	Yes	No	Comments
Is there a tear in the liner?	<input type="checkbox"/>	<input checked="" type="checkbox"/>	
Are there holes in the liner?	<input type="checkbox"/>	<input checked="" type="checkbox"/>	
Is the liner retaining any fluids?	<input type="checkbox"/>	<input checked="" type="checkbox"/>	
Does the liner have integrity to contain a leak?	<input checked="" type="checkbox"/>	<input type="checkbox"/>
