LINER INSPECTION AND CLOSURE REPORT

Spur Energy Partners

Stonewall 9 Fee #1H

Incident ID: nAPP2305834071

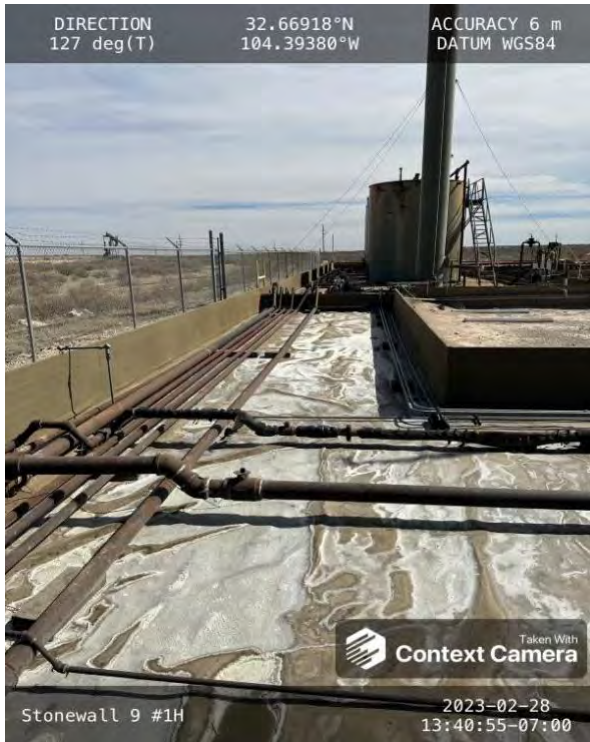
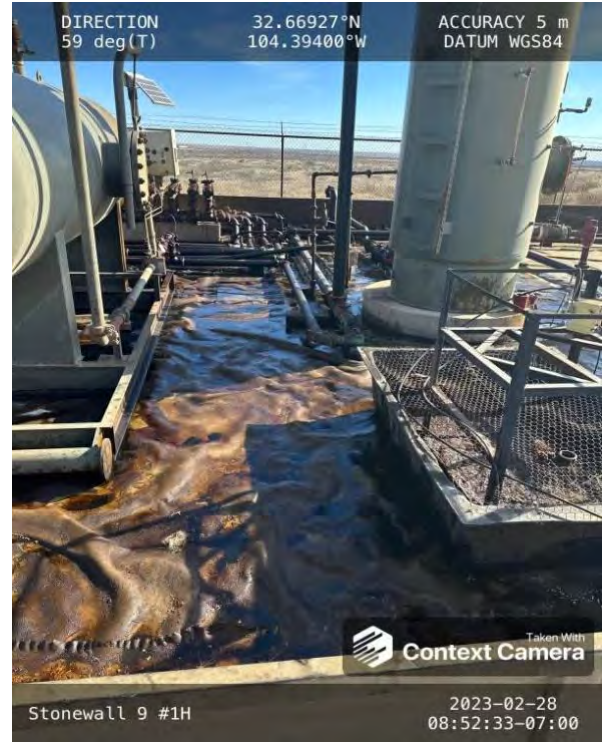
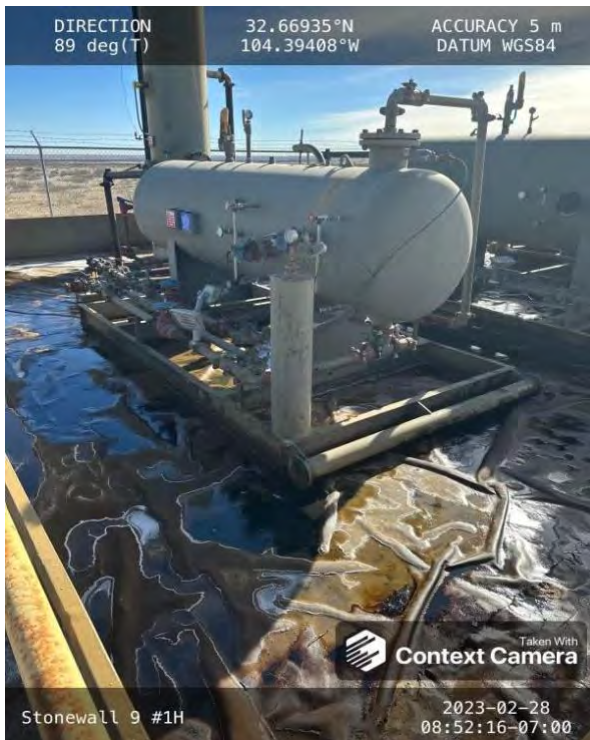
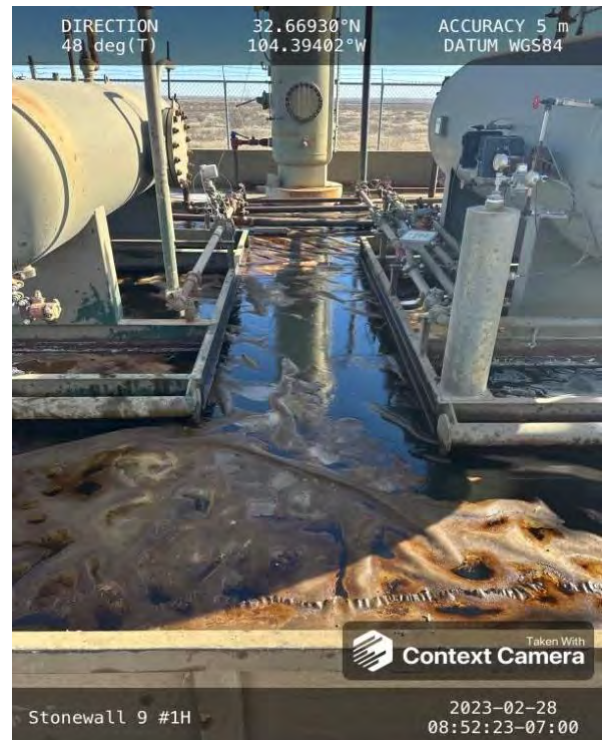
Before Remediation

This release was due to equipment failure. The plug on top of a 4-inch check valve blew off. This resulted in the release of 8 bbls of produced water contained in the Falcon Lined Containment. A vacuum truck was dispatched and recovered 8 bbls of the fluids.

On January 13, 2023, Paragon went to the Stonewall and conducted an initial assessment. There was obvious staining on the liner from the spill. There were no signs outside the containment that the liner had been breached. Therefore, no samples were taken.

On February 28, 2023, Paragon returned to the site with equipment and personnel to conduct cleanup activities. We initially sprayed the affected area with a degreaser. We then power washed and squeegeed the runoff to where the vacuum truck could capture the fluids.

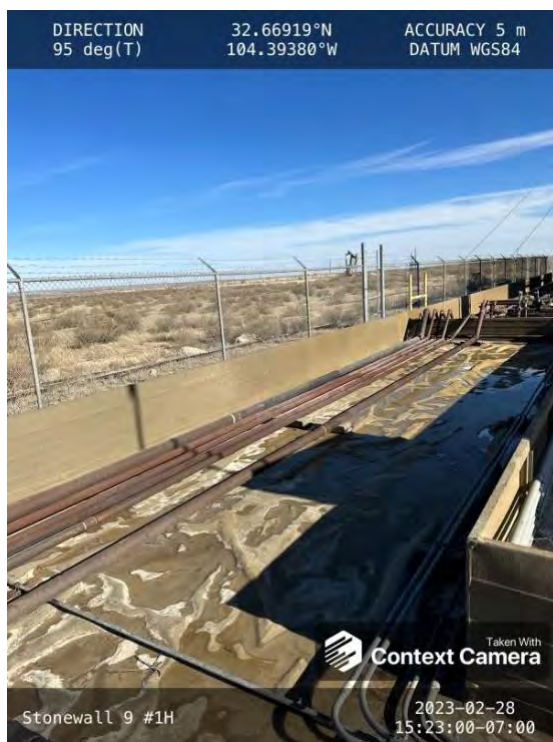
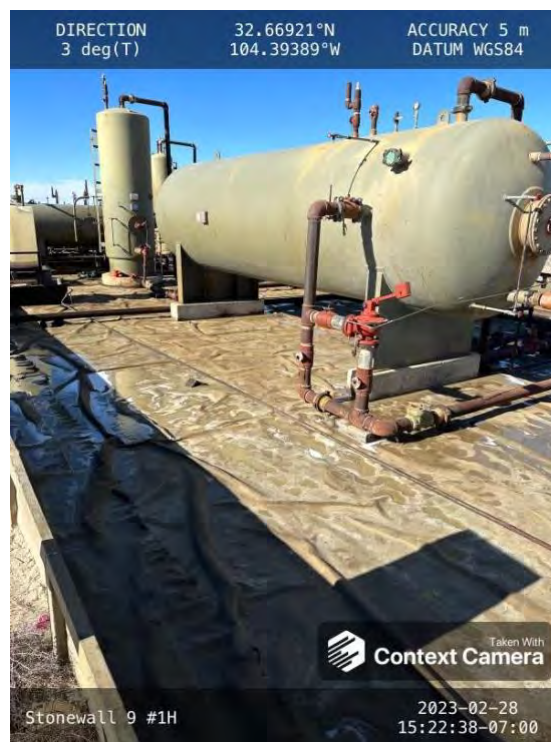
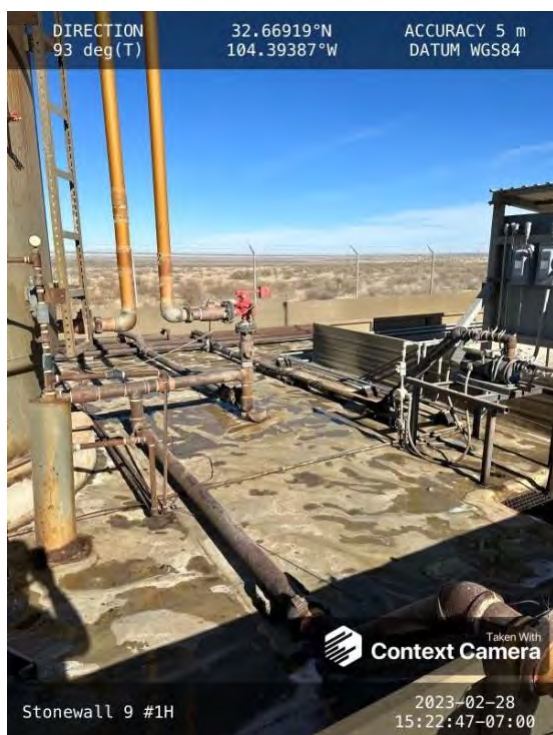
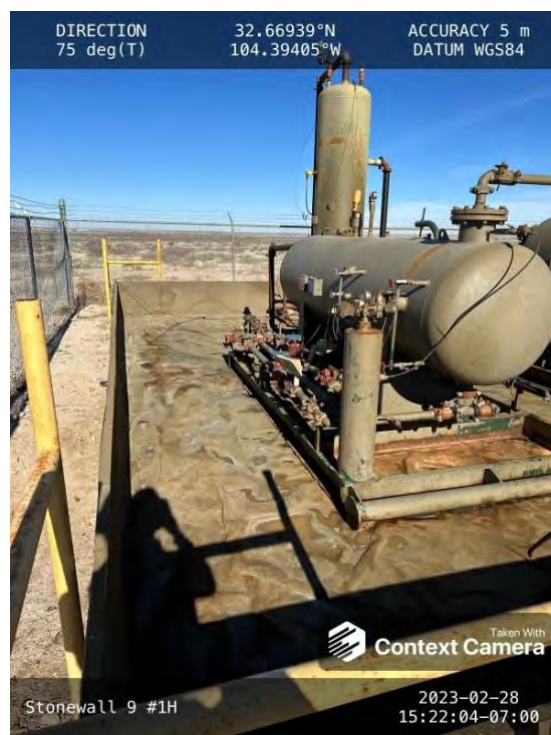
Post Remediation

On February 6, 2023, Paragon returned to the site to conduct a liner inspection. A 48-hour notification was sent out to the NMOCD on February 3, 2023. The inspection concluded that the liner was intact and in good condition. The integrity of the liner appears to have the ability to contain spills. See Appendix D for the email notification and liner report.
