# **LINER INSPECTION AND CLOSURE REPORT**

**Spur Energy Partners**  
Puckett 13 Federal Com 35H Battery  
Incident ID: NAPP2111652890  
Eddy County, NM

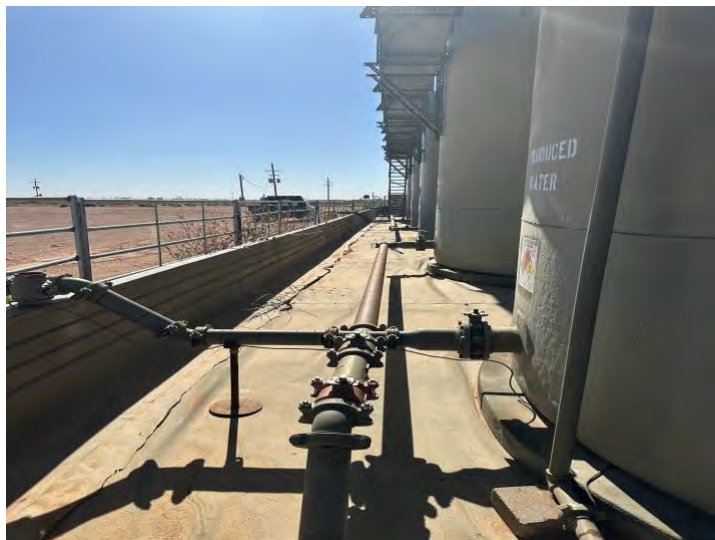
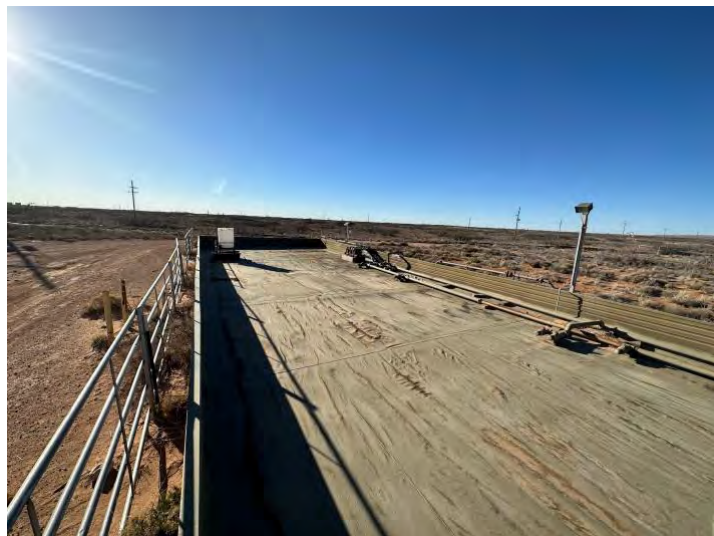
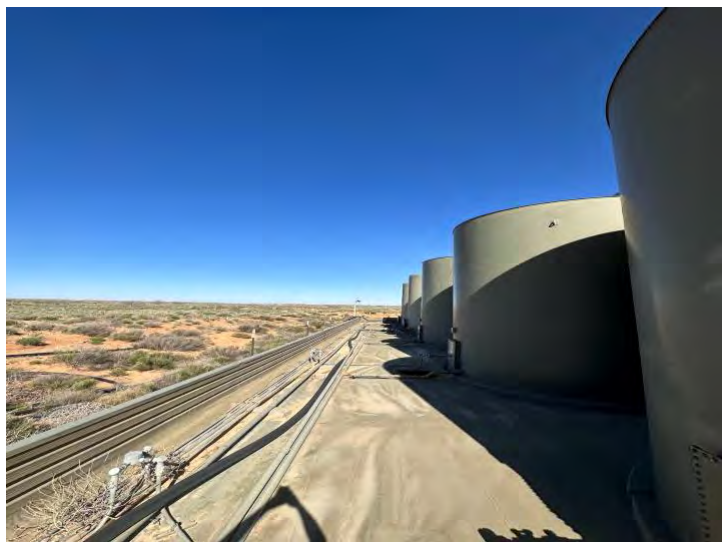
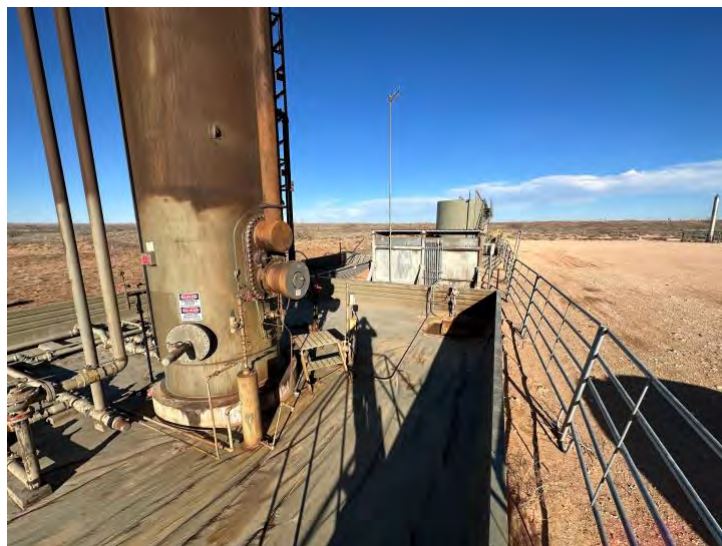
### Liner Inspection Pictures

On December 20, 2022, Paragon returned to the site to conduct a liner inspection. A 48-hour notification was sent out to the NMOCD on December 15, 2022. The liner inspection concluded that the liner's integrity was intact and in good condition. The liner appears to have the ability to contain spills. See Appendix D for the email notification and liner report.

Visualization	Yes	No	Comments
Is there a tear in the liner?		×	
Are there holes in the liner?		×	
Is the liner retaining any fluids?		×	
Does the liner have integrity to contain a leak?	×
