LINER INSPECTION AND CLOSURE REPORT

Spur Energy Partners

Bradley 8 Fee #2H

Incident ID: nAPP2215750109

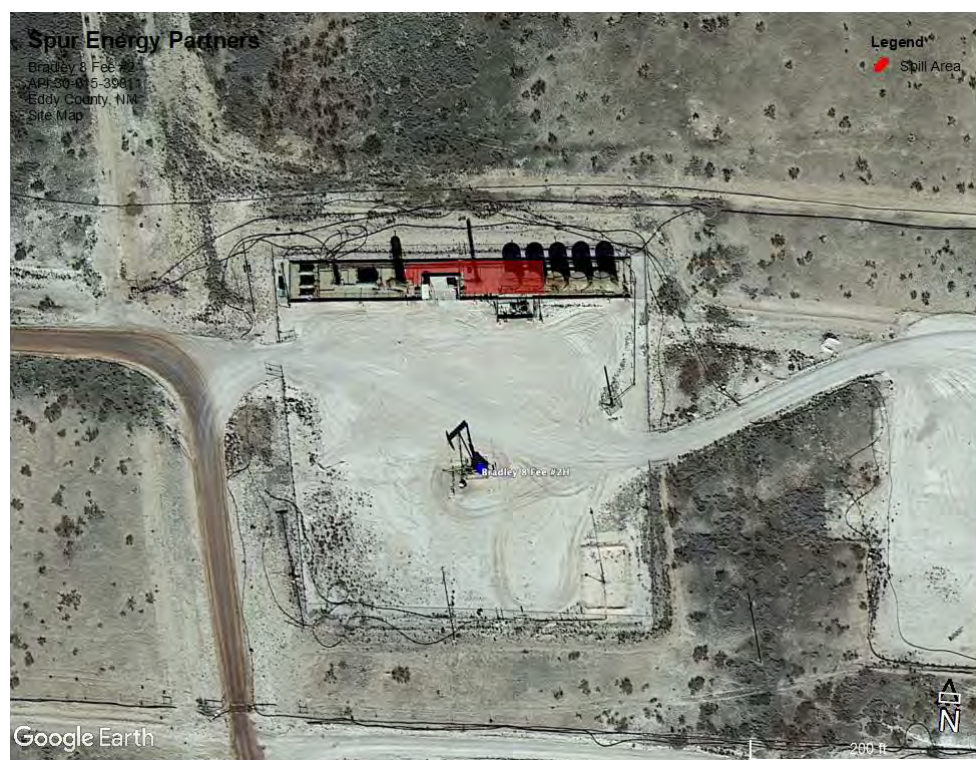
On May 23, 2022, Paragon went to the Bradley and conducted an initial assessment. There were noticeable oil stains on the liner from the spill. There were no signs outside the containment that the liner had been breached. Therefore, no samples were taken. See the site map below showing the affected area.

On June 9, 2022, Paragon returned to the site with equipment and personnel to conduct cleanup activities. We initially sprayed the affected area with surface cleaner. We then power washed and squeegeed the runoff to where the vacuum truck could capture the fluids.

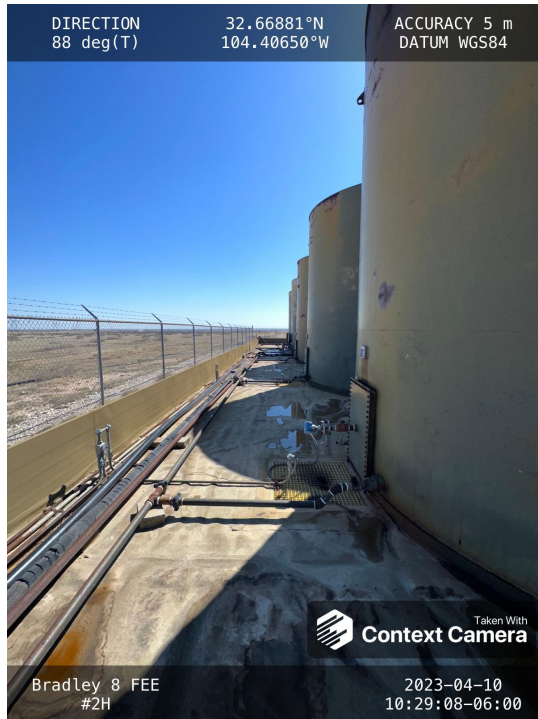
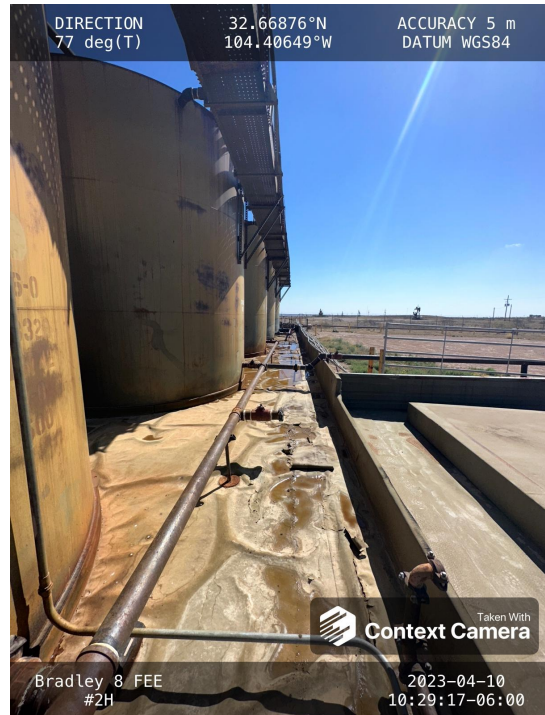
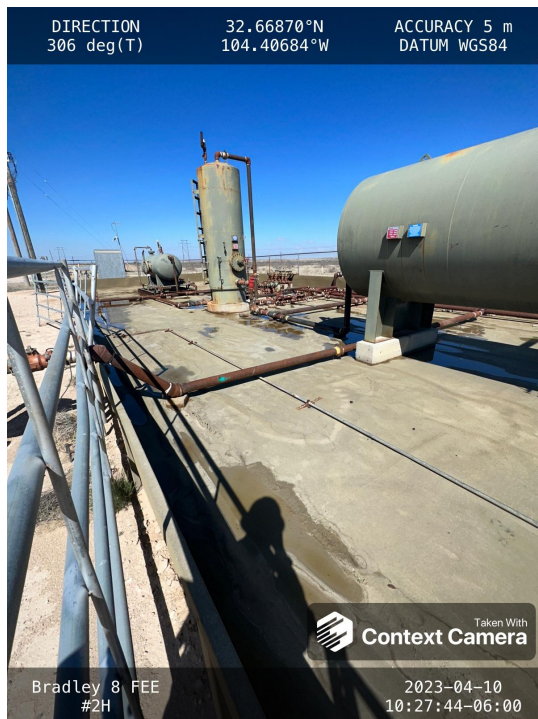
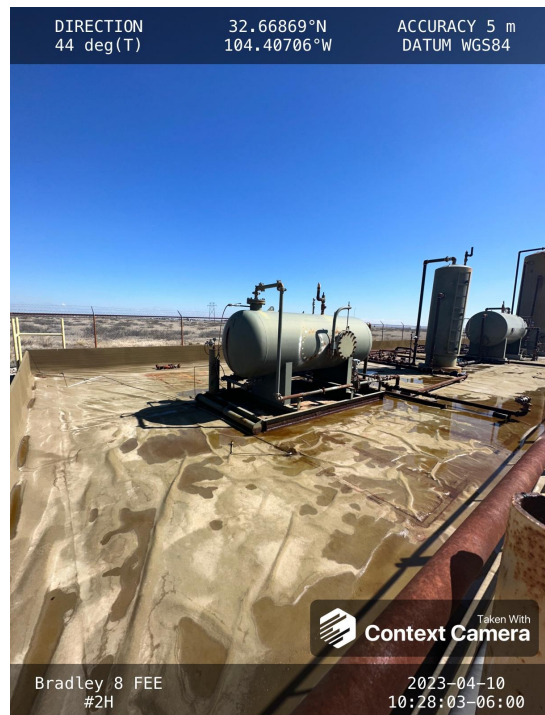
Liner Inspection

On April 10, 2023, Paragon returned to the site to conduct a liner inspection. A 48-hour notification was sent to the NMOCD on April 5, 2023. The liner inspection concluded that the liner was all intact and in good condition. The integrity of the liner appears to have the ability to contain spills. See Appendix D for the email notification and liner report.

Visualization	Yes	No	Comments
Is there a tear in the liner?		x	
Are there holes in the liner?		x	
Is the liner retaining any fluids?		x	
Does the liner have integrity to contain a leak?	x
