# LINER INSPECTION AND CLOSURE REPORT

## REPORTABLE RELEASE

**Spur Energy Partners**  
Sherman 4 Fee 6H  
Incident ID: nAPP2308951540  
Eddy County, NM

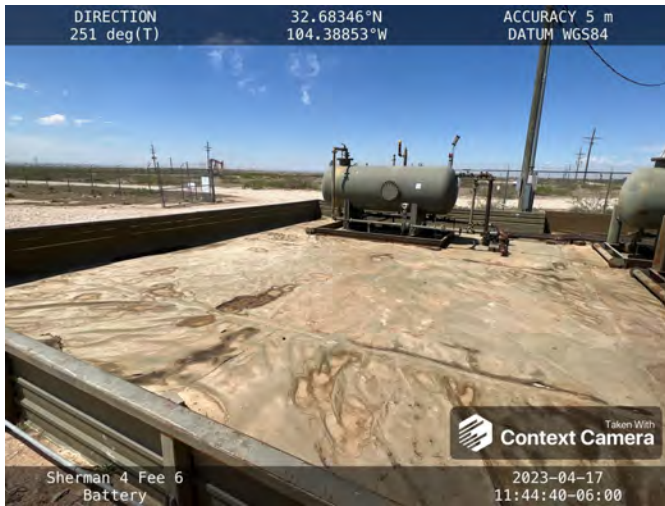
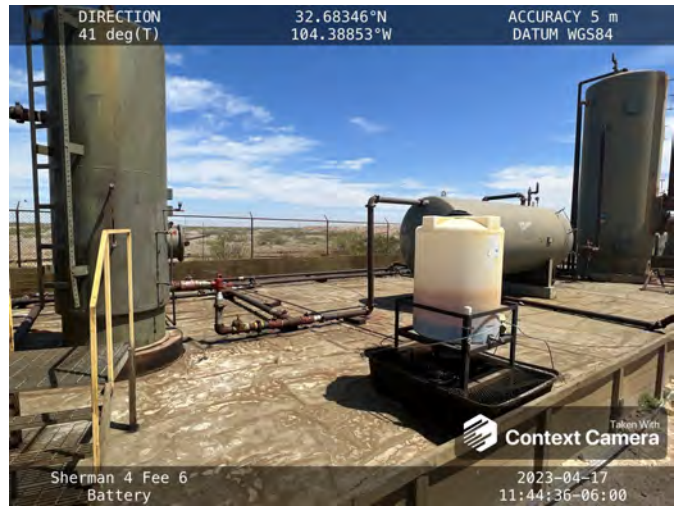
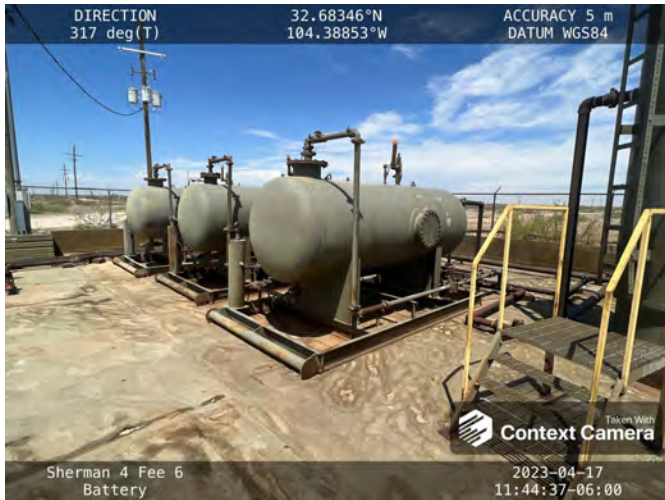
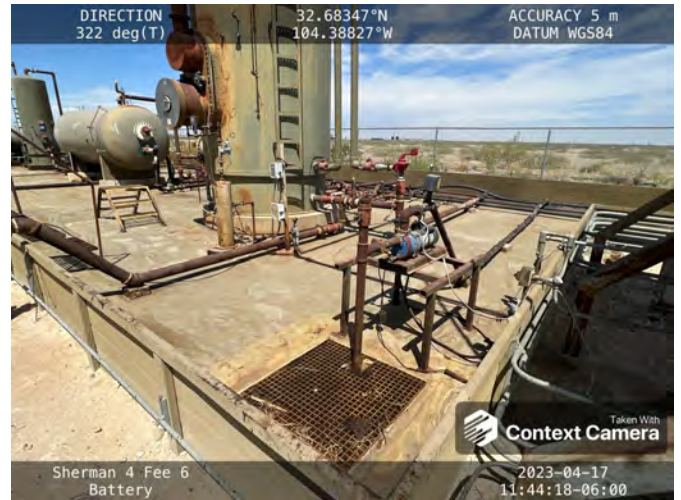
Liner Inspection

On April 17, 2023, Paragon returned to the site to conduct a liner inspection. A 48-hour notification was sent to the NMOCD on April 13, 2023. The liner inspection concluded that the liner's integrity was intact and in good condition. The liner appears to have the ability to contain spills. See Appendix D for the email notification and liner report.

Visualization	Yes	No	Comments
Is there a tear in the liner?	X		One of the corners on the berm has been damaged. The liner still maintains its integrity. Liner repair tape has been applied to this area.
Are there holes in the liner?		X	None.
Is the liner retaining any fluids?		X	None.
Does the liner have integrity to contain a leak?	X		This liner would be able to contain a substantial spill without any problems.

Comments: Liner is in good condition.\_\_\_\_\_
