LINER INSPECTION AND CLOSURE REPORT REPORTABLE RELEASE

Spur Energy Partners

Halberd 27 St Com 3H Battery Incident ID: nAPP2301731619 Eddy County, NM

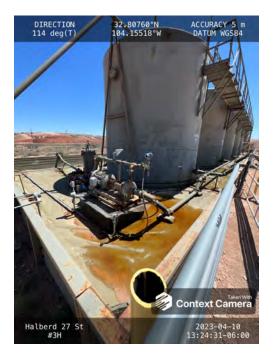
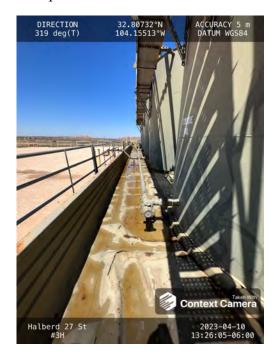
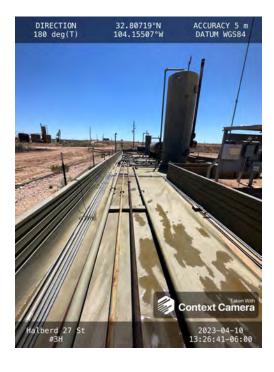
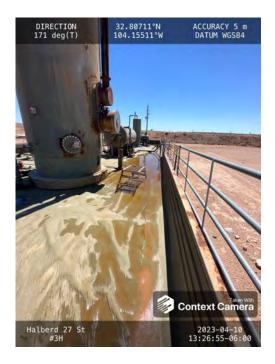
Post Remediation & Liner Inspection

On March 23, 2023, Paragon went to the and conducted an initial assessment. There was obvious staining on the liner from the spill. There were no signs outside the containment that the liner had been breached. Therefore, no samples were taken.

On April 10, 2023, Paragon returned to the site to conduct a liner inspection. A 48-hour notification was sent out to the NMOCD on April 5, 2023. The inspection concluded that the liner was intact and in good condition. The integrity of the liner appears to have the ability to contain spills. See Appendix D for the email notification and liner report.

On March 27, 2023, Paragon returned to the site with equipment and personnel to conduct cleanup activities. We initially sprayed the affected area with a degreaser. We then power washed and squeegeed the runoff to where the vacuum truck could capture the fluids.
