# **LINER INSPECTION AND CLOSURE REPORT**

## **REPORTABLE RELEASE**

**Spur Energy Partners**  
Falabella 31 Fee 1H Battery  
Incident ID: nAPP2307231629  
Eddy County, NM

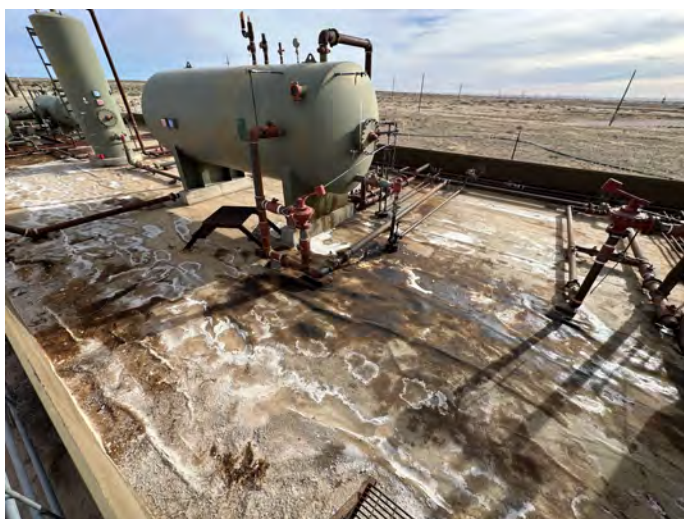
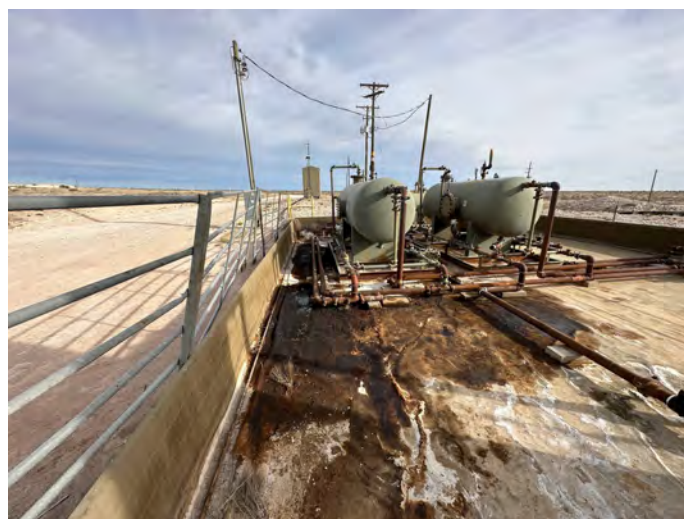
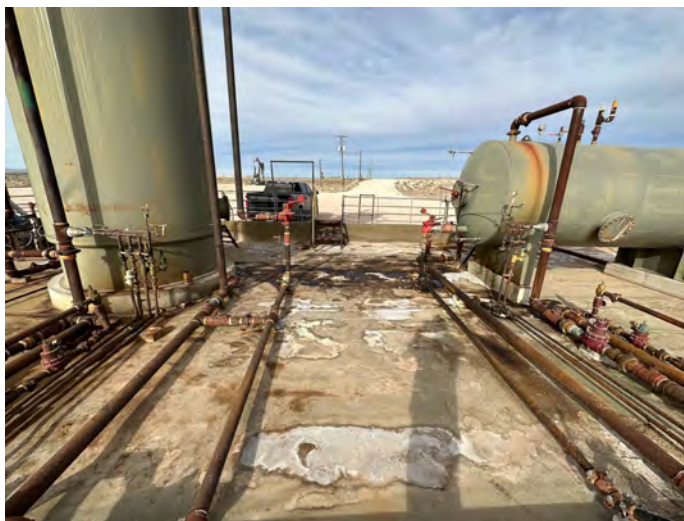
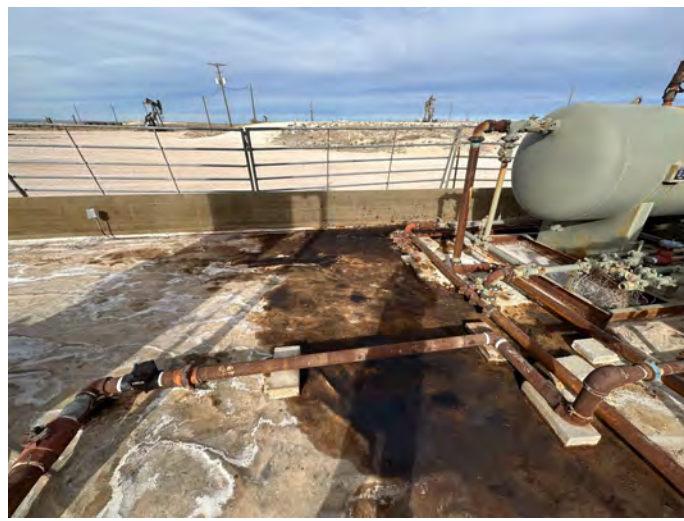
### Before Remediation

This release was due to corrosion of the joint on the FWKO. This resulted in the release of 6 bbls of produced water and 7 bbls of crude oil into the Falcon Lined Containment. A vacuum truck was dispatched and recovered 12 bbls of the fluids.

On March 23, 2023, Paragon went to the Falabella and conducted an initial assessment. There was obvious staining on the liner from the spill. There were no signs outside the containment that the liner had been breached. Therefore, no samples were taken.

On March 24, 2023, Paragon returned to the site with equipment and personnel to conduct cleanup activities. We initially sprayed the affected area with a degreaser. We then power washed and squeegeed the runoff to where the vacuum truck could capture the fluids.

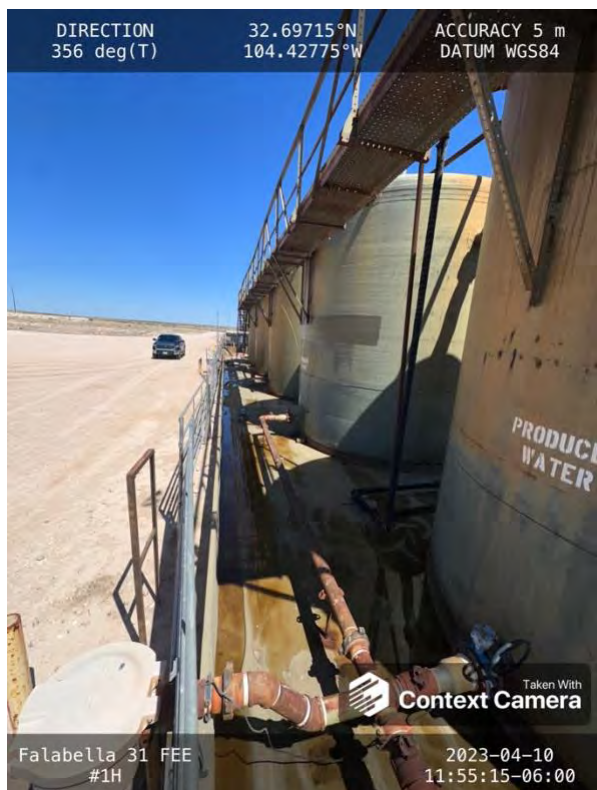
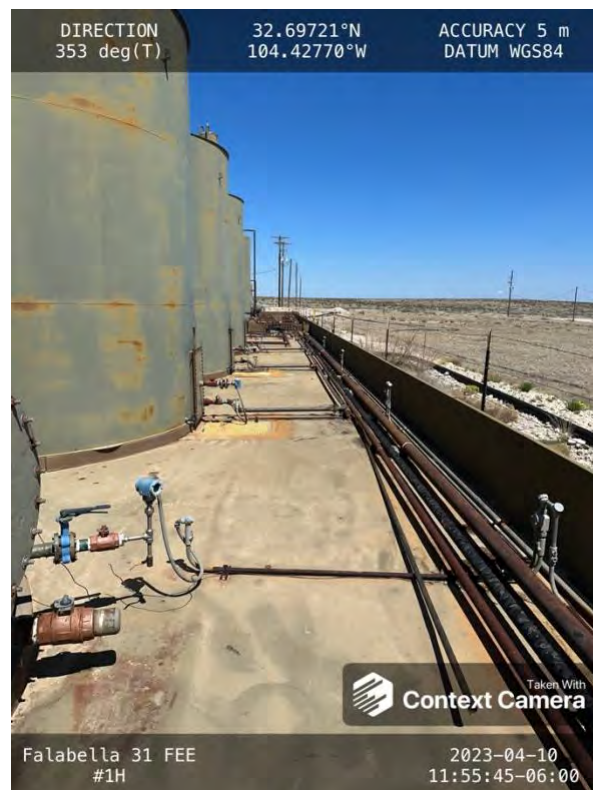
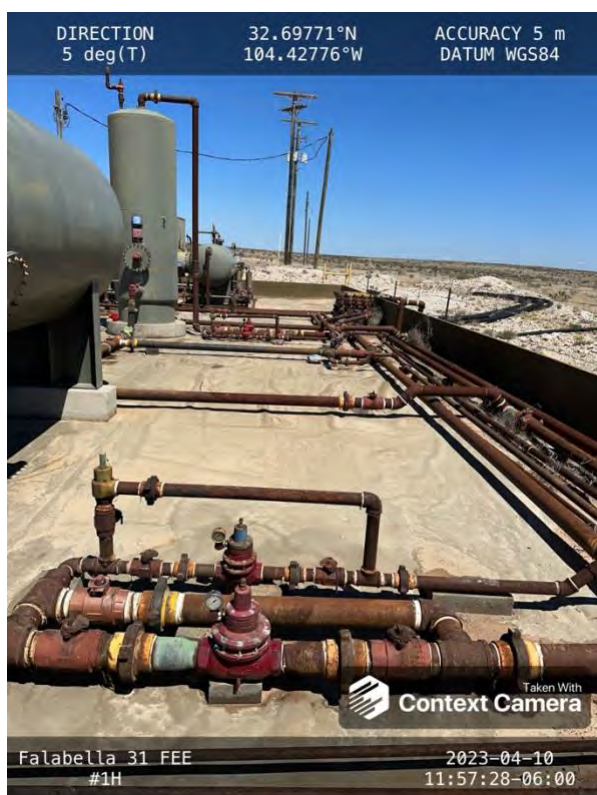
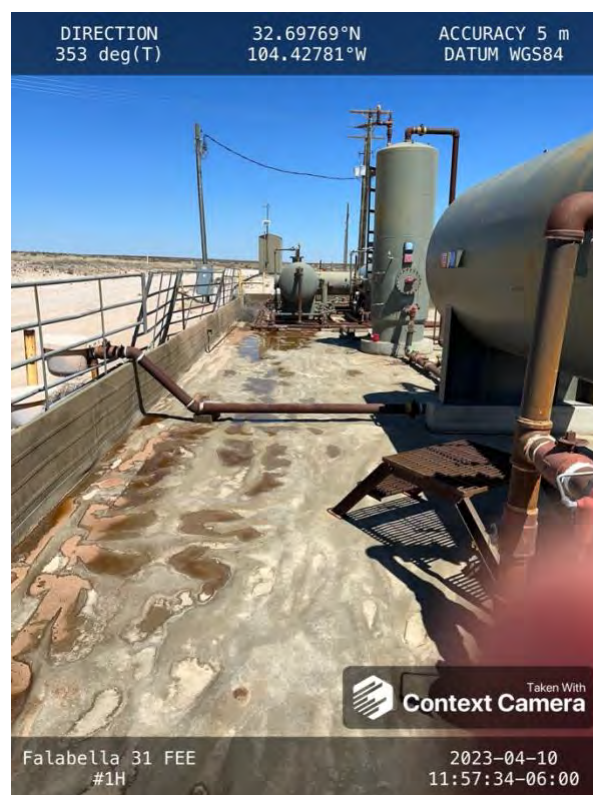
### Photographic Documentation Liner Inspection

On April 10, 2023, Paragon returned to the site to conduct a liner inspection. A 48-hour notification was sent out to the NMOCD on April 5, 2023. The inspection concluded that the liner was intact and in good condition. The integrity of the liner appears to have the ability to contain spills. See Appendix D for the email notification and liner report.

Visualization	Yes	No	Comments
Is there a tear in the liner?		✓	
Are there holes in the liner?		✓	
Is the liner retaining any fluids?	✓		Rain water
Does the liner have integrity to contain a leak?	✓
