# LINER INSPECTION AND CLOSURE REPORT REPORTABLE RELEASE

### **Spur Energy Partners**

Stonewall 9 Fee #1H Incident ID: NRM2034259537 Eddy County, NM

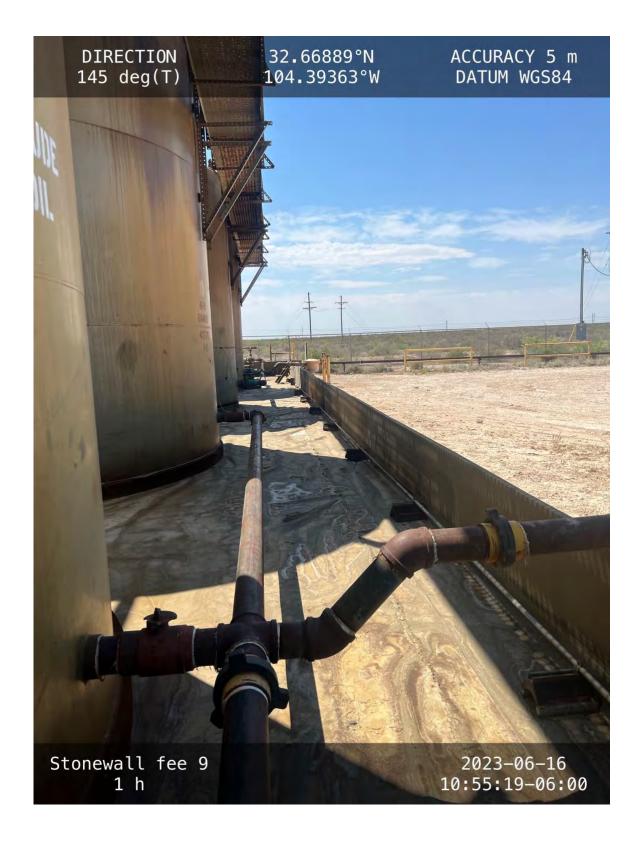
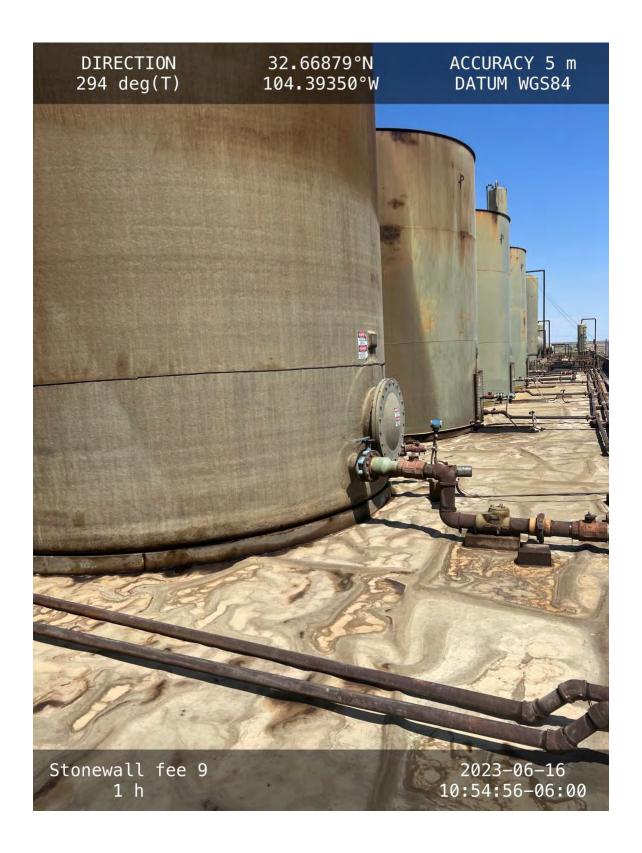
### **Photographic Documentation**

On June 13, 2023, Paragon returned to the site to conduct a liner inspection. A 48-hour notification was sent out to the NMOCD on June 13, 2023. The inspection concluded that the liner was intact and in good condition. The integrity of the liner appears to have the ability to contain spills. See Appendix D for the email notification and liner report.

Visualization	Yes	No	Comments
Is there a tear in the liner?		X	
Are there holes in the liner?		X	
Is the liner retaining any fluids?		X	
Does the liner have integrity to contain a leak?	X
