RE: Liner Inspection and Closure Report Kool Aid State Tank Battery API No. N/A GPS: Latitude 32.82540 Longitude -104.12830 UL- B, Section 24, Township 17S, Range 28E NMOCD Reference No. NAPP2310329856

SITE PHOTOGRAPHS SPUR ENERGY PARTNERS KOOL AID STATE TANK BATTERY

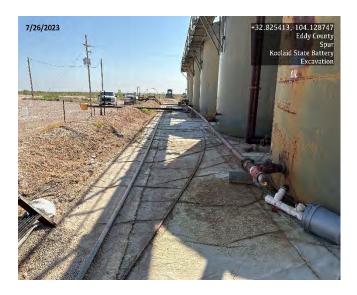
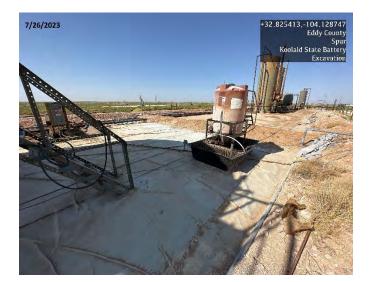
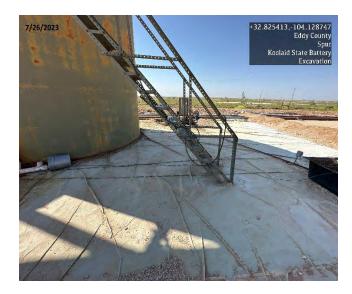
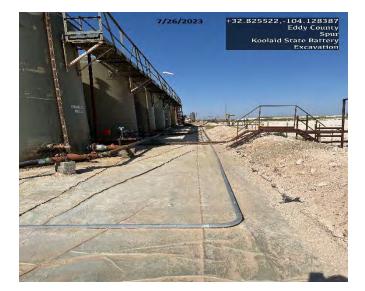
Excavation and Gravel Removal

All fluid and surrounding contaminated gravel were removed utilizing hand shovels. The liner was visually inspected by Spur field staff for any pinholes or punctures, and none were found. Based on this inspection there is no evidence that the spilled fluids left containment.

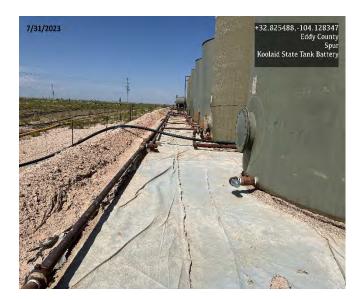
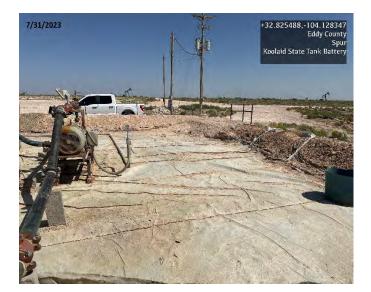
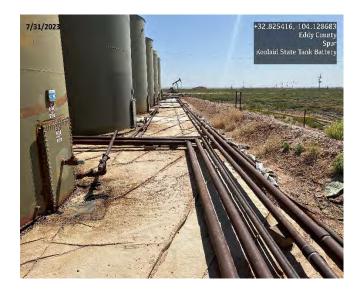
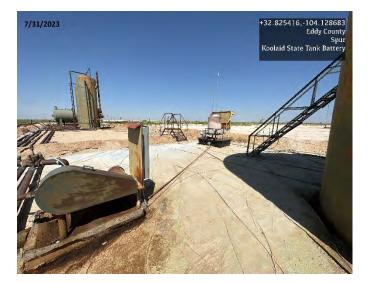
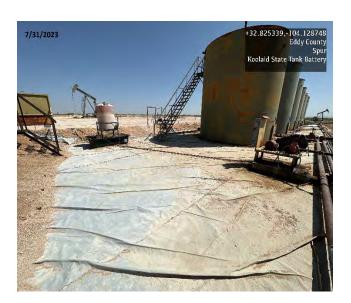
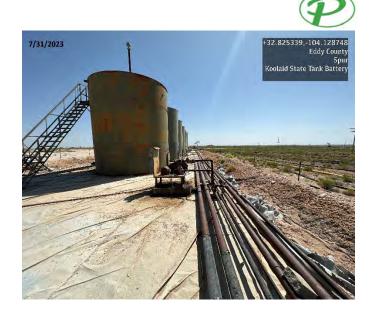
Post Excavation

On August 3, 2023, after sending the 48-hour notification via email, Pima Environmental conducted a liner inspection at this location. We concluded that this liner and containment maintained its integrity and was able to retain the fluids. The liner inspection form and photographic documentation can be found in Appendix C.
