LINER INSPECTION AND CLOSURE REPORT

REPORTABLE RELEASE

Spur Energy Partners
Loco Hills SWD 34 #3
Incident ID: nAPP2129931777
Eddy County, NM

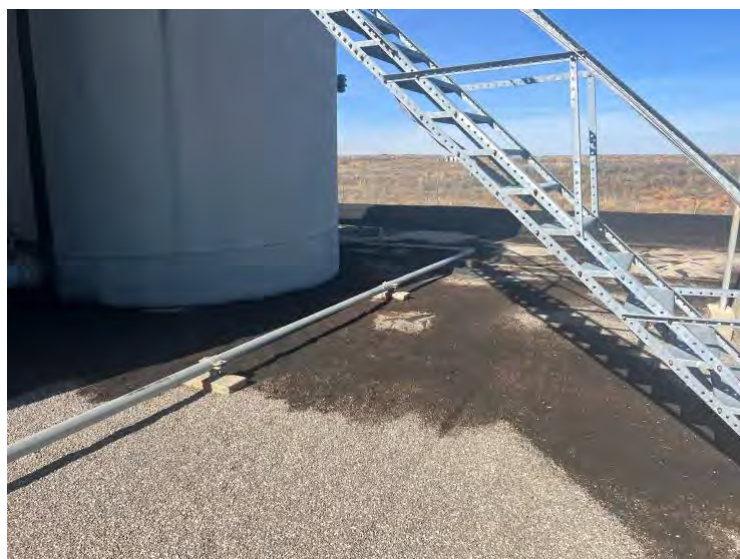
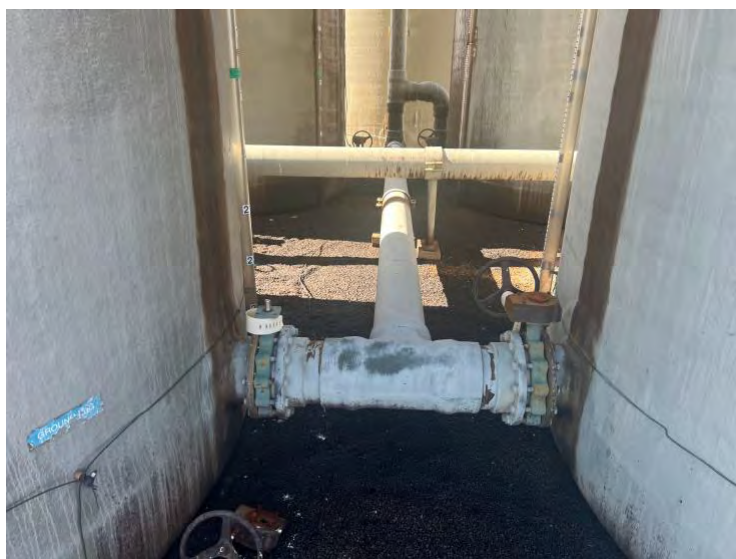
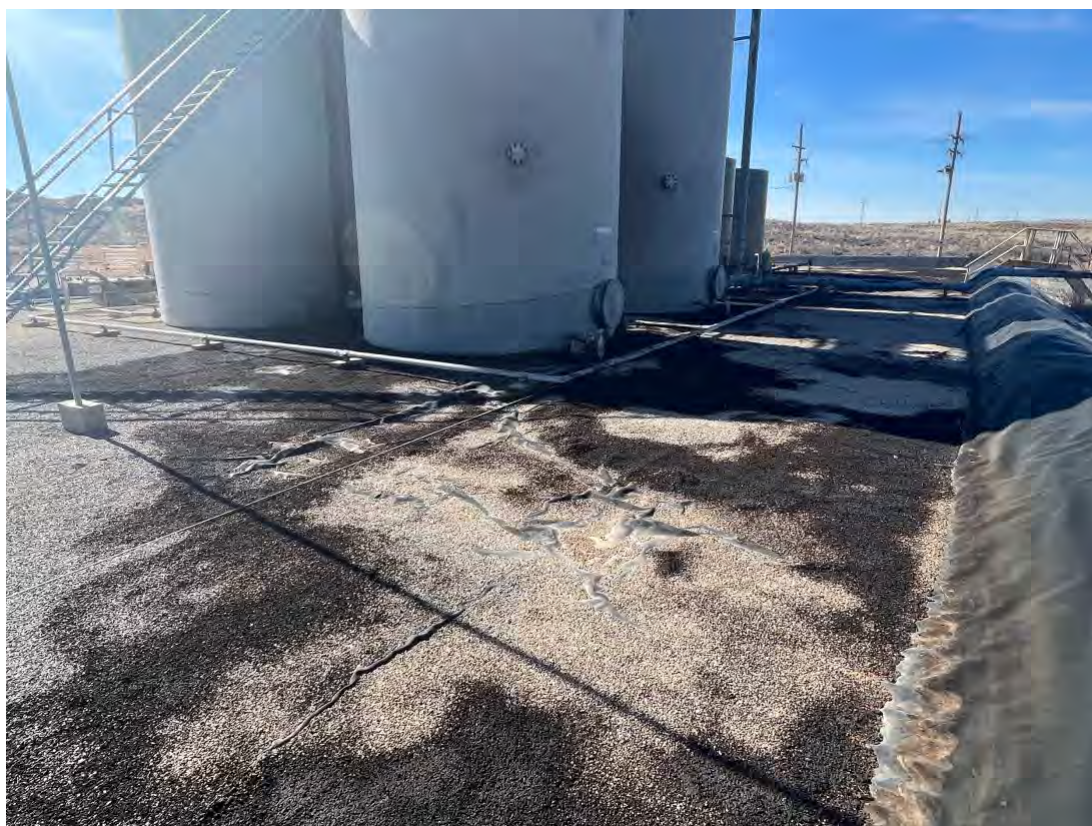
Before

On December 20, 2022, Paragon went to the site and conducted an initial assessment/liner inspection. There was obvious staining on the material from the spill. There were no signs outside the containment that the liner had been breached. Therefore, no samples were taken.

Comments: Liner appears to be in good condition, however contaminated pea gravel is covering up most of the containment.

On August 7, 2023, Paragon went to the site and began removing the contaminated material from the containment to expose the liner.

Upon removing all the contaminated material, Paragon returned to the site with equipment and personnel to conduct cleanup activities. We initially sprayed the affected area with a degreaser. We then power washed and used a squeegee to move the runoff to where the vacuum truck could capture the fluids.

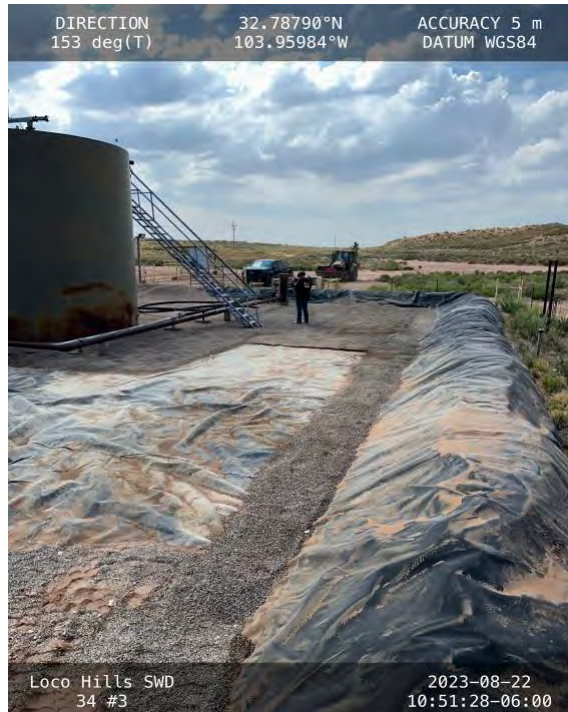
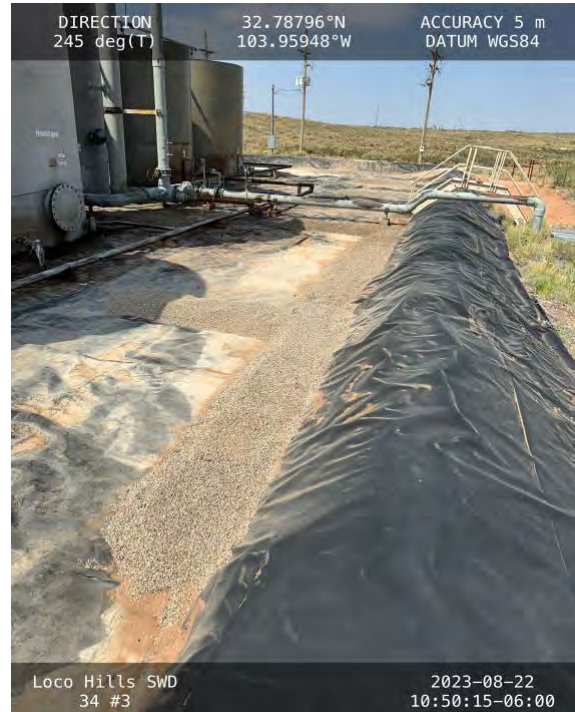
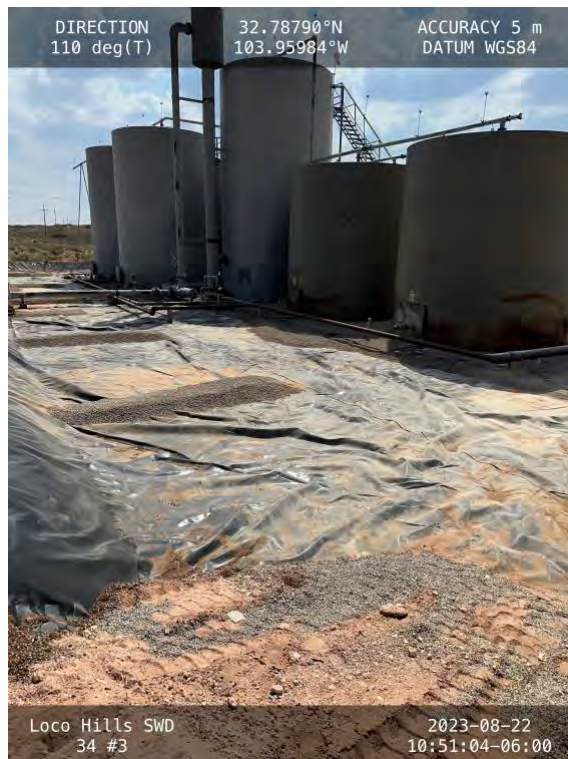
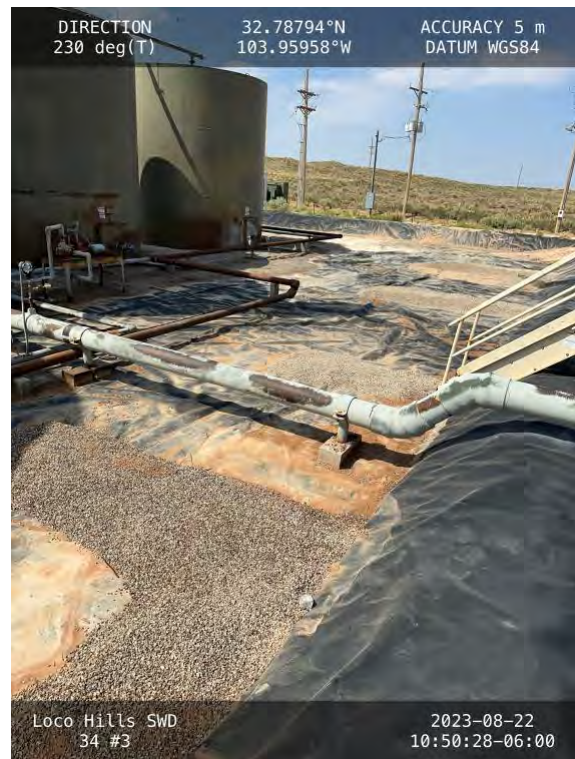
After

On June August 14, 2023, Paragon returned and conducted a liner inspection. A 48-hour notification was sent to the NMOCD on August 9, 2023. The liner inspection concluded that the liner's integrity was intact and in good condition. The liner is clean and appears to have the ability to contain spills. See Appendix D for the email notification and liner report.

Comments: The Liner is in good condition and will contain any potential spill._____
