**RE:** Liner Inspection and Closure Report

**Cotton Draw Unit 25 CTB**

NMOCD Reference No. NAPP2310779984

# SITE PHOTOGRAPHS DEVON ENERGY – LINER INSPECTION COTTON DRAW UNIT 25 CTB

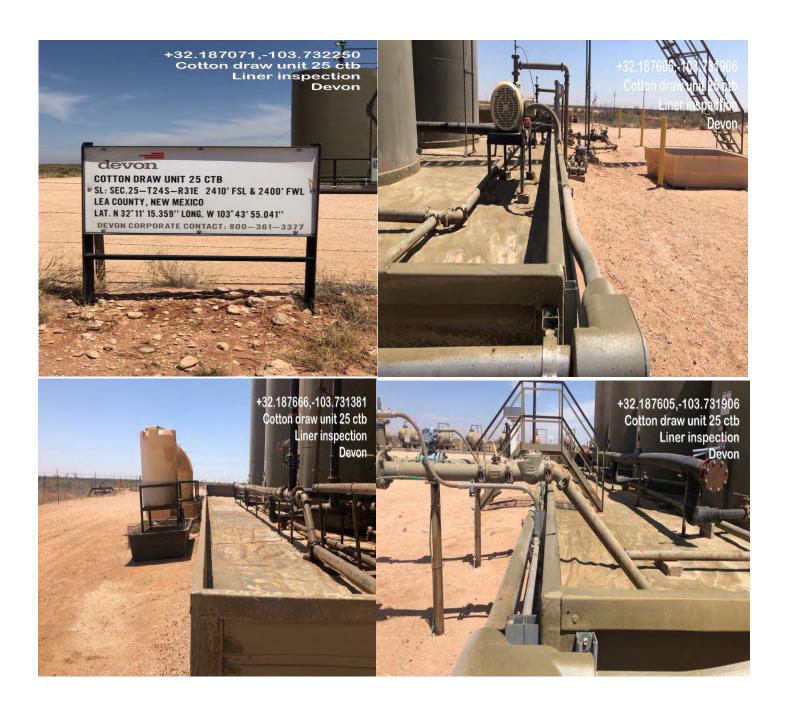
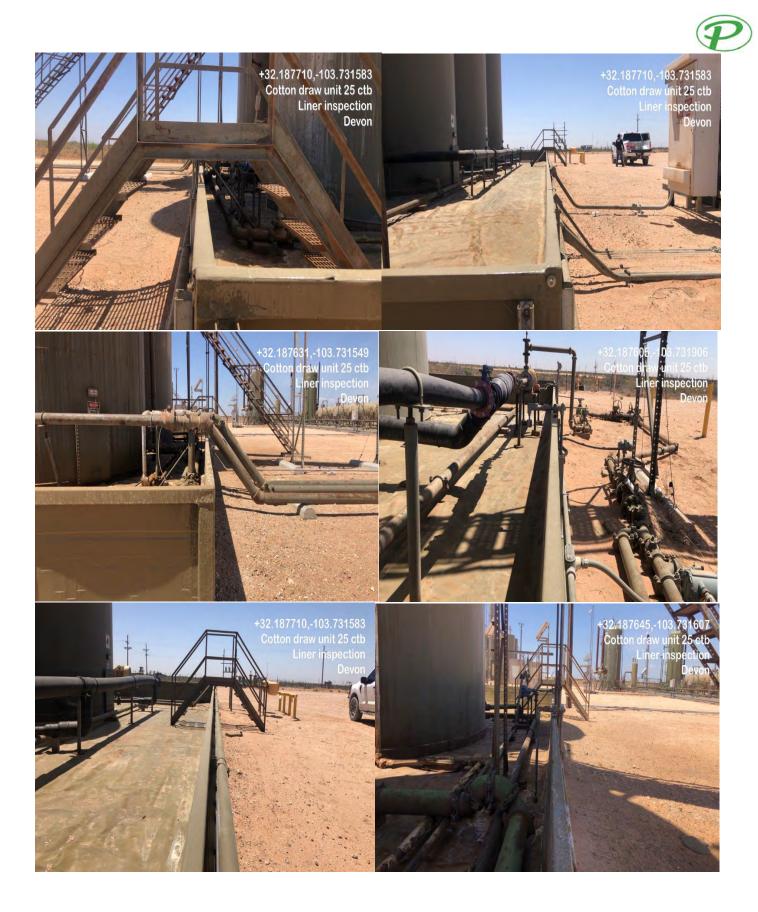
On April 29, 2023, after sending the 48-hour notification email, Pima Environmental conducted a liner inspection at this location. We concluded that this liner and containment maintained its integrity and was able to retain the fluids. The Liner Inspection Form and Photographic Documentation can be found in Appendix C.
