RE: Liner Inspection and Closure Report

Longview Federal 31-3H

GPS: Latitude 32.342934 Longitude -104.025269 UL N, Section 31, Township 22S, Range 29E NMOCD Reference No. NAPP2319780461

Devon Energy Production Company (Devon) has contracted Pima Environmental Services, LLC (Pima) to perform a liner inspection and prepare this closure report for a crude oil and produced water release that happened at the Longview Federal 31-3H (Longview). An initial C-141 was submitted on July 26, 2023, and can be found in Appendix B. This incident was assigned Incident ID NAPP2319780461, by the New Mexico Oil Conservation Division (NMOCD).

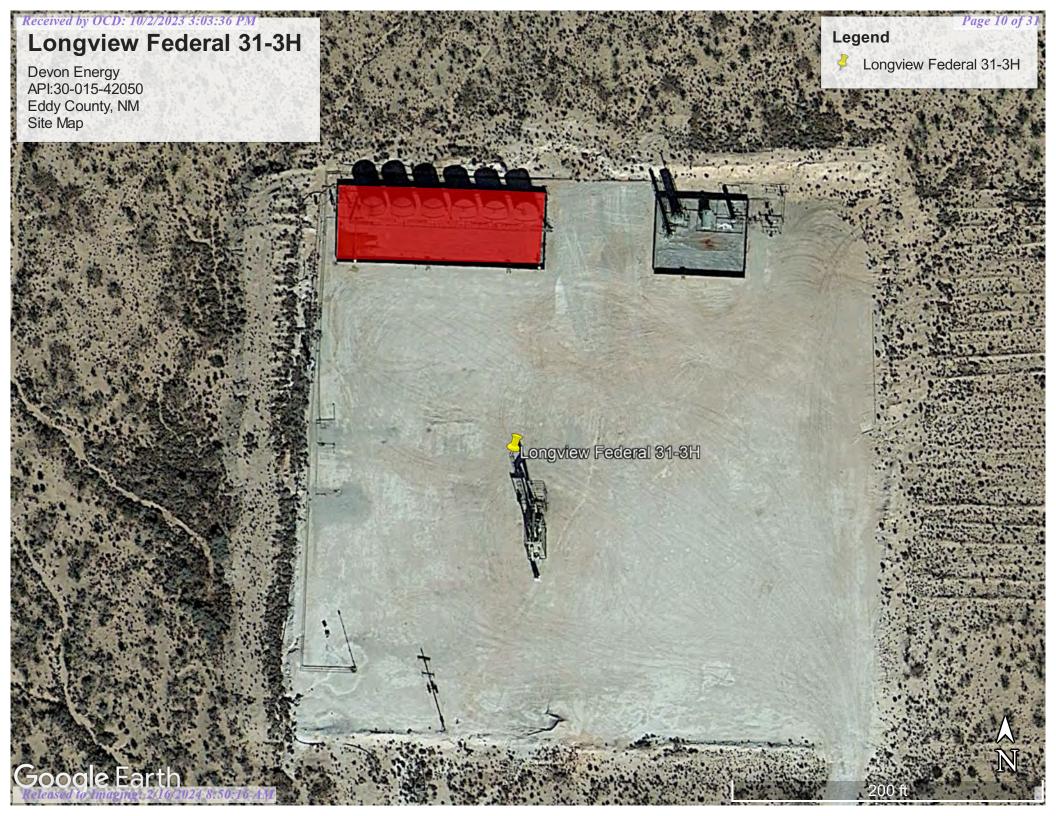
4-Site Map

NAPP2319780461: On July 13, 2017, a leak developed on a water transfer pump, causing oil, and produced water to be released in lined containment. Approximately 2 barrels (bbls) of crude oil and 3.74 bbls of produced water were released from the pump into the lined, secondary containment. A vacuum truck was dispatched and recovered approximately 5.74 bbls of fluid from the lined SPCC containment ring. Once standing fluids were removed, the liner was visually inspected by Devon field staff for any pinholes or punctures; none were found. Based on this inspection there is no evidence that the spilled fluids left containment.

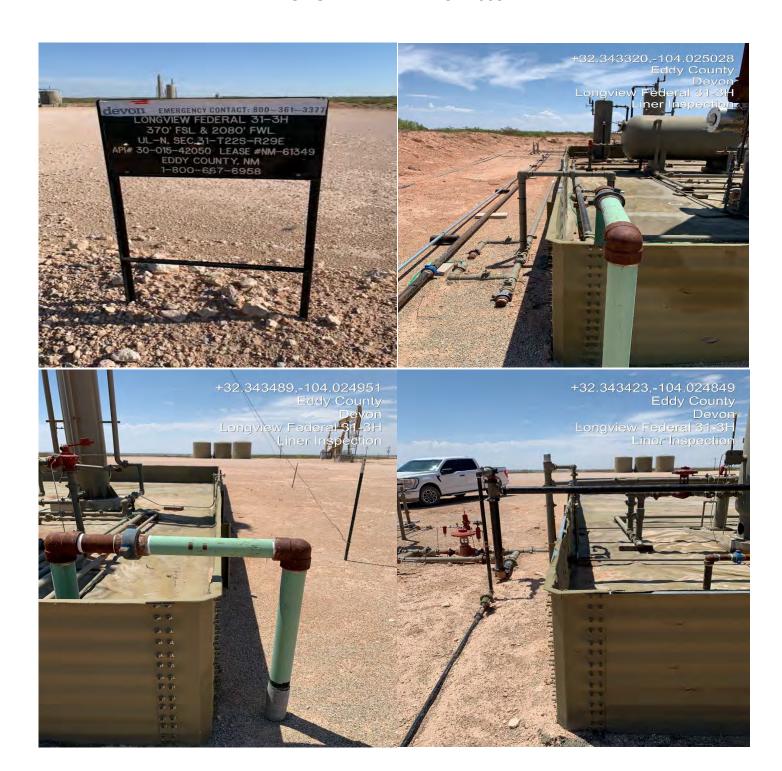
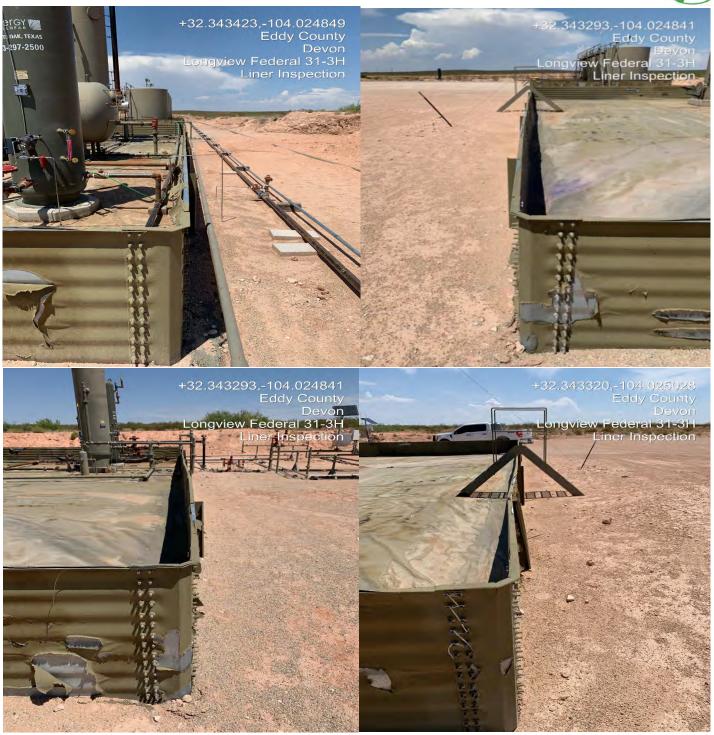
SITE PHOTOGRAPHS DEVON ENERGY – LINER INSPECTION LONGVIEW FEDERAL 31 #003H

On September 30, 2023, after sending the 48-hour notification email, Pima Environmental conducted a liner inspection at this location. We concluded that this liner and containment maintained its integrity and was able to retain the fluids. The liner inspection form and photographic documentation can be found in Appendix C.
