RE: Liner Inspection and Closure Report
Falabella 31 Fee #001H Battery
API No. N/A
GPS: Latitude 32.69749 Longitude -104.42780
UL- M, Section 31, Township 18S, Range 26E
NMOCD Reference No. NAPP2324038155

Liner Inspection Form

Site: Falabella 31 Fee #1 Battery

**SPUR ENERGY PARTNERS
FALABELLA 31 FEE #1 BATTERY
SITE PHOTOGRAPHS**

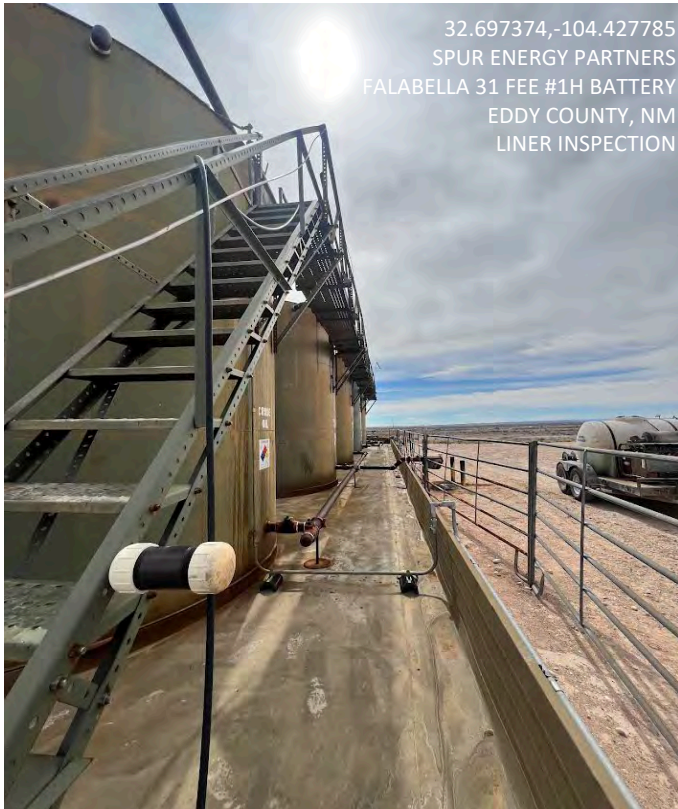
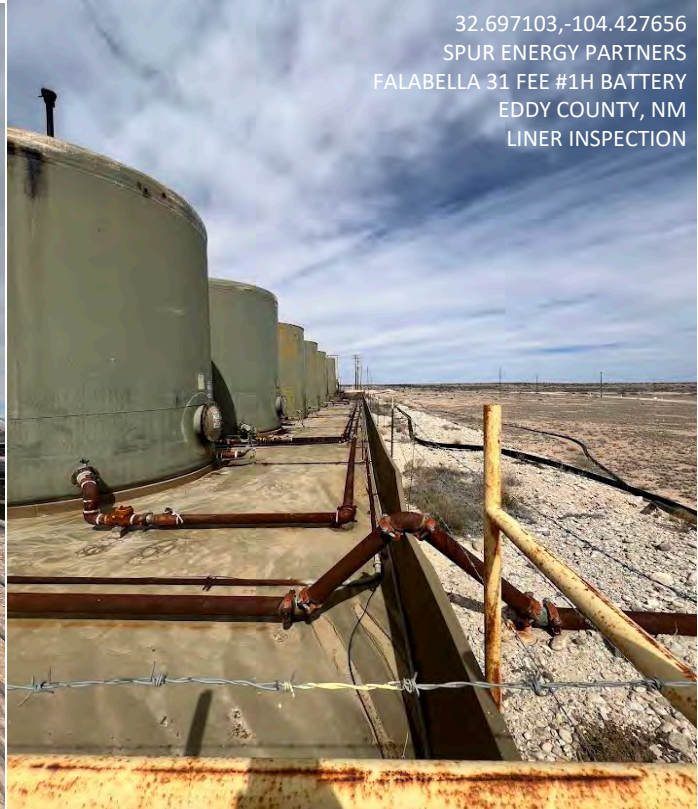
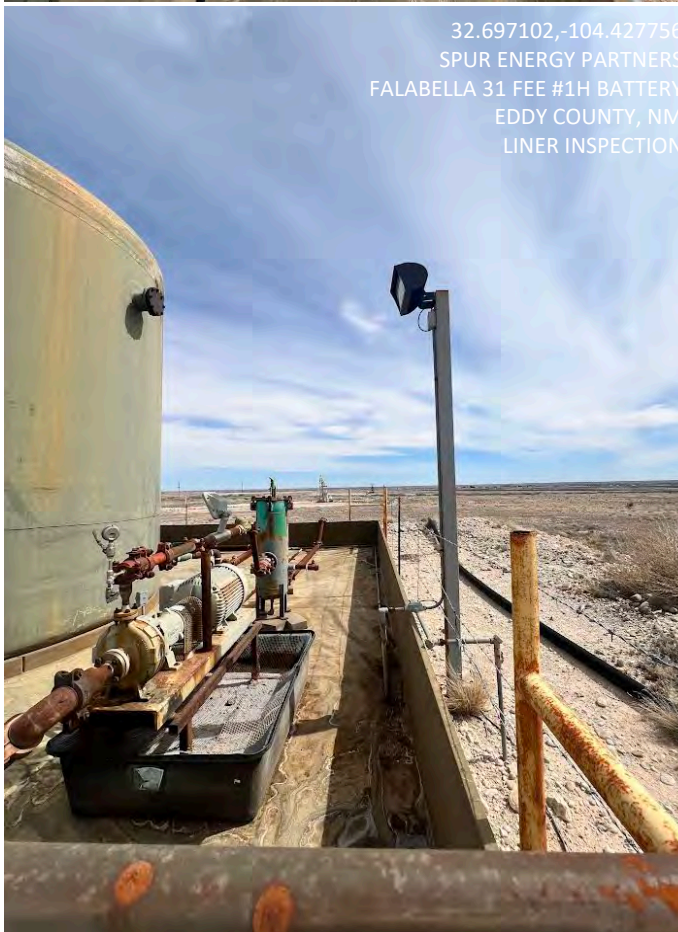
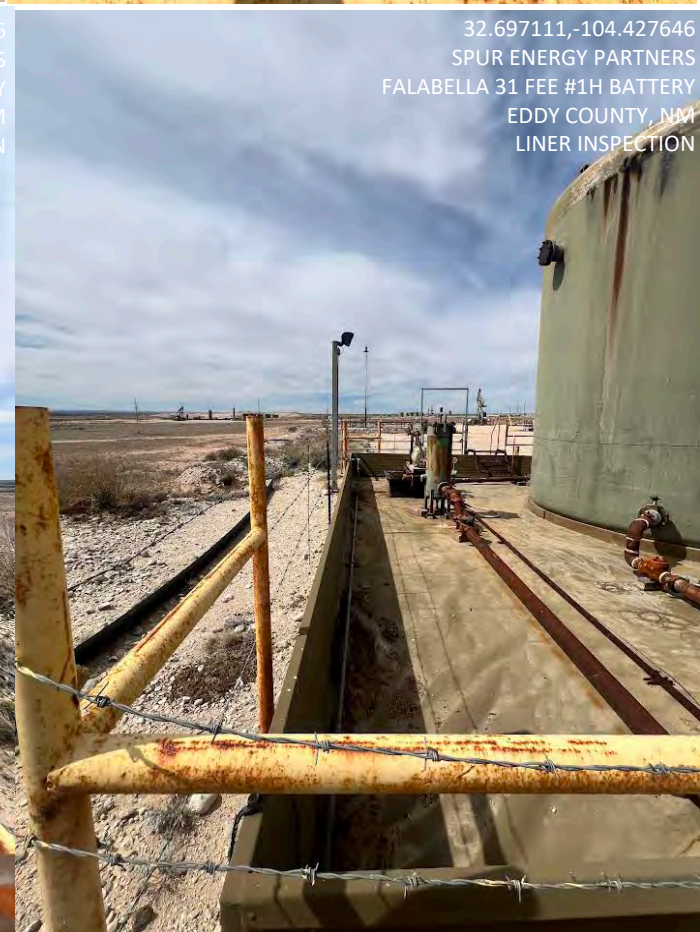
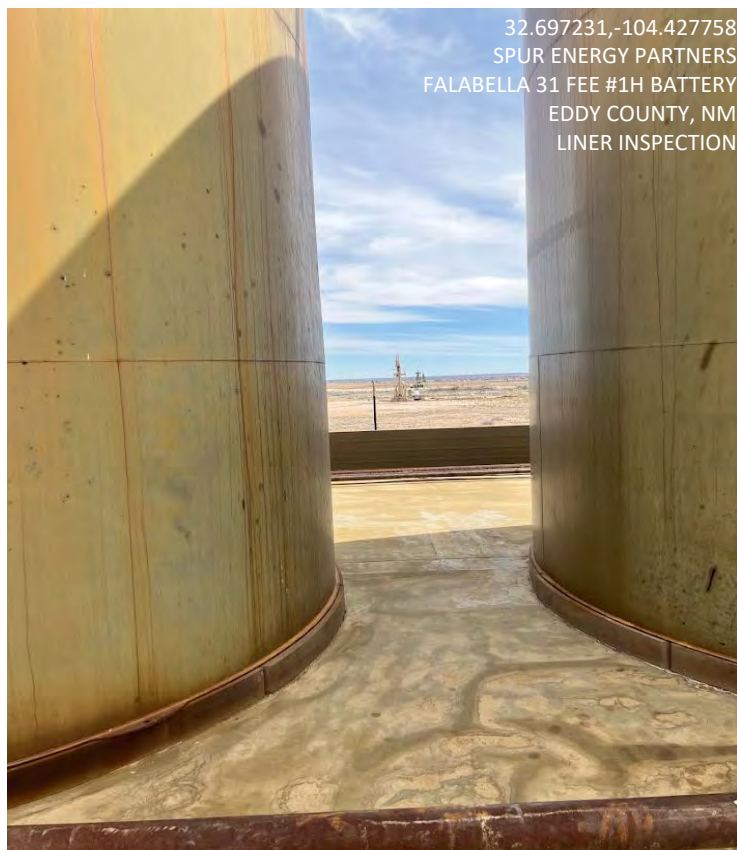
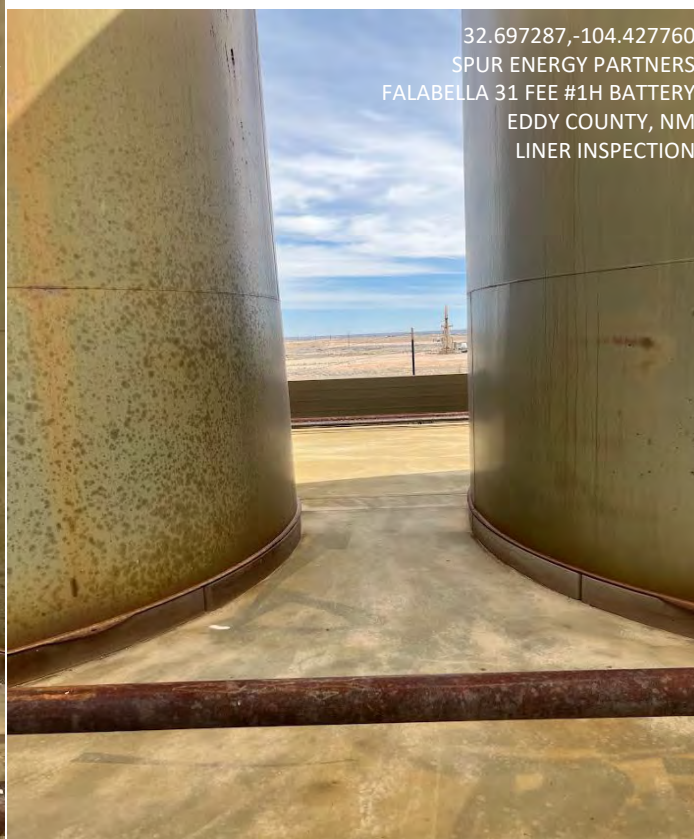
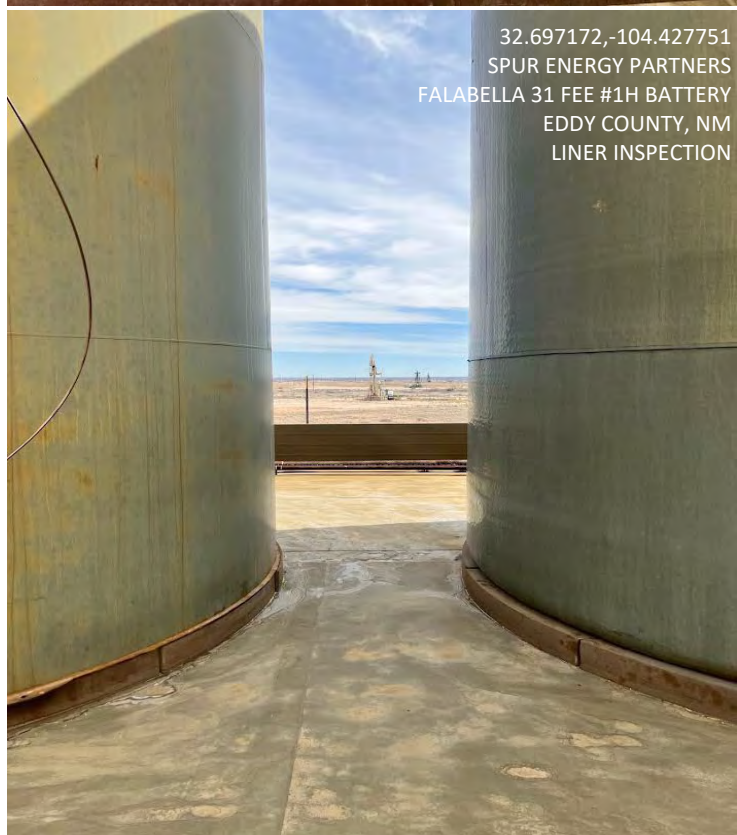
On February 28, 2024, Pima Environmental conducted a liner inspection at this location. We concluded that this liner and containment maintained its integrity and was able to retain the fluids. The liner inspection form and photographic documentation can be found in Appendix C.

Visualization	Yes	No	Comments
Is there a tear in the liner?		X	
Are there holes in the liner?		X	
Is the liner retaining any fluids?	X		The inspection images of the liner reveal residual fluid resulting from the remediation event involving power washing.
Does the liner have integrity to contain a leak?	X
