LINER INSPECTION CLOSURE REPORT

Incident ID nAPP2416940193

Cotton Draw Unit 1-12 Bone Spring CTB

July 1, 2024

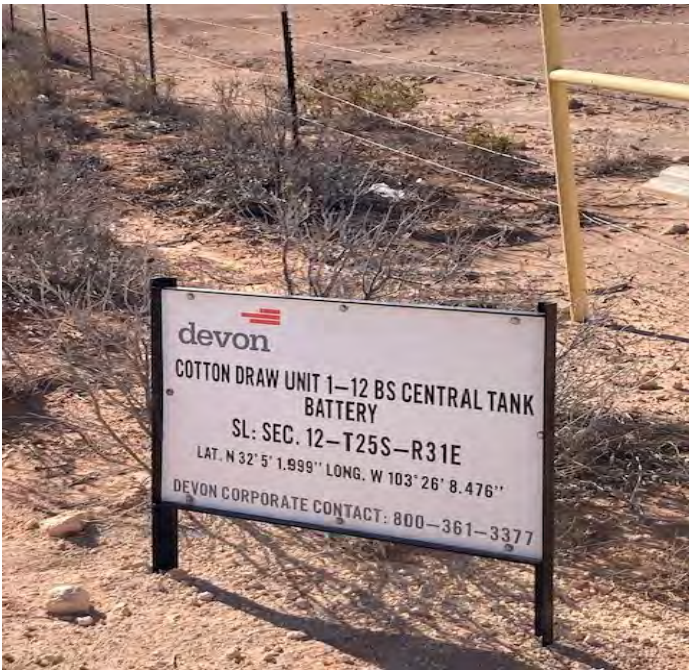
Lease Sign

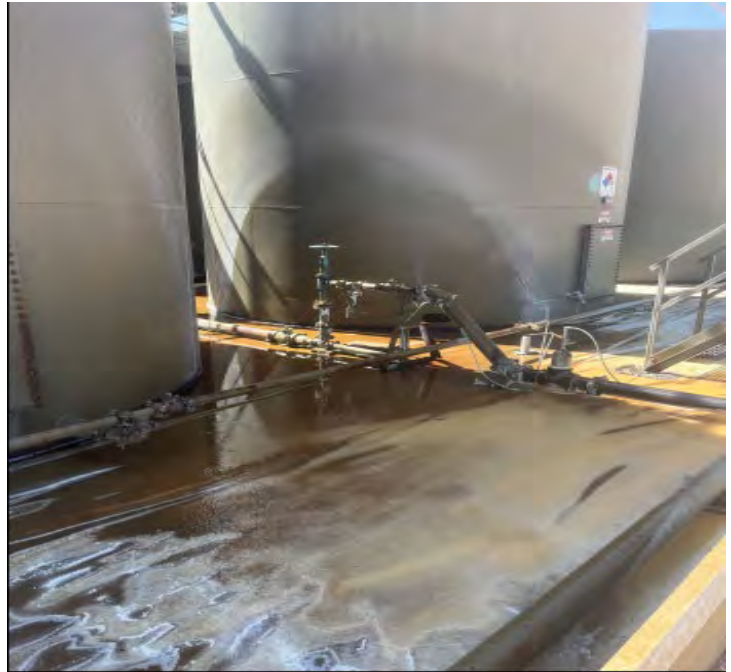
Point of Release

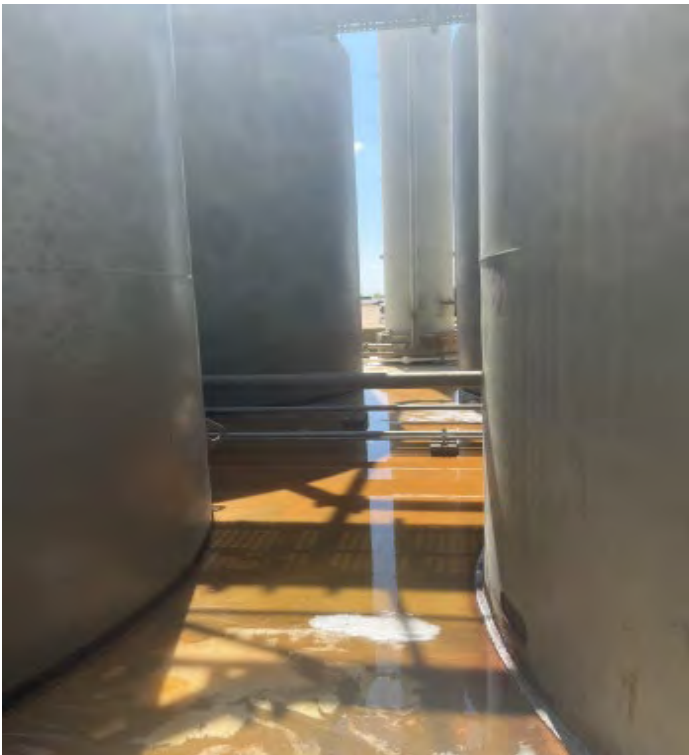
Fluid Inside Containment

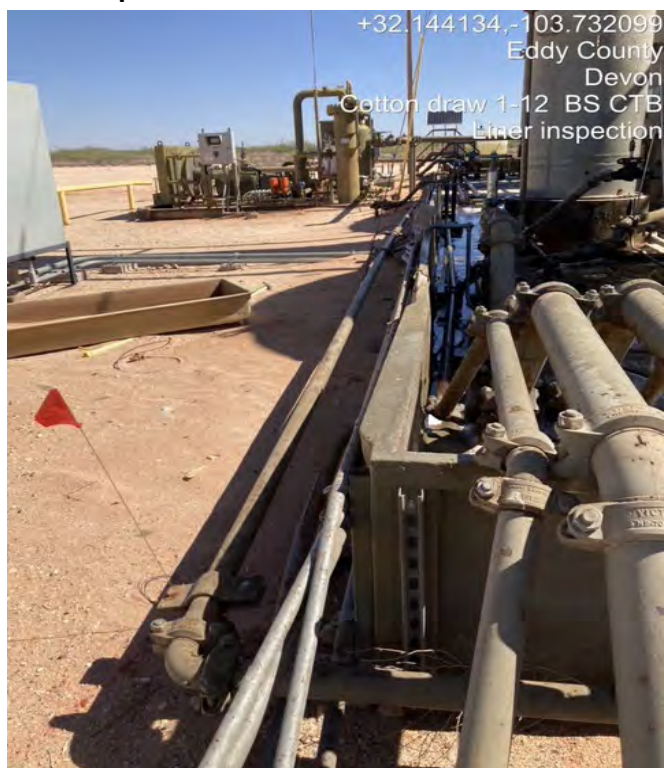
Post-wash, southwest corner looking north

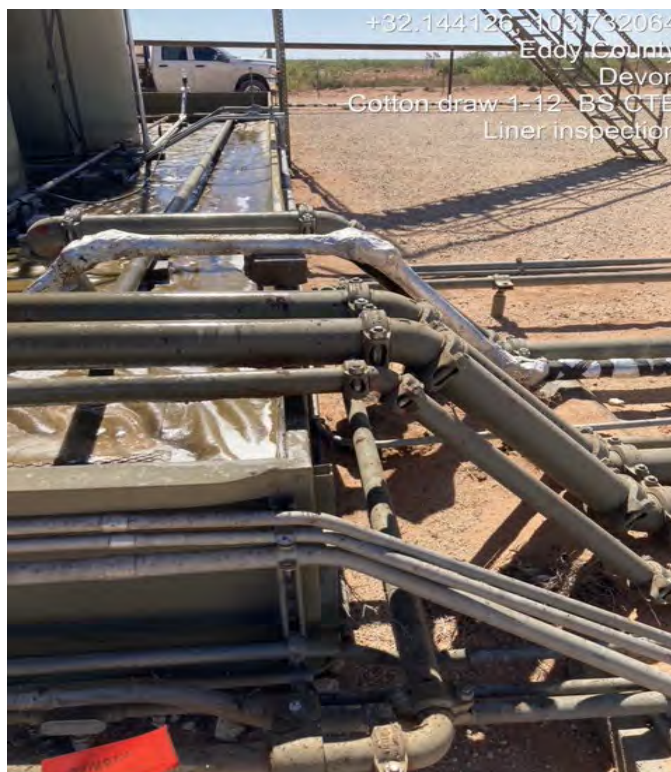
Post-wash, southeast corner looking west

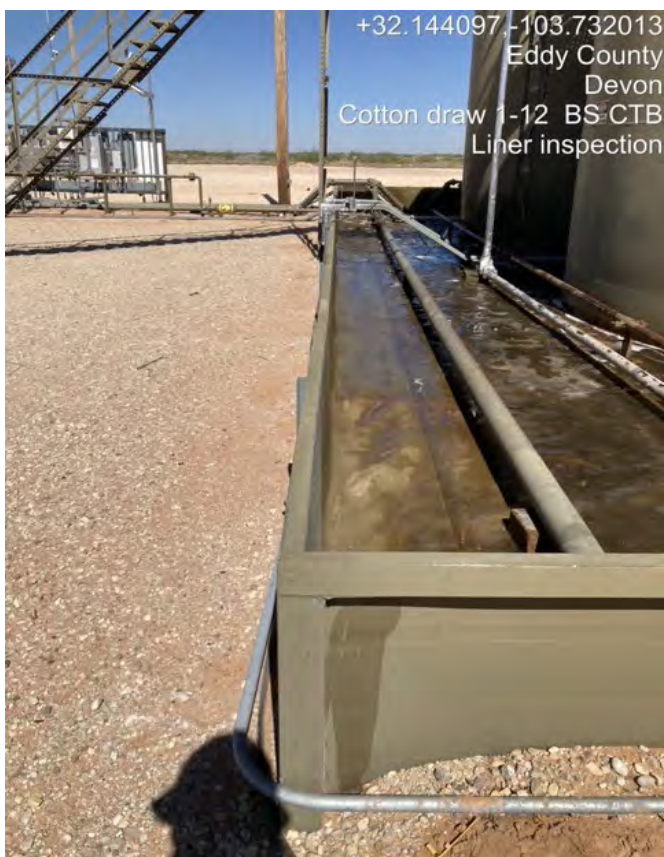
Post-wash, southeast corner looking west

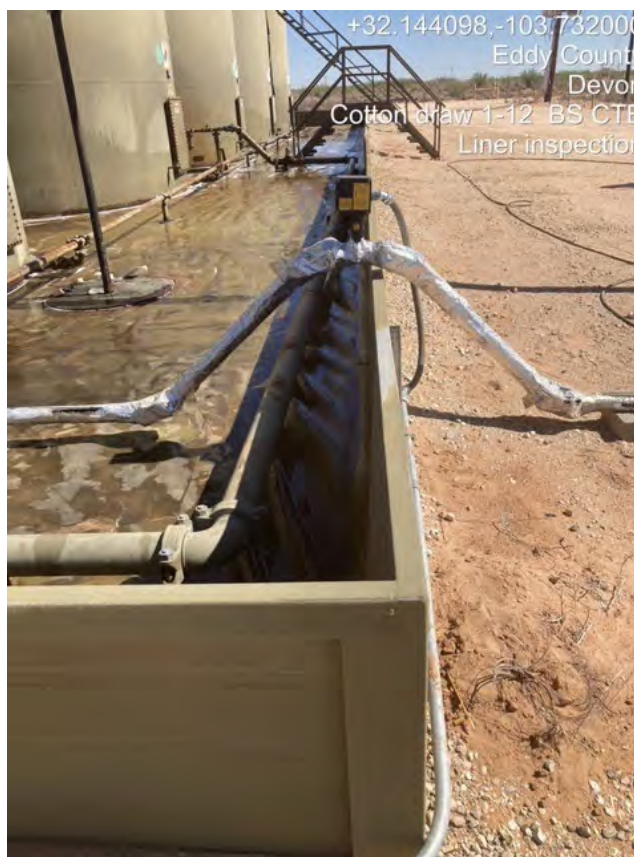
Post-wash, southeast corner looking north

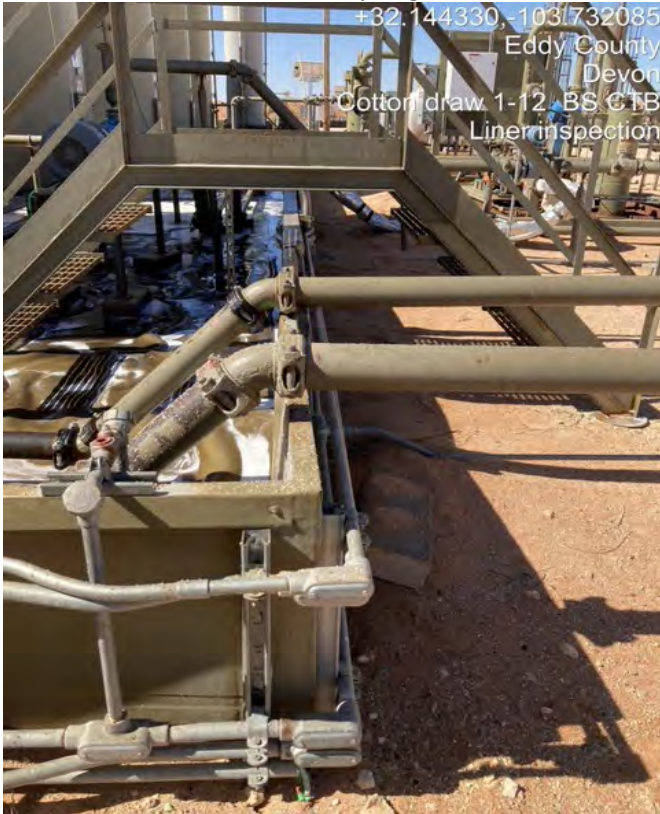
Post-wash, northeast corner looking south

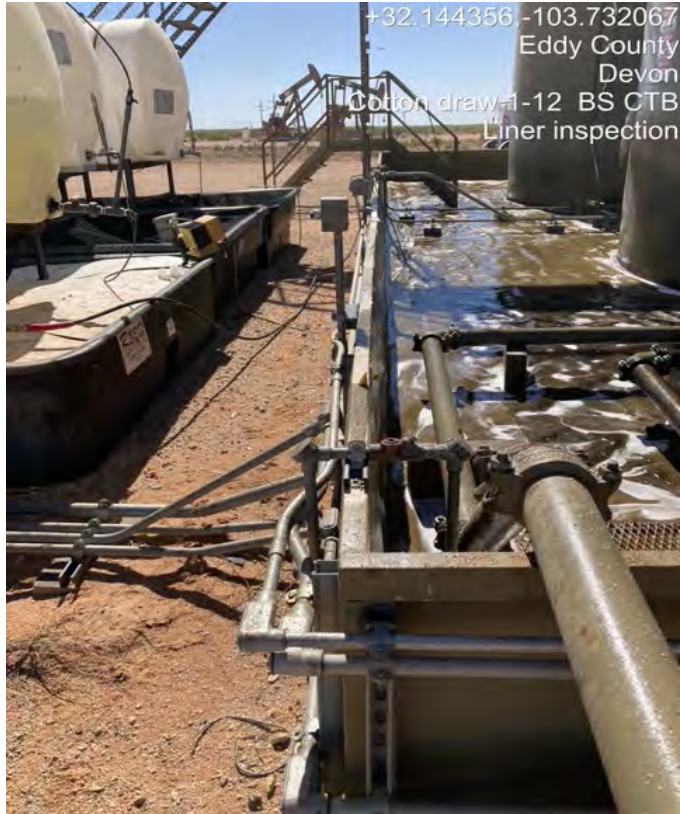
Post-wash, northeast corner looking west

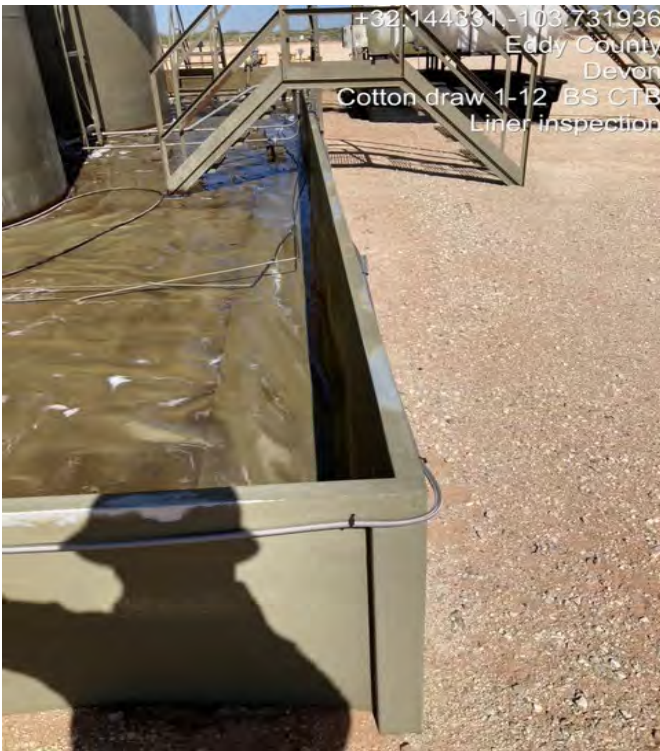
Post-wash, northwest corner looking east

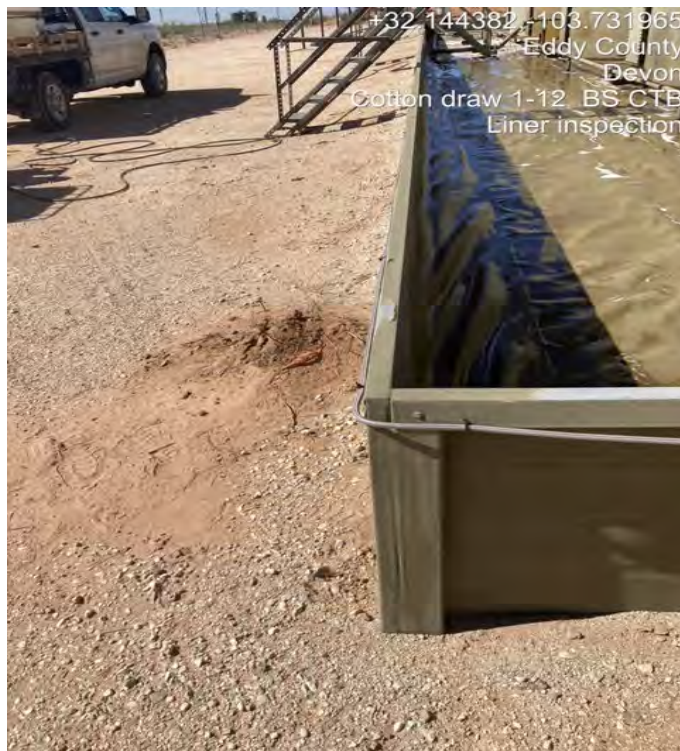
Post-wash, northwest corner looking south

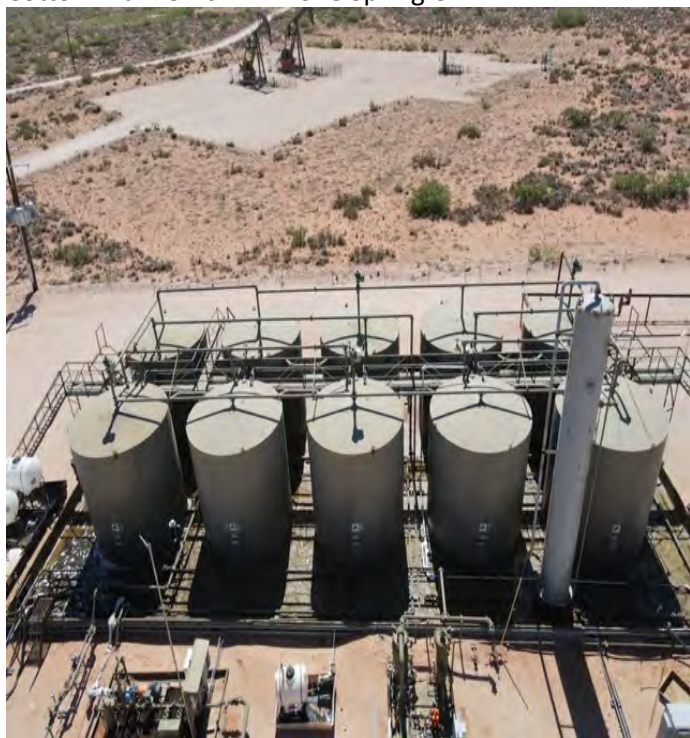
Post-wash, aerial view east side

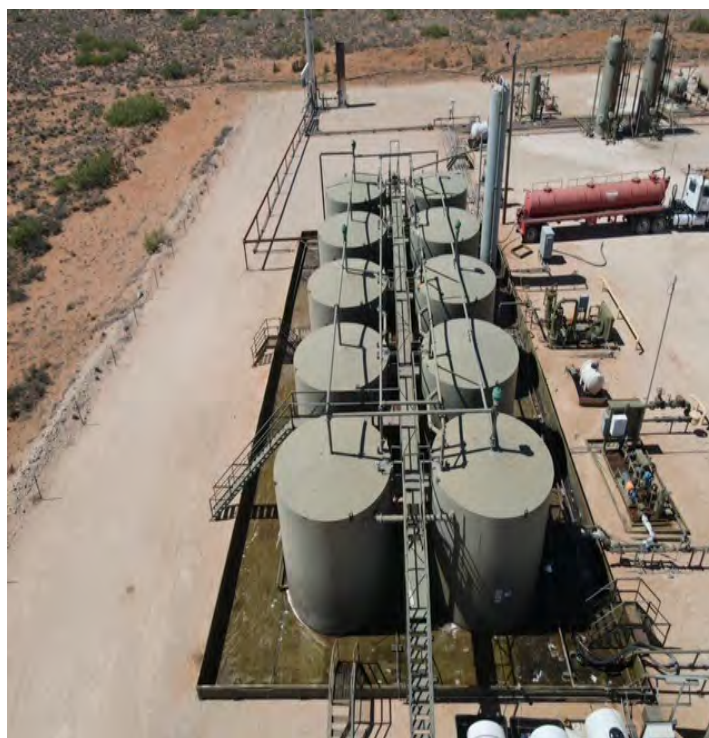
Post-wash, aerial view north side

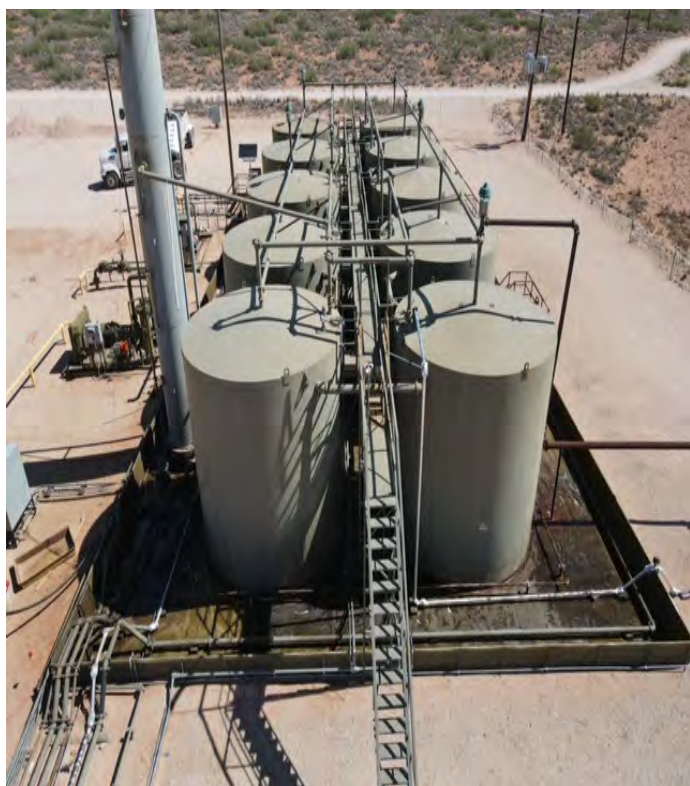
Post-wash, aerial view south end

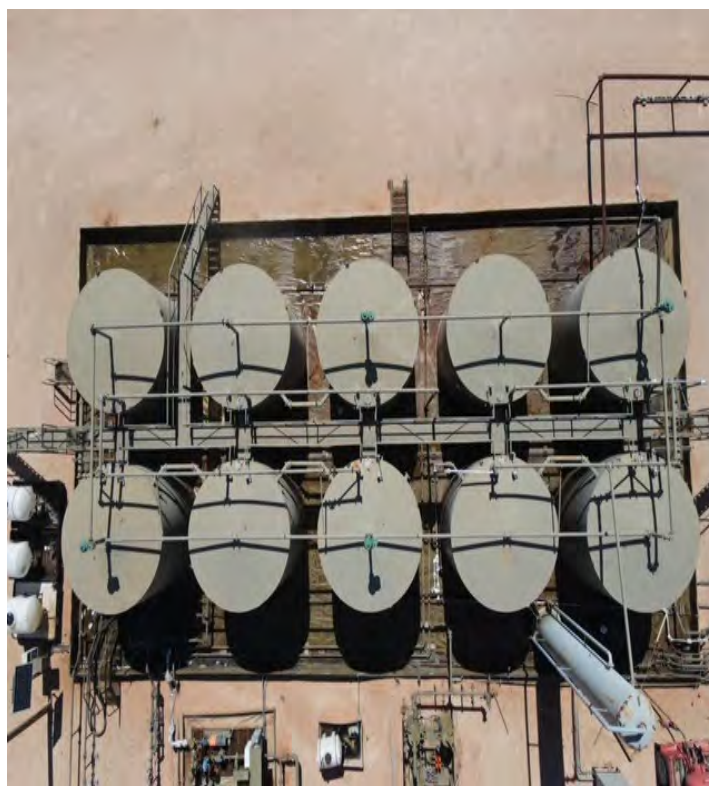
Post-wash, aerial view overhead
