RE: Liner Inspection and Closure Report
JC Federal 13 Tank Battery
API No. 30-025-38697
GPS: Latitude 32.82449 Longitude -103.75303
UL- B, Section 22, Township 17S, Range 32E
Lea County, NM
NMOCD Reference No. NAPP2416351391

JC Federal 13 Tank Battery

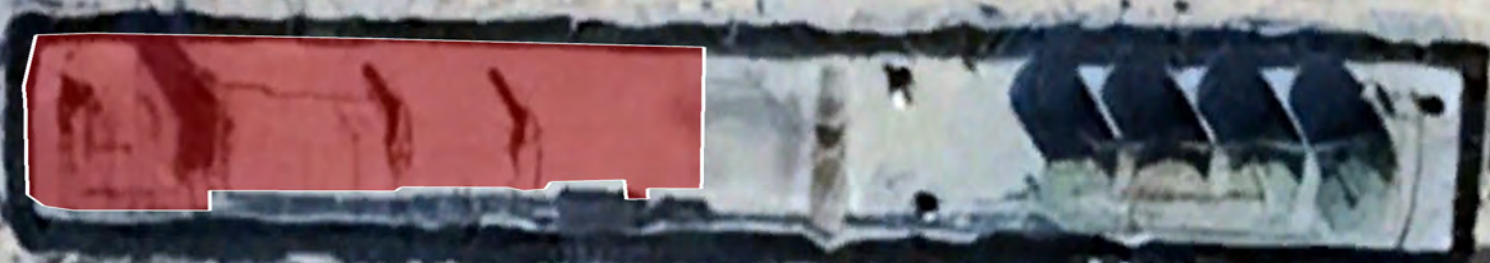
Figure 4- Site Map

Gravel Removal Area

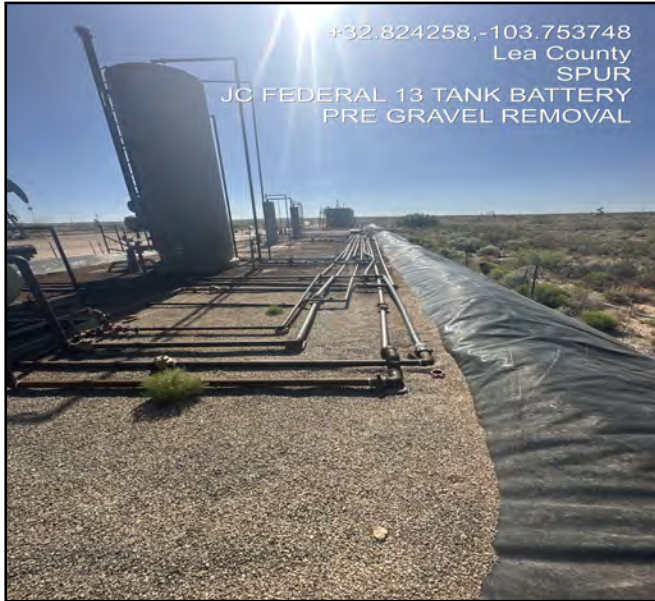
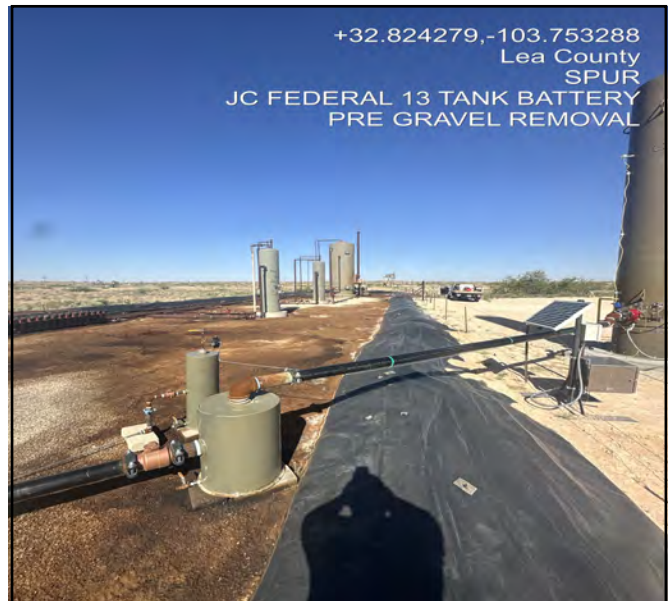
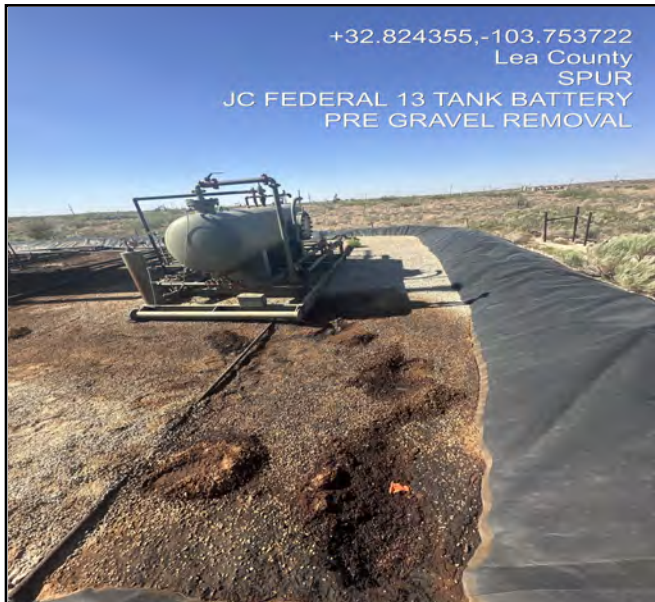
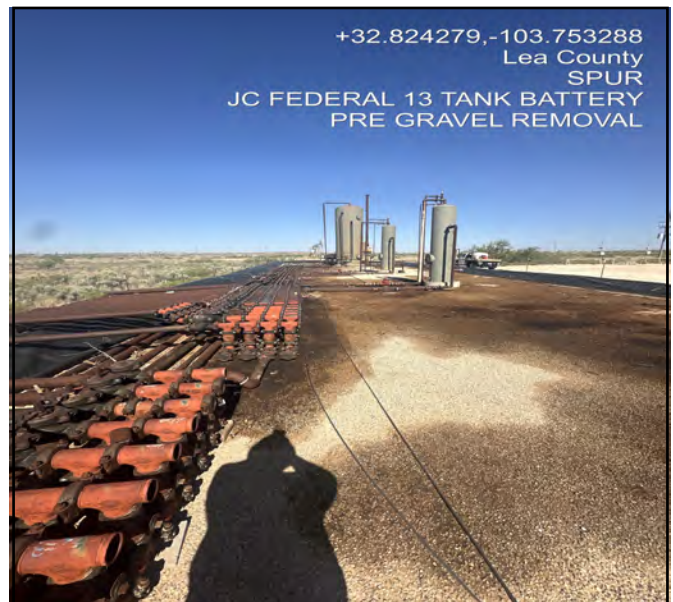
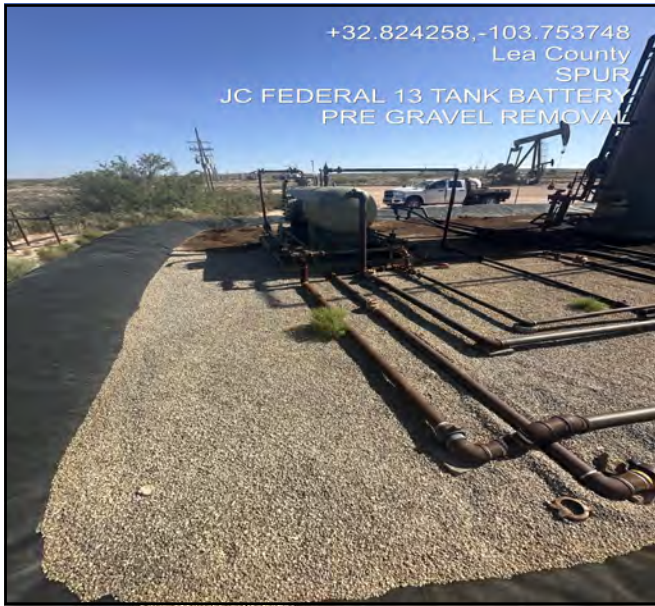
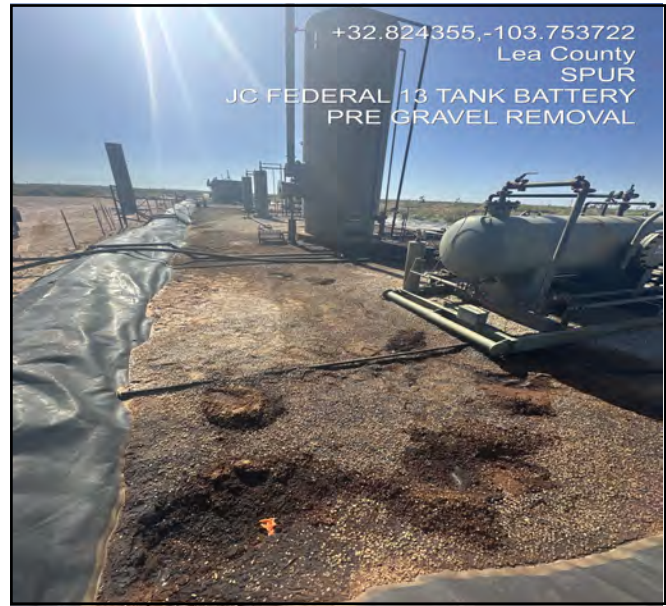
Photo showing the area of release that spill occurred at.

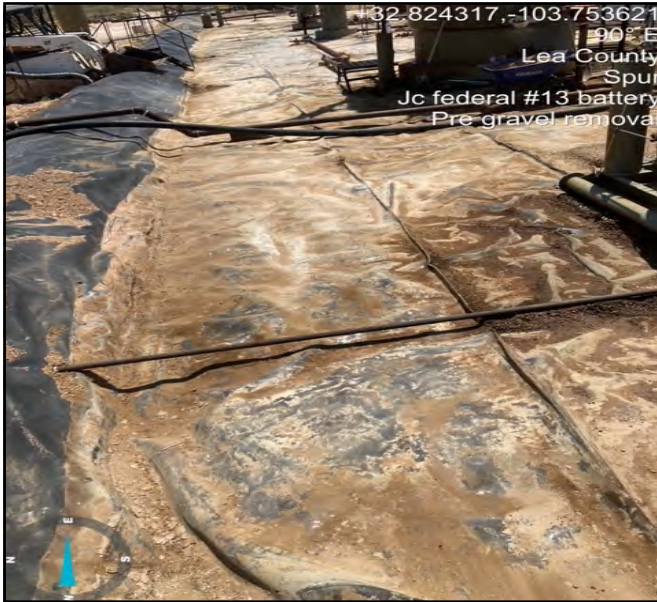
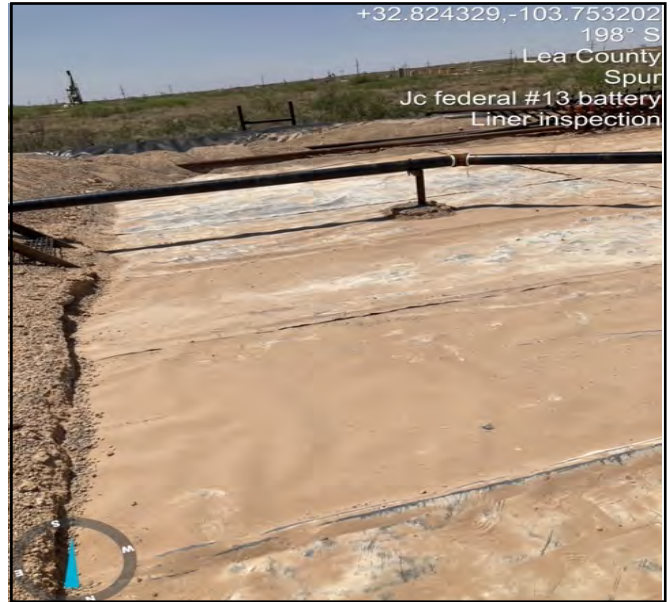
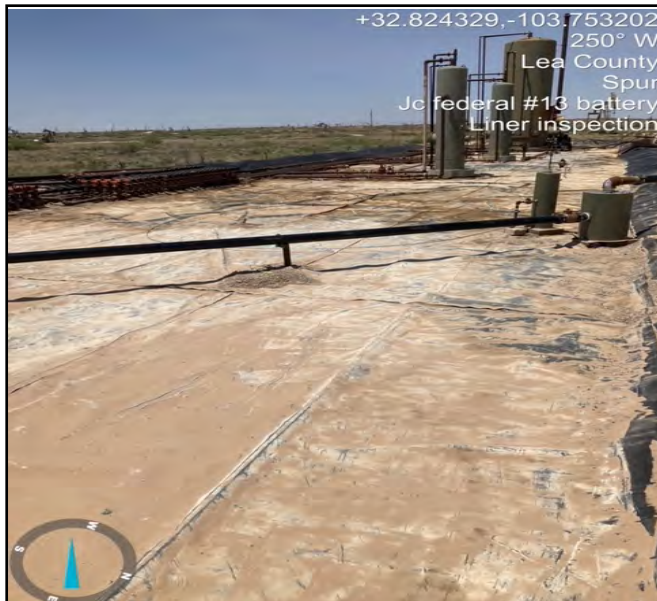
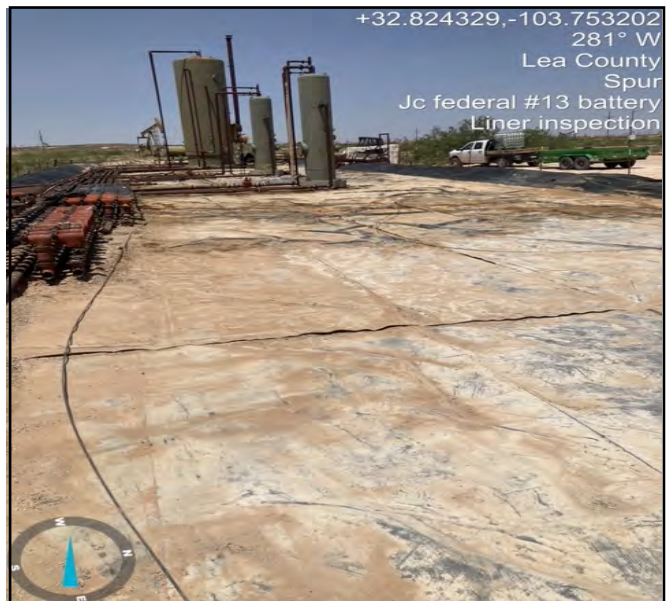
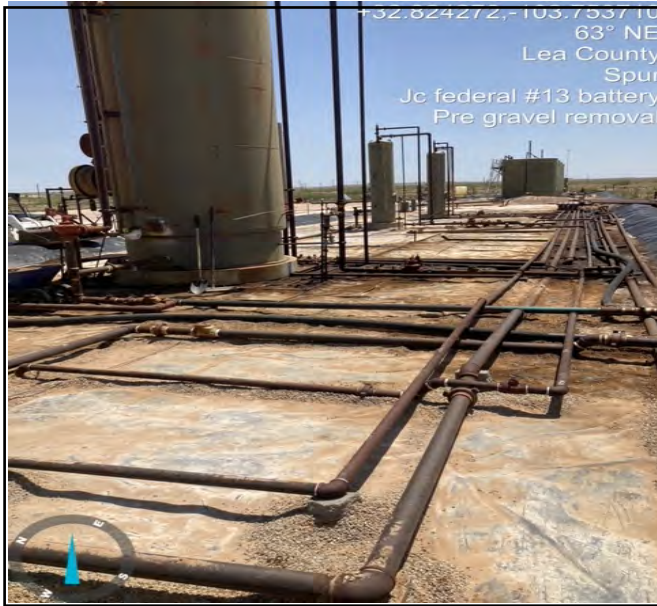
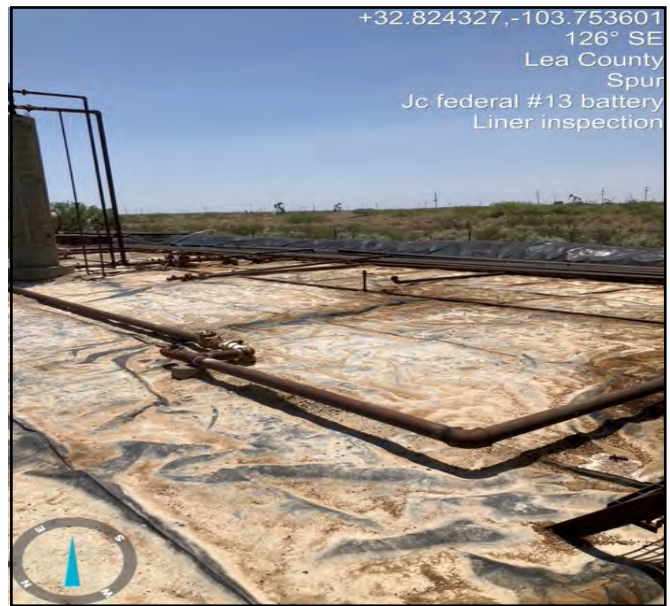
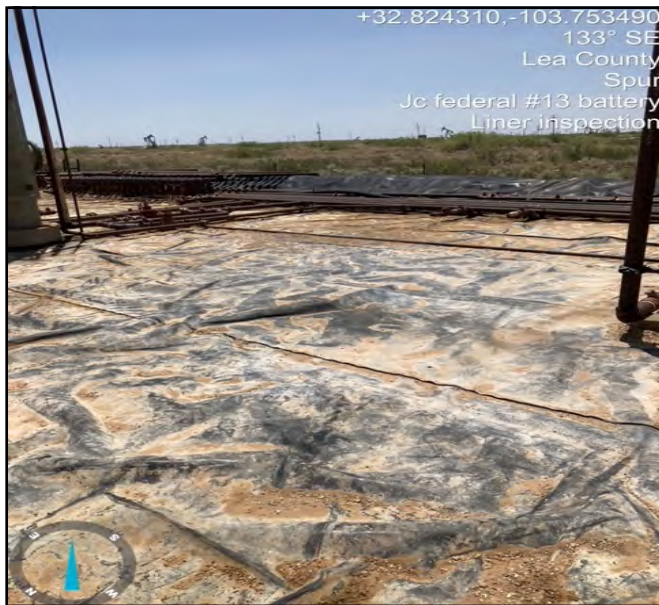
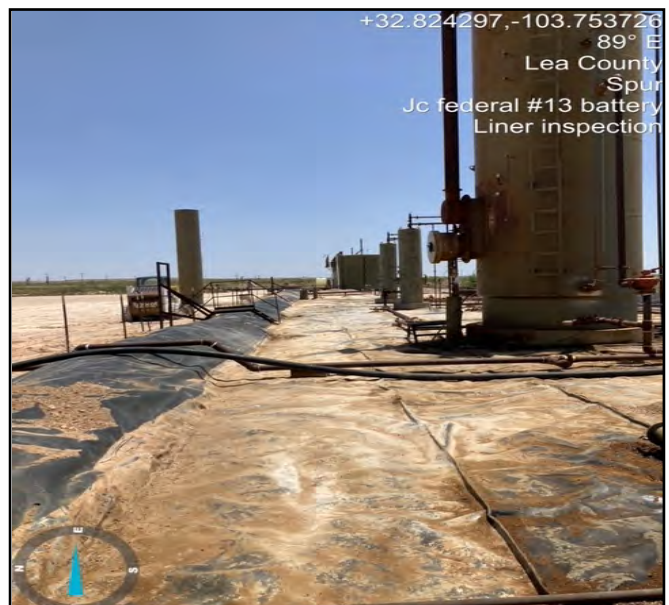
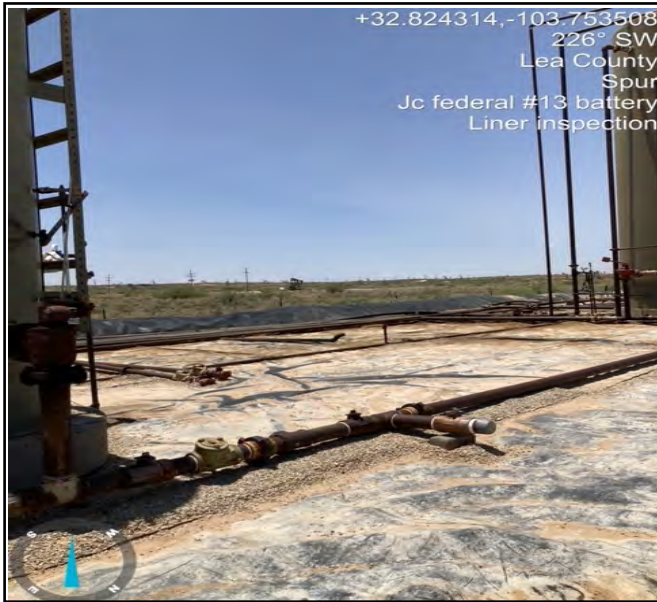
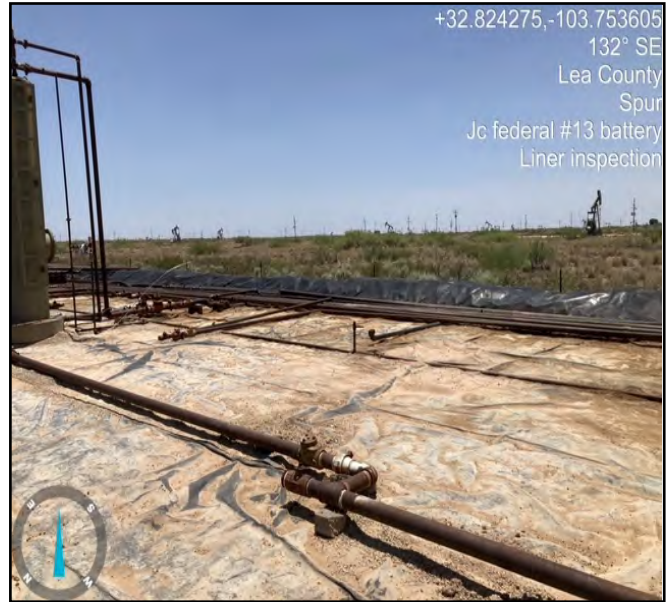
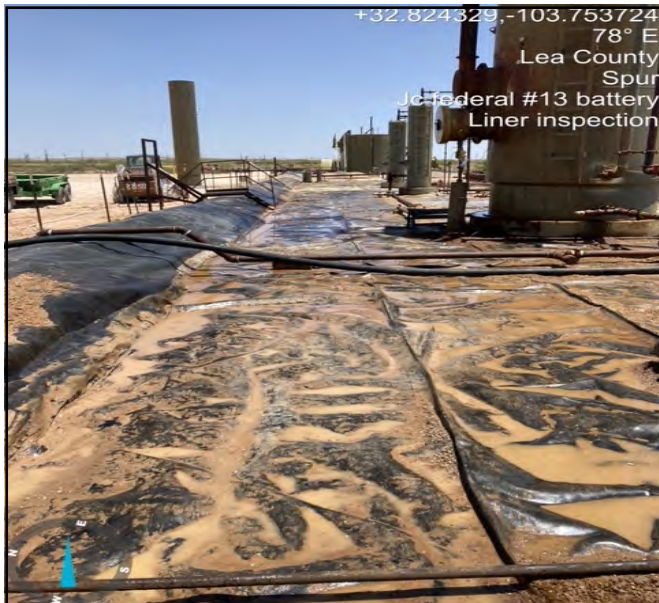
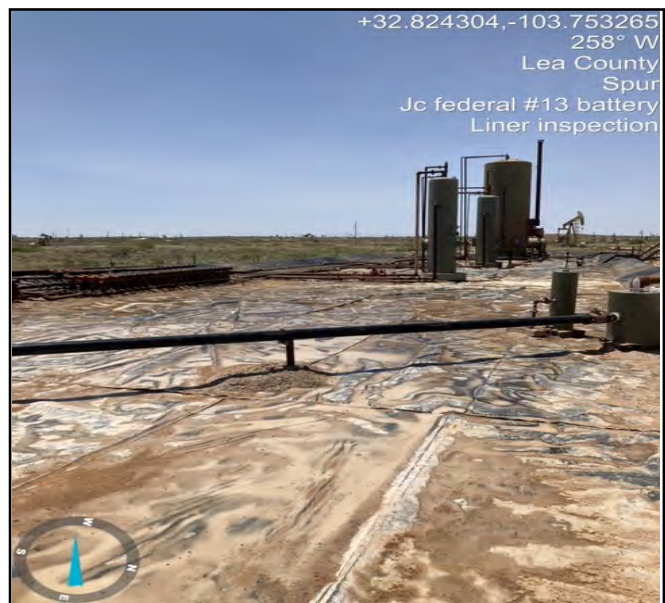
Photo exposing the liner that was underneath the contaminated gravel

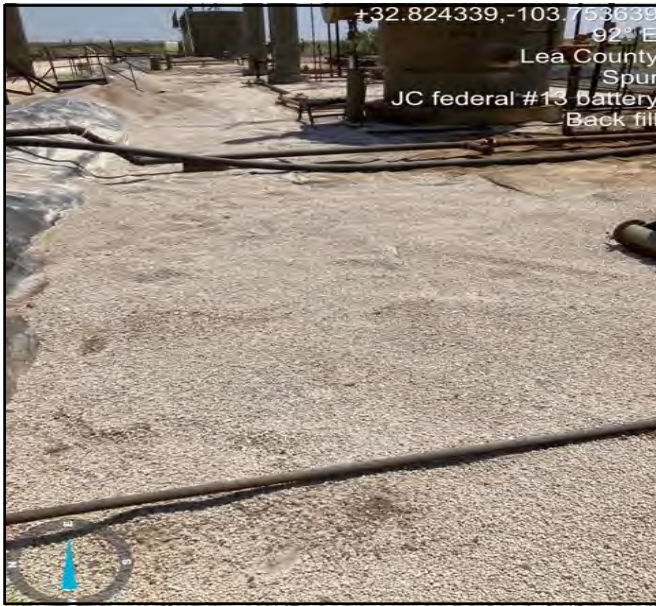
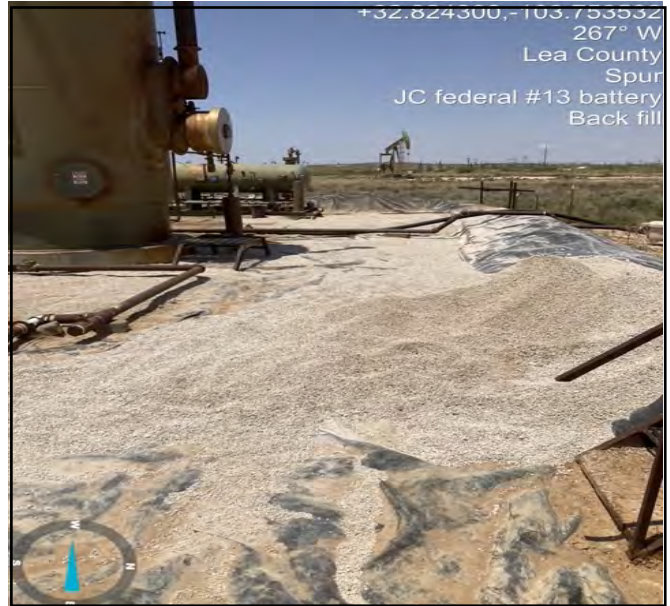
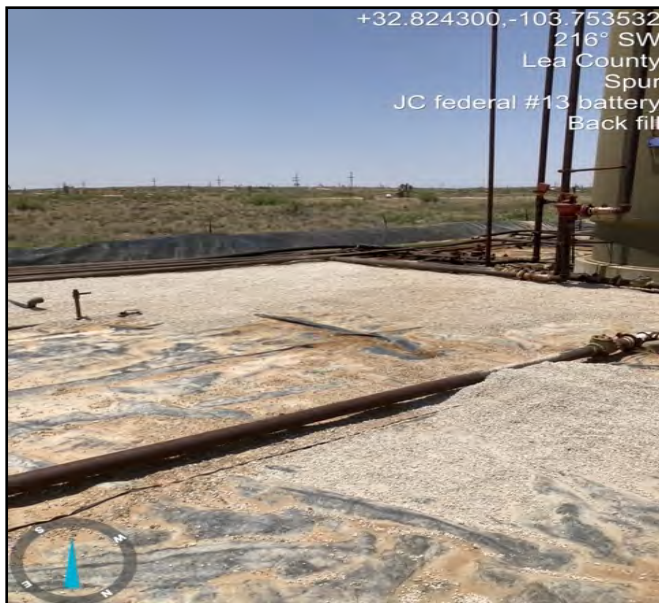
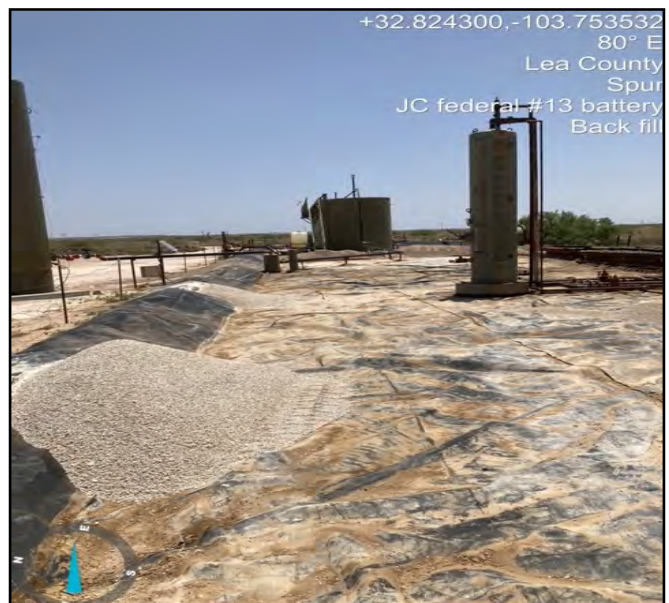
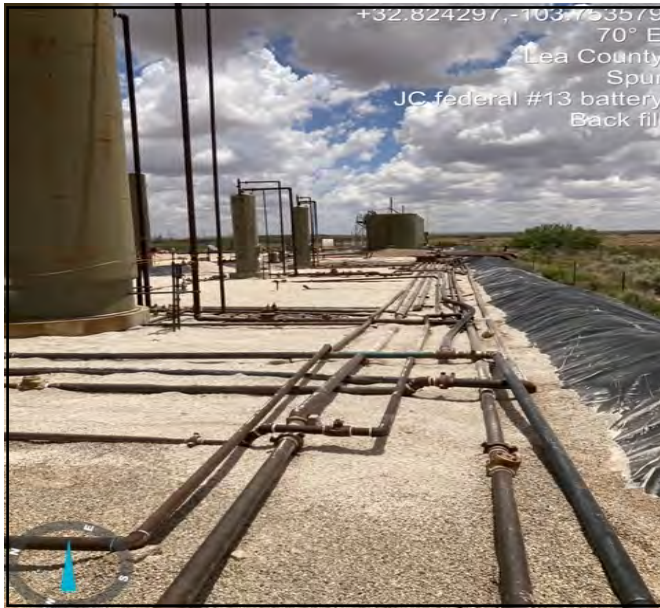
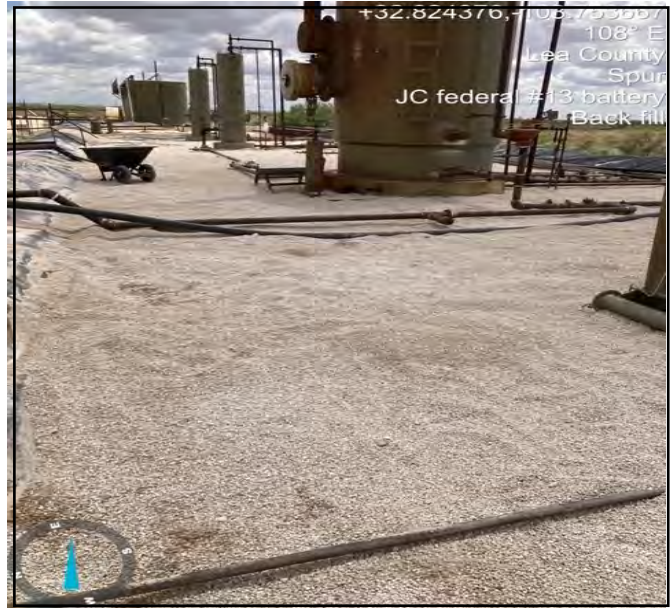
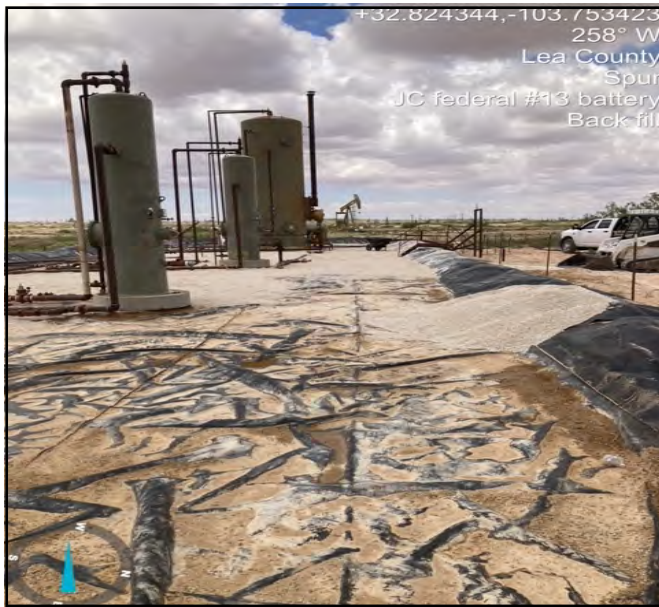
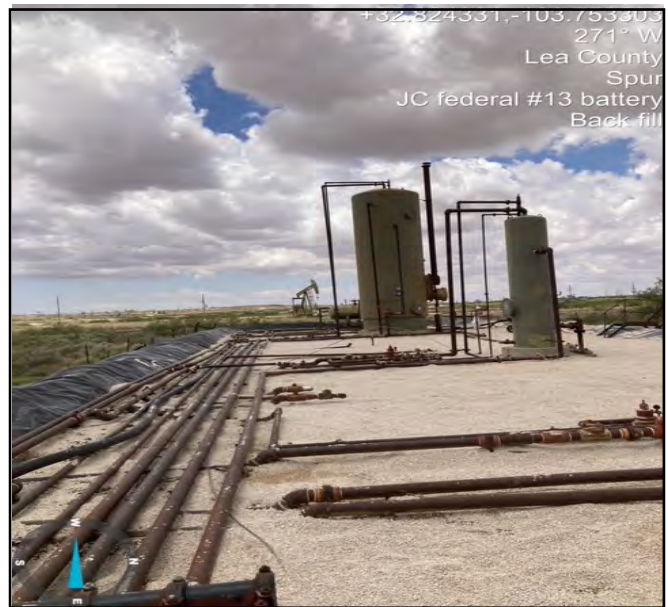
Photo showing backfill areas with clean gravel
