Liner Inspection and Closure Report

BKU 13C Battery

Incident ID nAPP2424656984

September 25, 2024

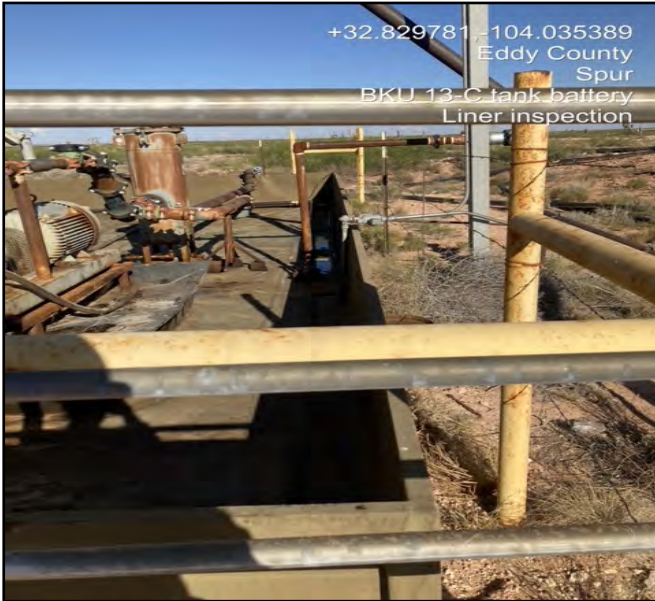
Photo of the liner pursuant to power washing.

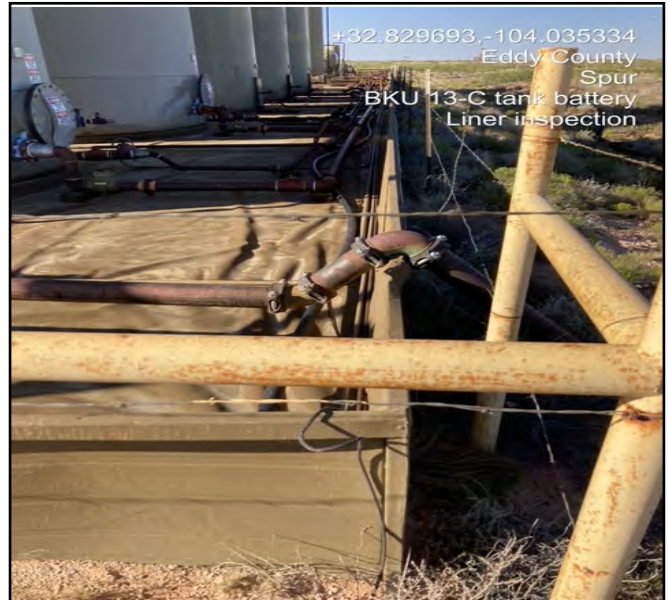
Photo of the liner pursuant to power washing.

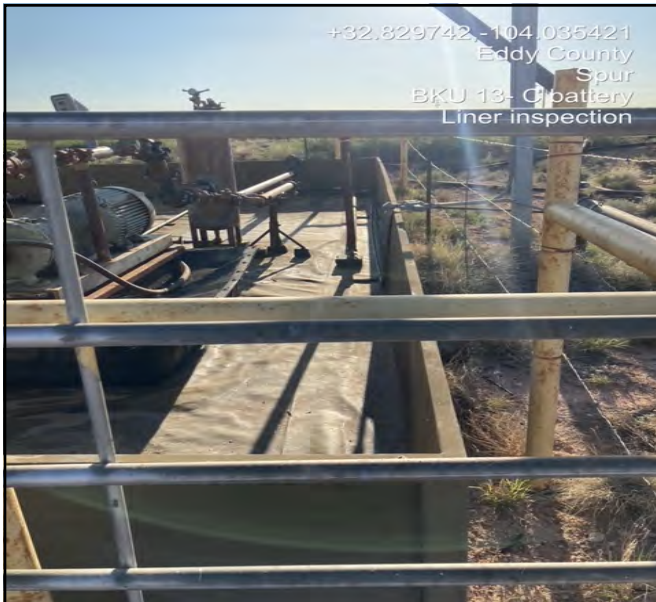
Photo of the liner pursuant to power washing.

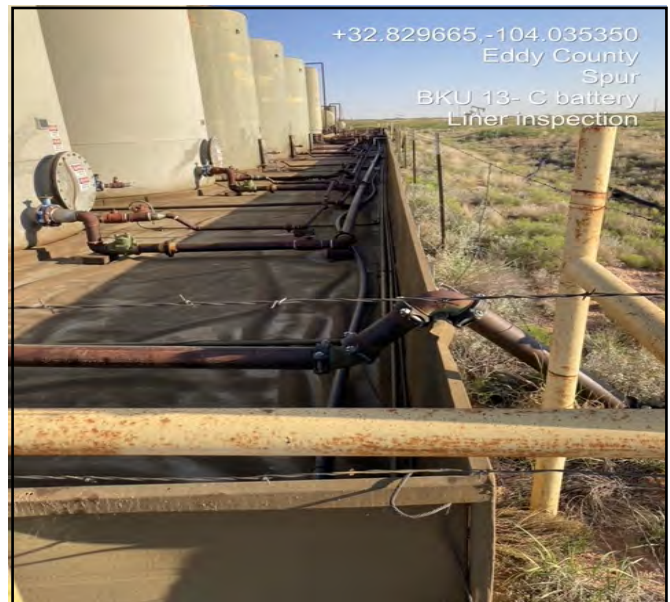
Photo of the liner pursuant to power washing.

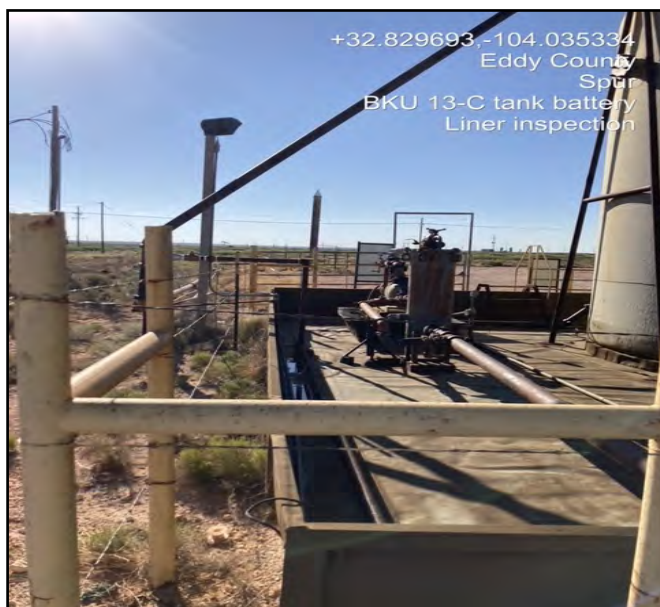
Photo of the liner pursuant to power washing.

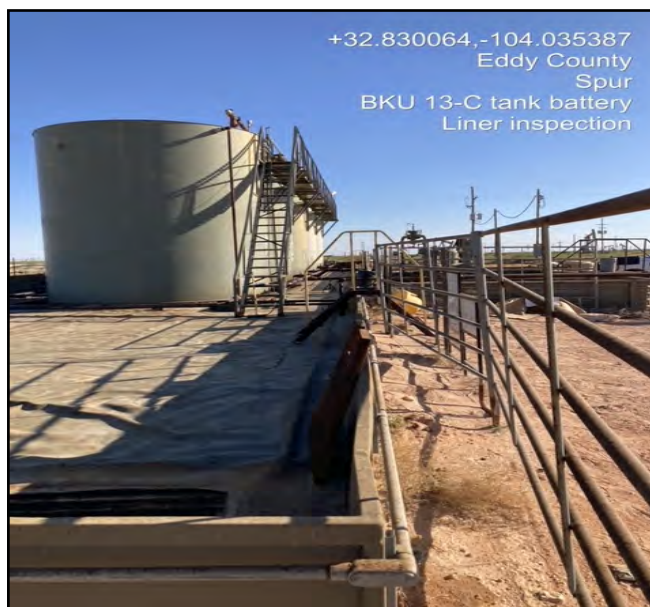
Photo of the liner pursuant to power washing.

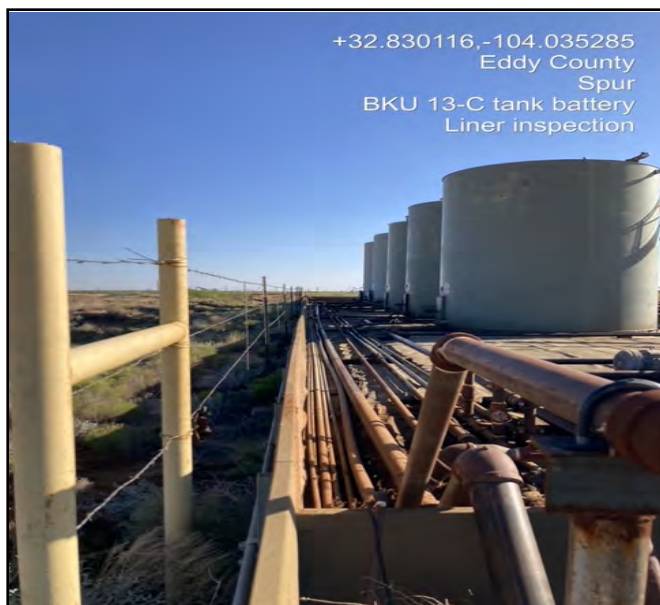
Photo of the liner pursuant to power washing.

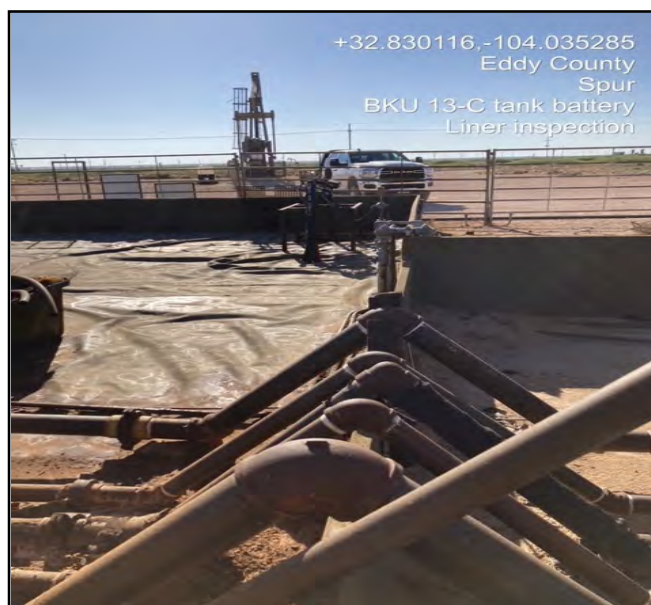
Photo of the liner pursuant to power washing.
