McCoy State Battery

Incident ID nAPP2424850463

## Liner Inspection and Closure Report

November 17, 2024

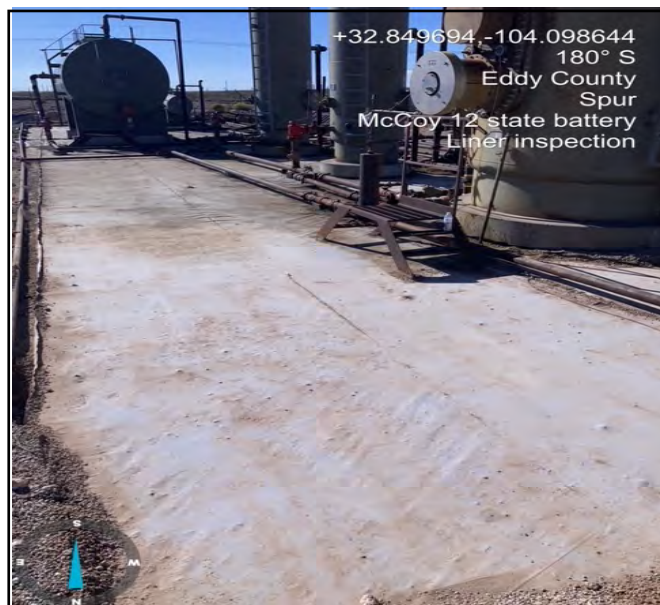
Photo of liner being inspected facing South.

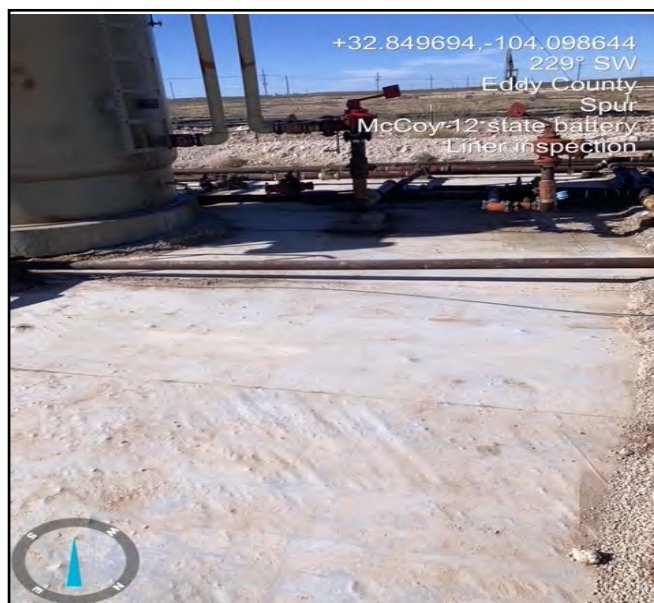
Photo of liner being inspected facing Southwest.

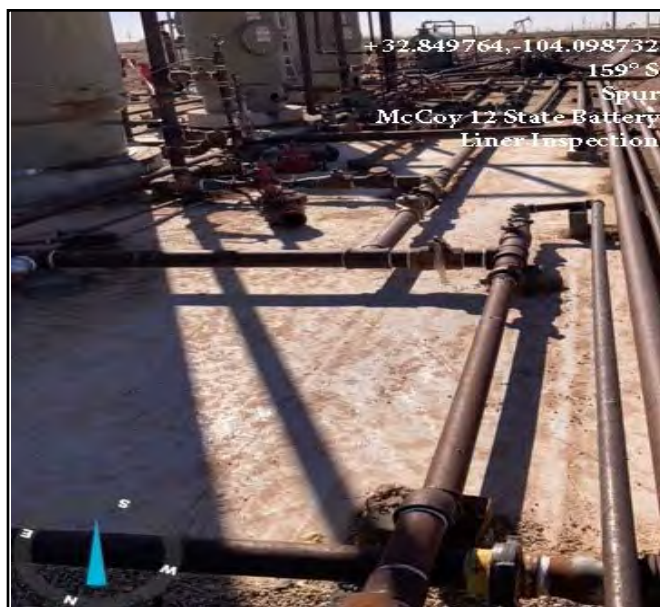
Photo of liner being inspected facing South.

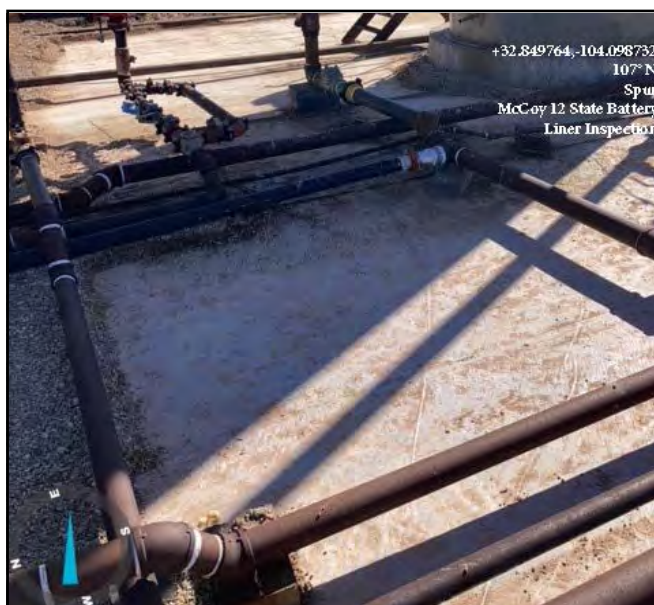
Photo of liner being inspected facing North.

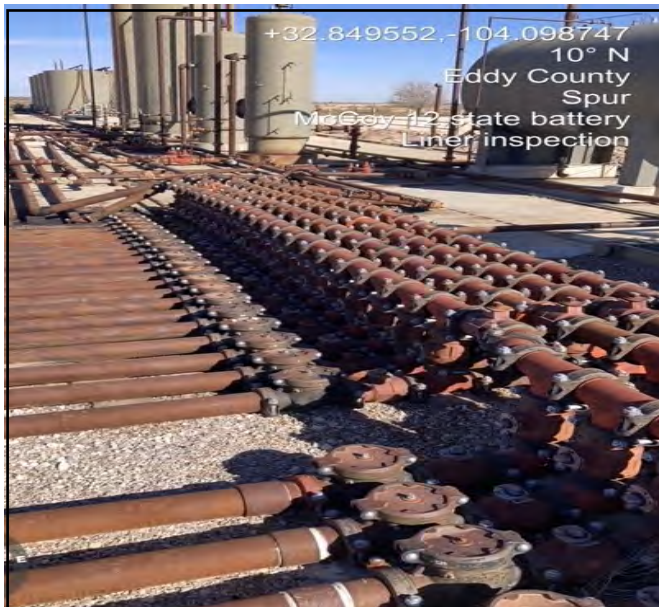
Photo of liner being inspected facing North.

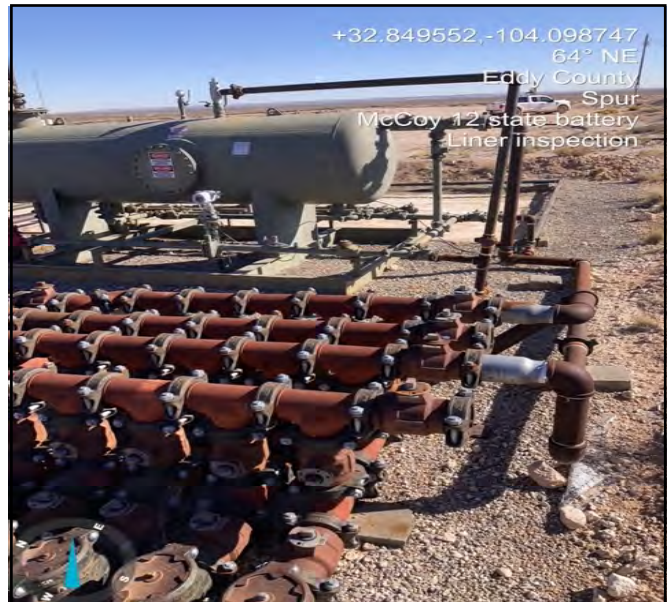
Photo of liner being inspected facing Northeast.

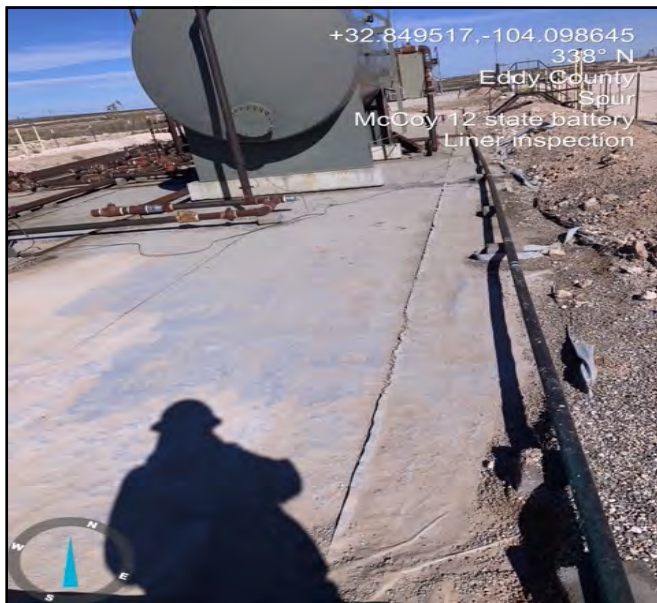
Photo of liner being inspected facing North.

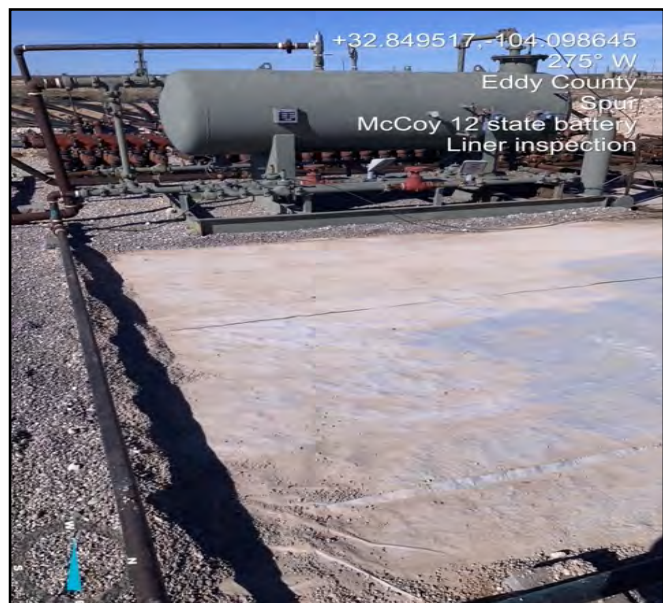
Photo of liner being inspected facing West.
